**PUBLIC FUND ARCHAEOLOGICAL SOCIETY OF KAZAKHSTAN,
REPUBLIC OF KAZAKHSTAN
THE SOCIETY FOR THE EXPLORATION OF EURASIA,
SWITZERLAND**

SCIENTIFIC REPORT

**Archaeological studies of the ancient settlement
Kesken-Kuyuk-Kala (Juvara) in 2018**

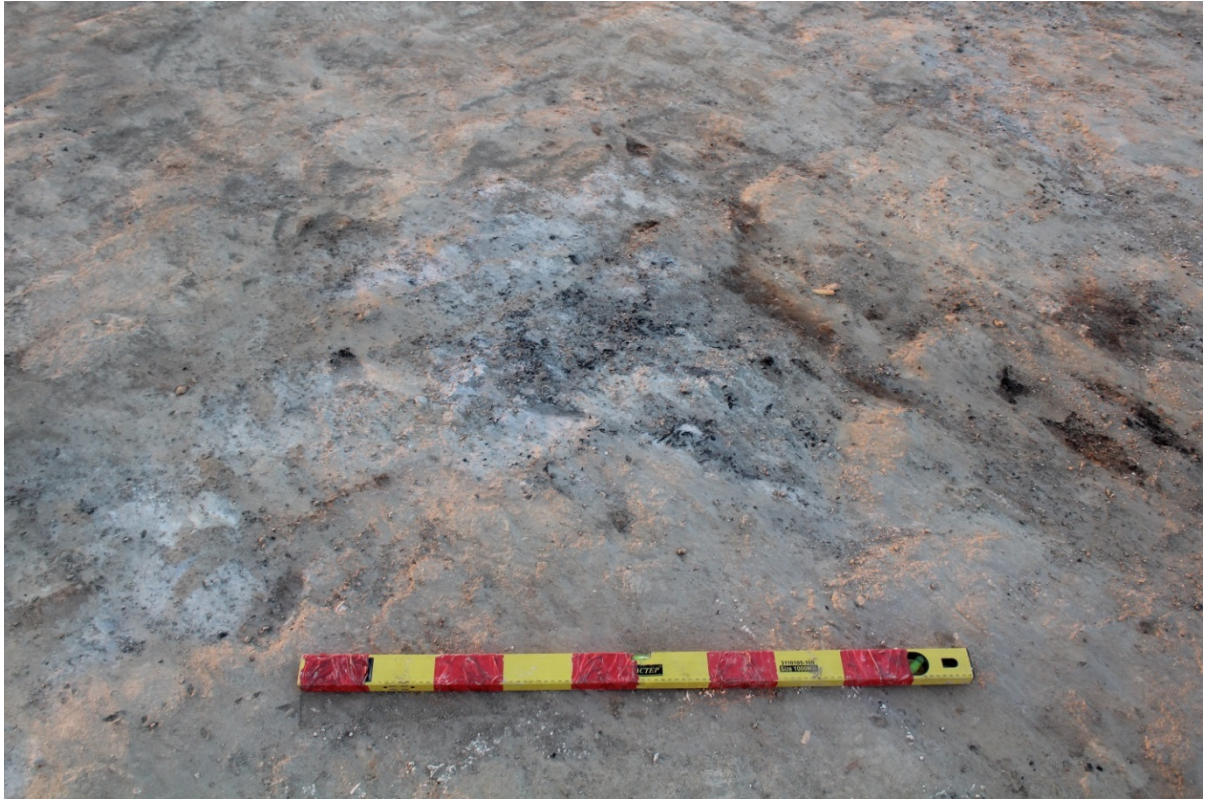
Photo 11. Excavation No.14. Ash spots (traces of fire) in the central part of the excavation

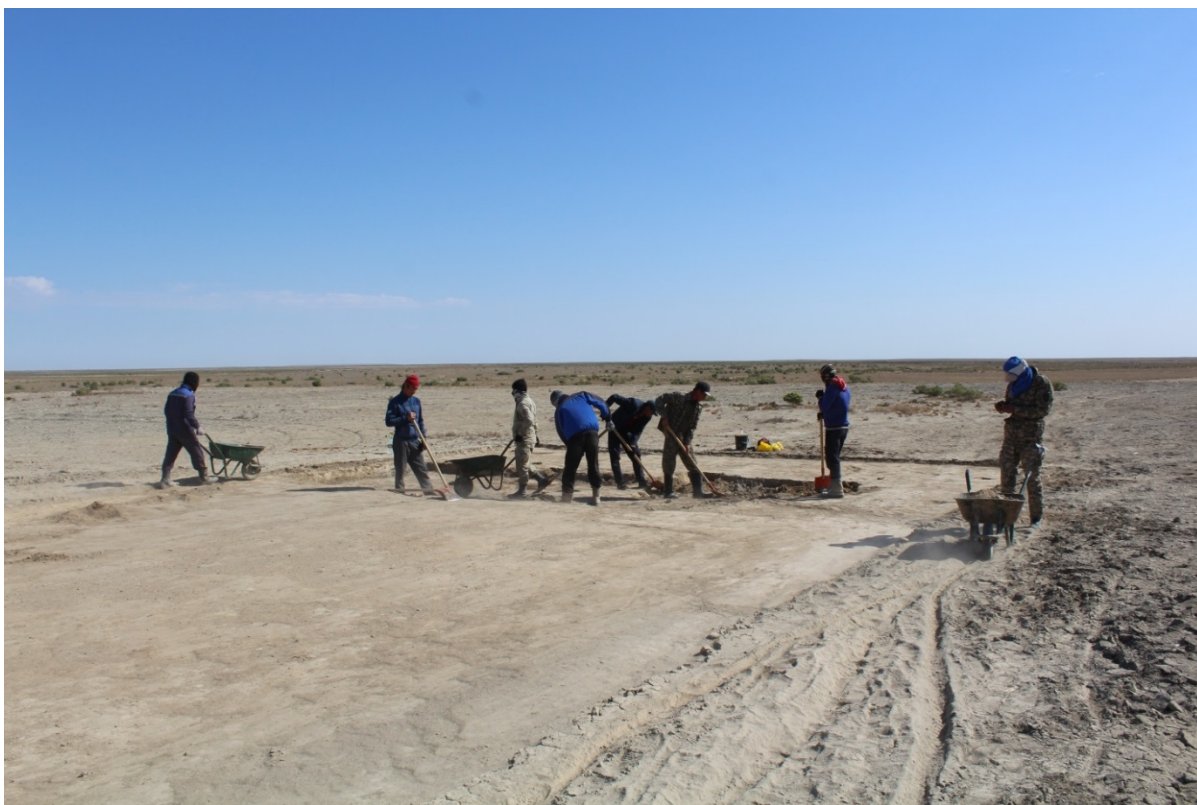
Photo 12. Excavation No.14. Ash spots (traces of fire) in the central part of the excavation

Element 398. The ash spot of the right-angled form was revealed after removing the upper inflatable layer in the central part of the excavation (Photo 11-12). The power of ash mixed with coals, 3-5 cm.

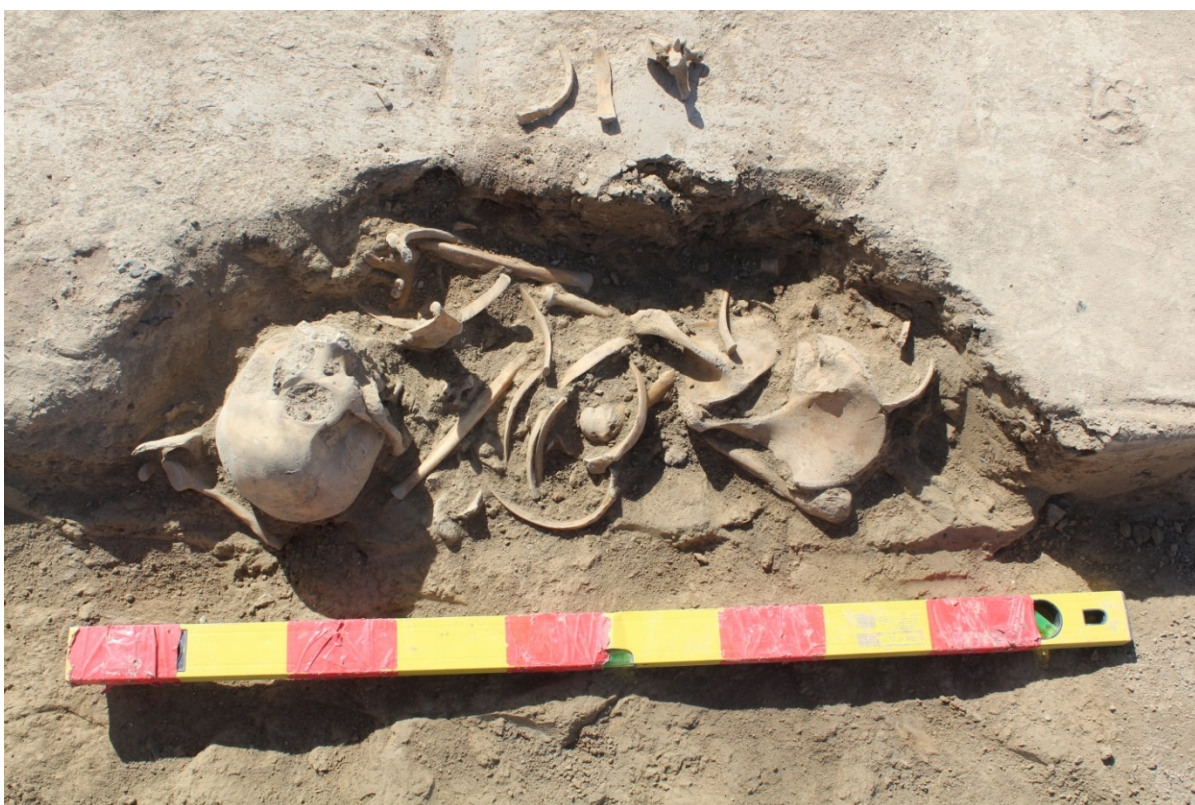
Photo 20. Excavation No.14. Late burial in the central part of the excavation

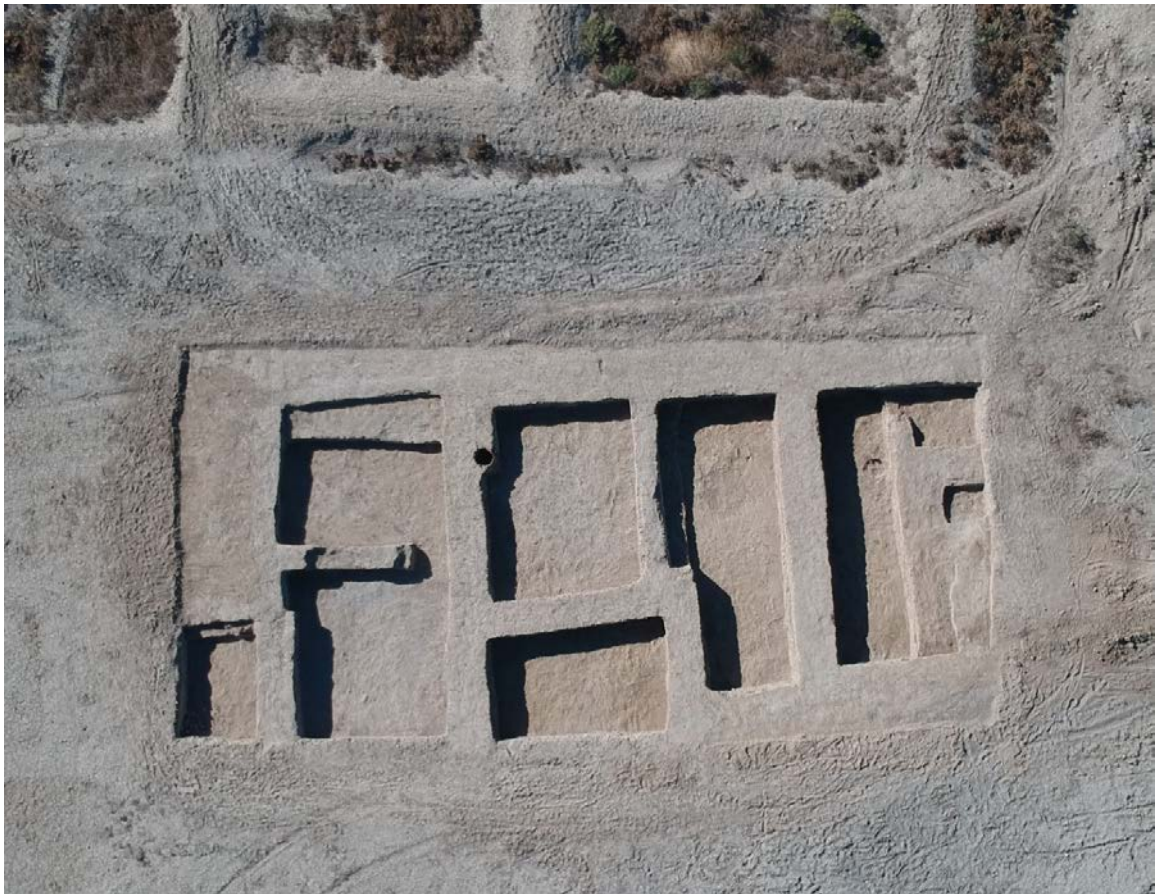
Photo 28. General view of the excavation No.14. View from above

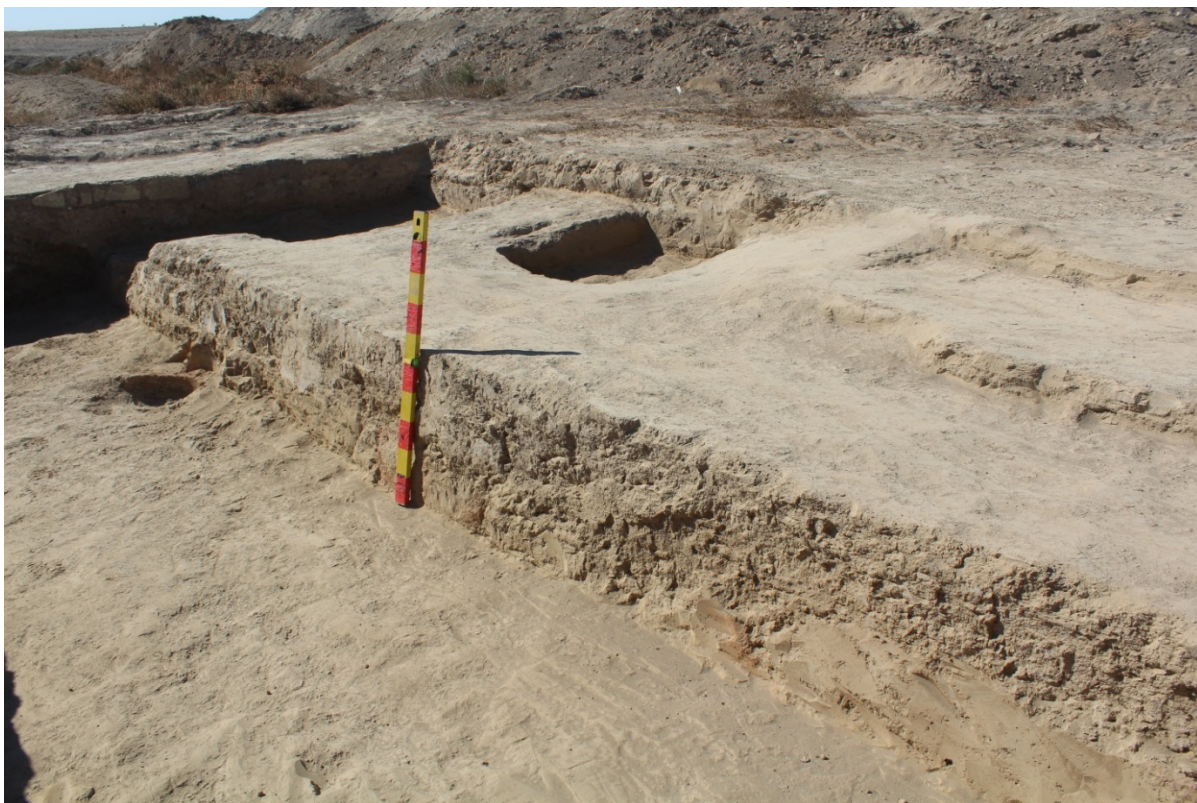
*Photo 33. Excavation No.14. Room number No.1. Sufa along the western wall of the room.
Southwest view*

Element 401. The interior wall between rooms No.1 and No.2 (photo 33). The wall is well-preserved, 0.8 m high, has 7 rows of masonry (brick size is 30 x 20 x 10 cm), the wall thickness is 1 m. Partly preserved plaster.

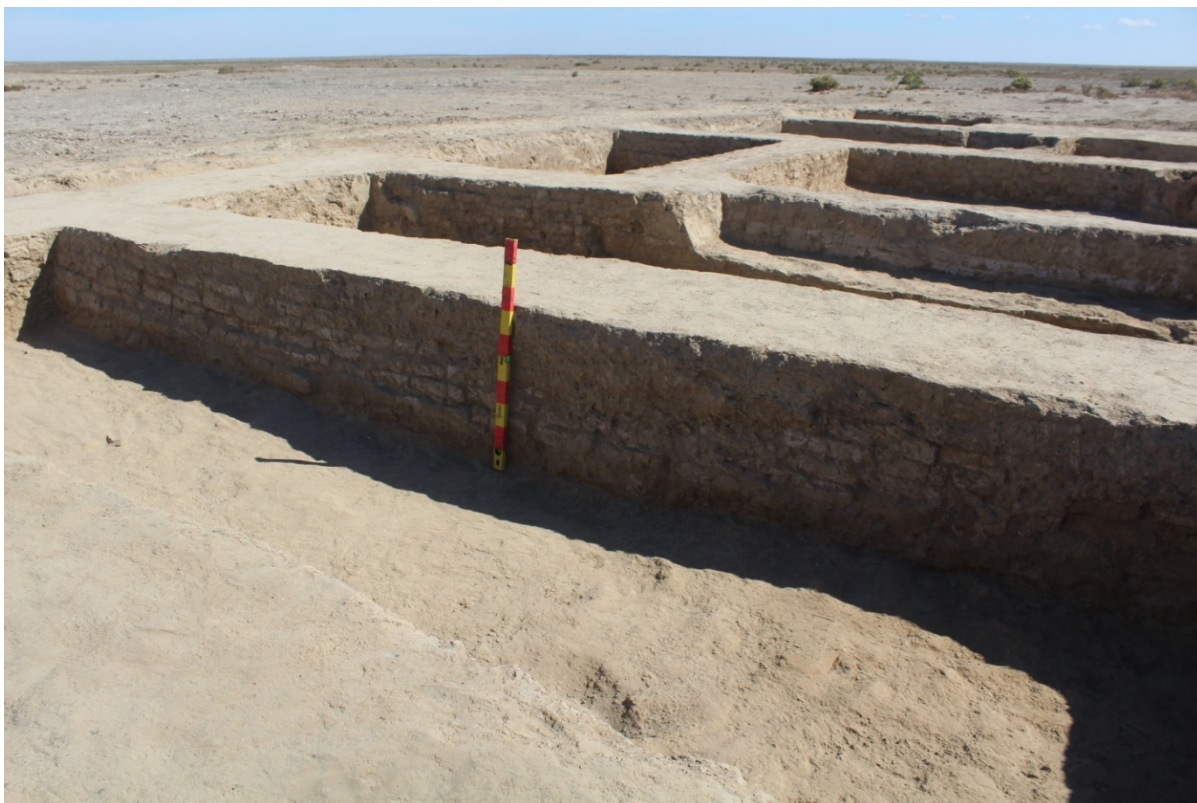
Photo 34. Excavation No.14. Room No.1. Hearth in sufa

Element 405. Sufa Room No.1 is located in the western part of the room. Width 0.9 m, height 53 cm. The board of the sufa is well preserved. The inner space of the sufa is clogged with fragments of raw bricks. A clay coating is partially preserved on the surface of the sufa (Photo 35).

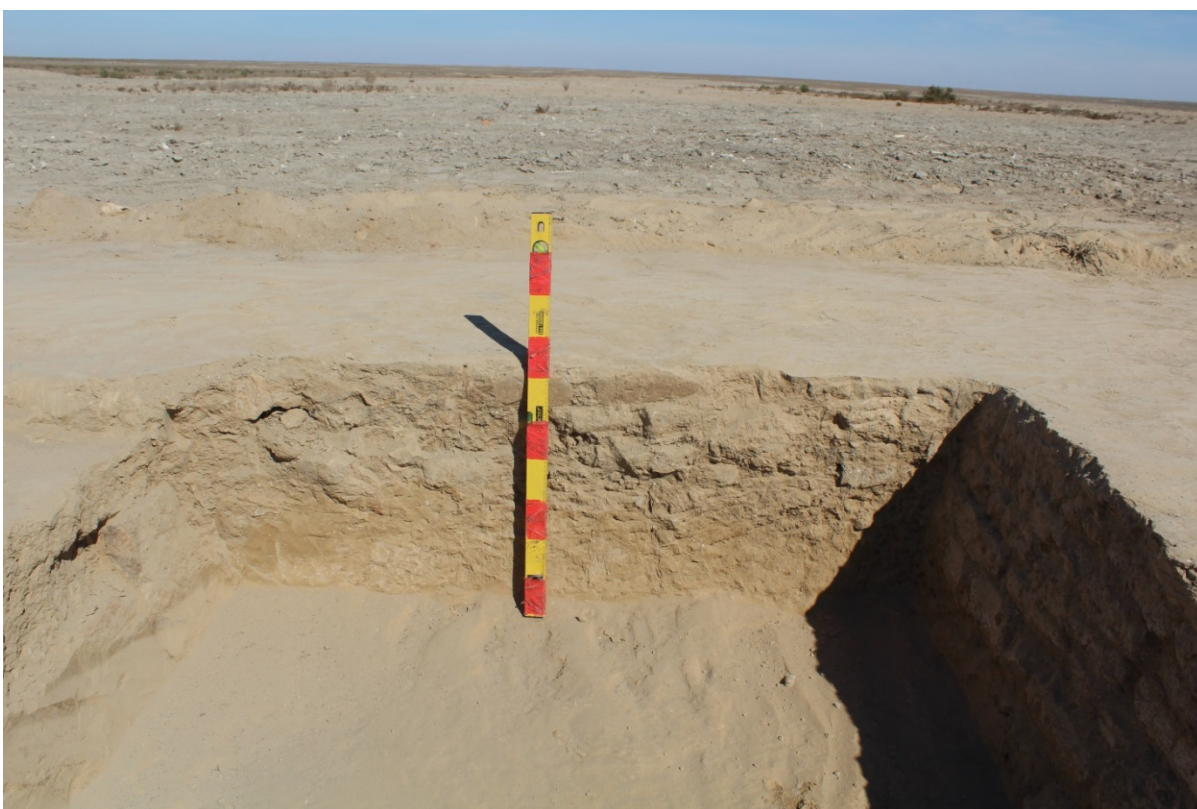
Photo 35. Excavation No.14. Room No.1. East wall. Northeast view

Room No.1 with a size of 7.5 x 4.2 m, the long side is oriented along the north-south line. A sufa with a width of 0.9 m and a height of 0.53 m is attached to the western wall. The side of the sufa is well preserved. The inner space of the sufa is filled with debris - fragments of bricks and lumps of clay. A clay plaster is partially preserved on the surface of the sufa (Photo 33). Before the sufa, there were remains of a hearth with a diameter of 0.5 m, a preserved wall height of 10 cm, and a thickness of 2 cm (photo 34). The hearth is filled with ash; the hearth floor is calcined. The walls of the room are made of mud brick of 30x20x10 cm in size: the eastern wall is better preserved: it has 7 rows of brickwork with a height of 0.7-0.8 m (photo 35). The northern wall is common for rooms 1 and 2 and is preserved to a height of 0.5-0.7 m (4-5 rows of masonry), wall thickness 1 m, preserved plaster (photo 36).

Element 406. The hearth in room No.1 (photo 36) is built into the sufa. The remains of the destroyed hearth were cleared: diameter 0.5 m, preserved wall height 0.1 m. Thickness of the wall 2 cm. The center is filled with ash; the floor of the hearth is calcined.

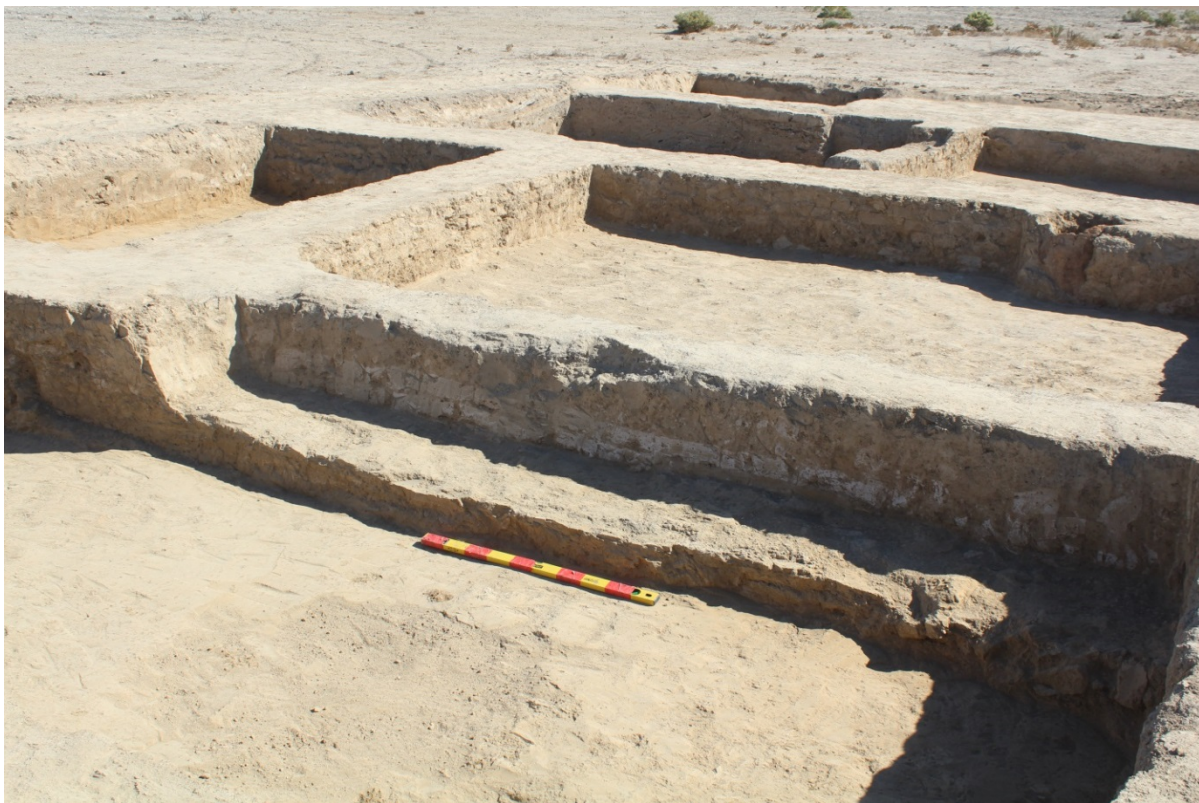
Photo 39. Excavation No.14. Room No.2. East wall

Walls of the room: the eastern wall is common with room No.3, 1.2 m thick, the preserved height is 0.8 m (photo 38). Clearly traced 6-7 rows of masonry. The eastern wall is common with room No.4, stands at an earlier one, the lower one is offset to the west (photo 39). The thickness of the upper part of the wall is 0.8 m, the preserved height is 0.5 m. 4 rows of masonry are clearly visible. The bottom wall is fixed in two rows of masonry. The southern wall of room No.2 is the southern wall of rooms 1, 4 and 5 – this is the longest wall in the excavation area. It separates the residential buildings from the street, the wall thickness is 1.2 m, the preserved height is 0.8 m (photo 40). On all the walls of the room is partially preserved coating.

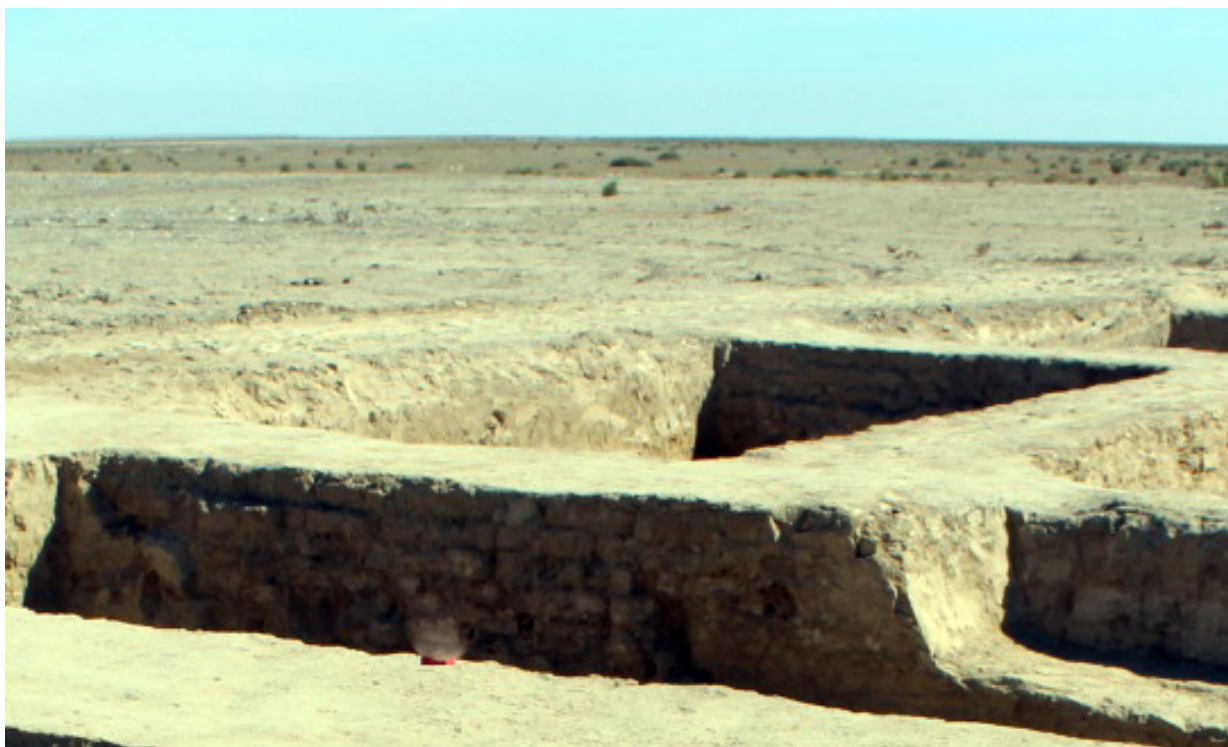
Photo 41. Excavation No.14. Room No.3. Southeast view

Room No.3 is located in the northern part of the excavation (photo 41). A room width of 4.9 m was recorded, the northern part of the room remained outside the excavation site and its length is unknown. The southern wall of room No.3 is a common room with room No.4 (photo 42). The wall stands on the lower, earlier, it is somewhat offset to the west. The thickness of the upper part of the wall is 0.8 m, the preserved height is 0.6 m. The plaster on the two sides of the wall is well preserved.

Element 411. The interior wall of rooms No.3 and No.4 (photo 41). The wall stands on the wall of the lower layer, partially offset to the west. The thickness of the upper part of the wall is 0.8 m, the preserved height is 0.6 m. The plaster on the two sides of the wall is well preserved.

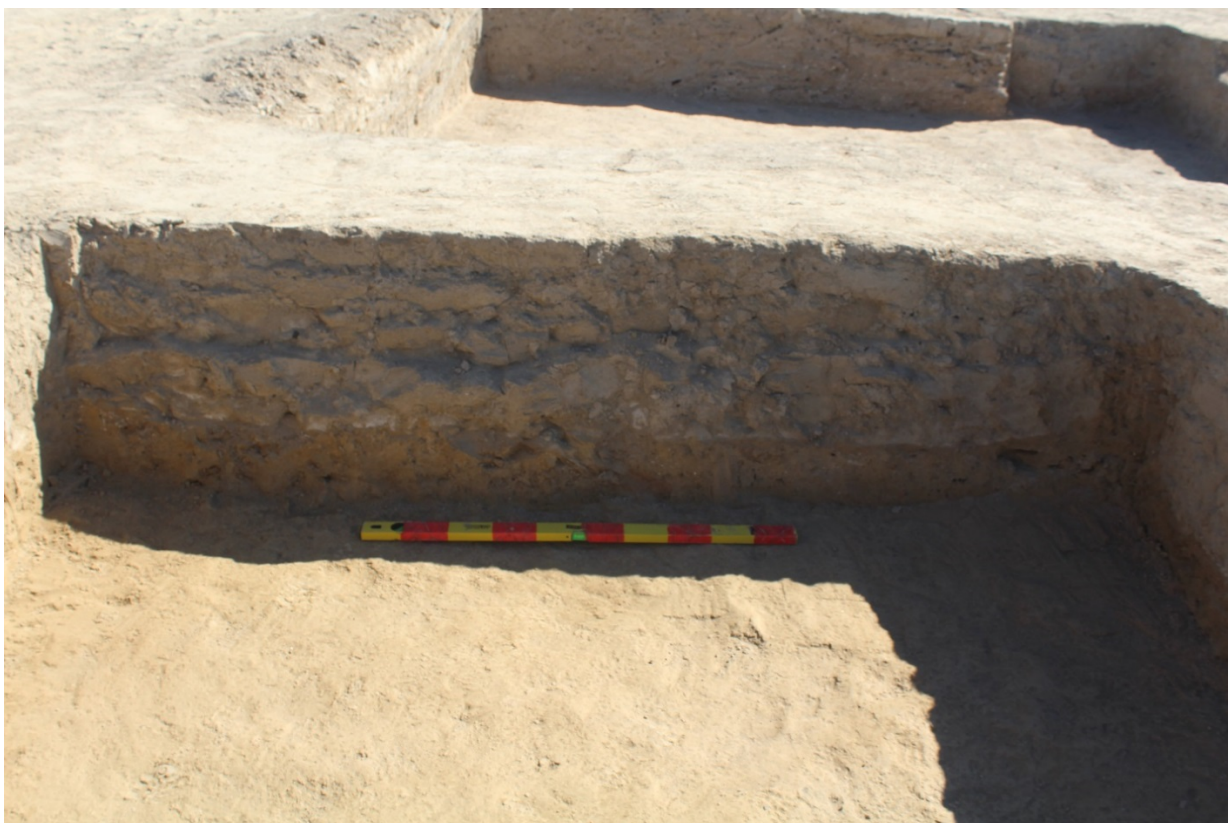
Photo 42. Excavation No.14. Room No.3. East wall

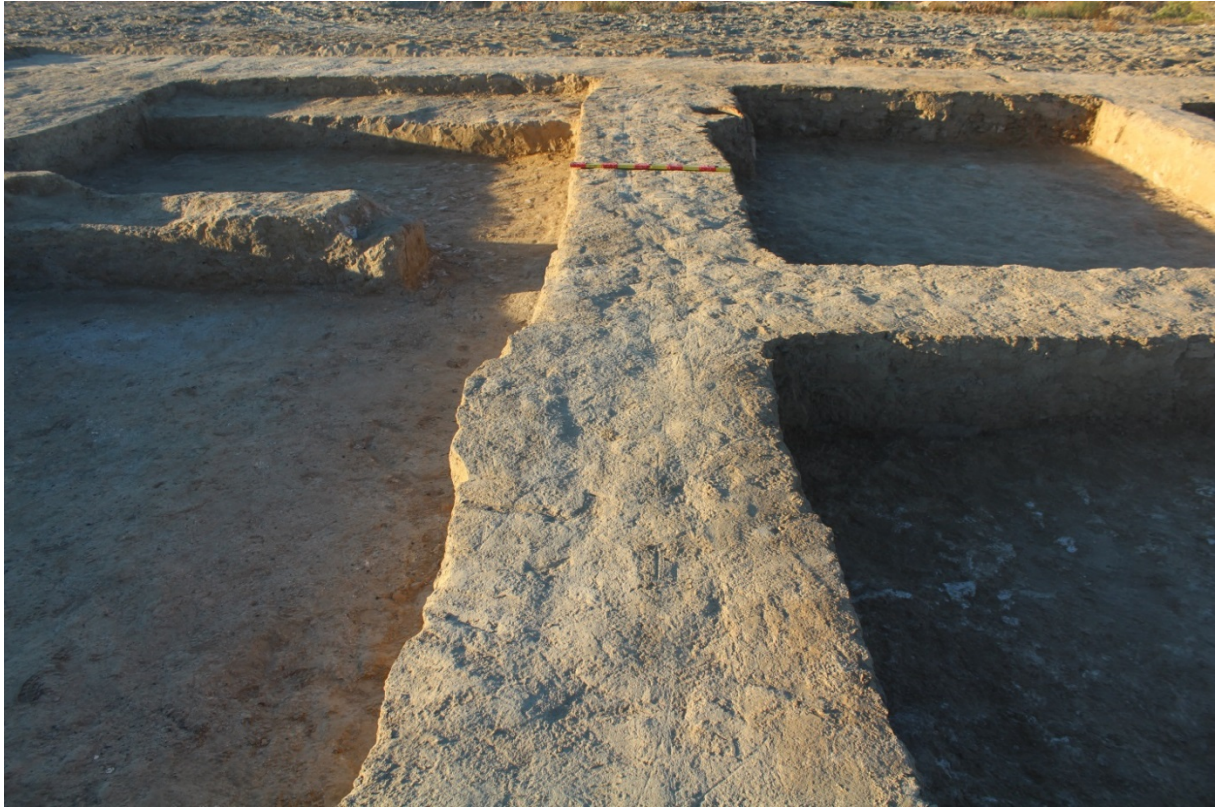
Photo 43. Excavation No.14. The wall between rooms No.3 and No.6. West View

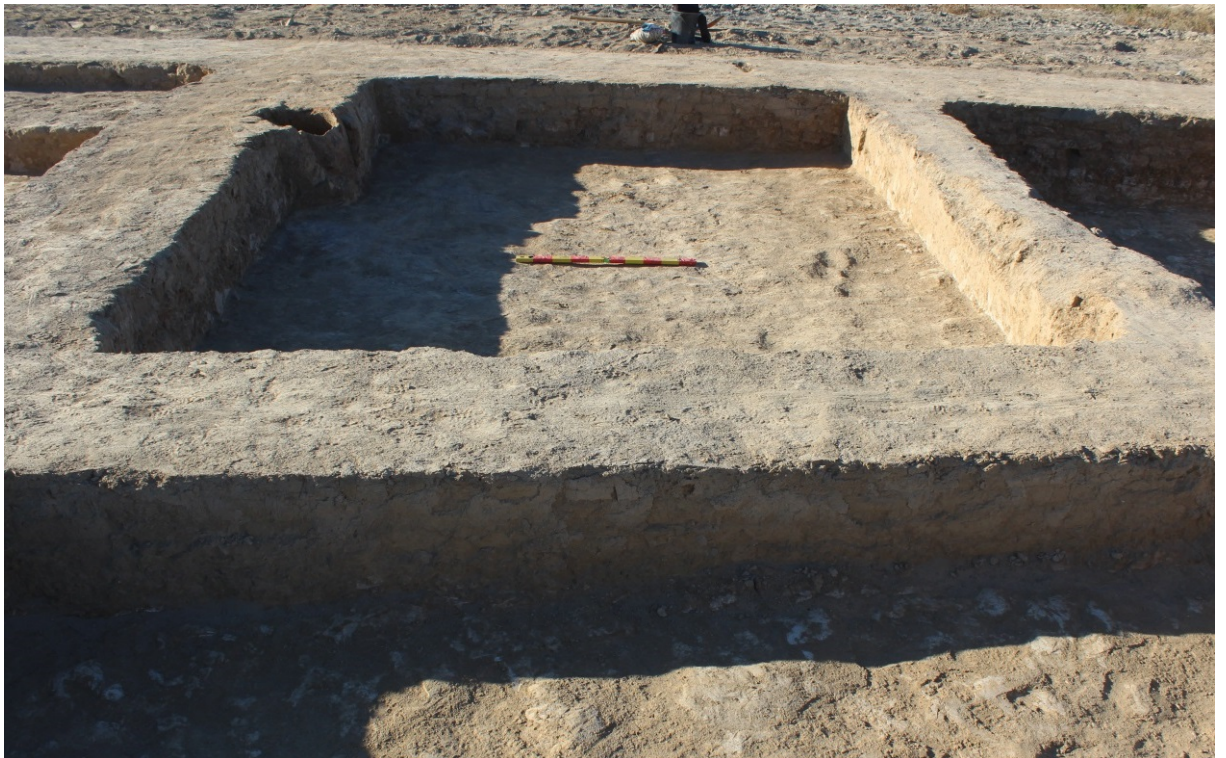
Photo 44. Excavation No.14. Room No.4. South view

Room No.4 is located in the central part of the excavation. The size of the room is 5.5 x 4.5 m (photo 44). In the southwestern part of the room, remains of a destroyed hearth were found.

Element 412. Room No.4, 5.5 x 4.5 m in size, in its south-western part, remains of a destroyed hearth were found (photo 44).

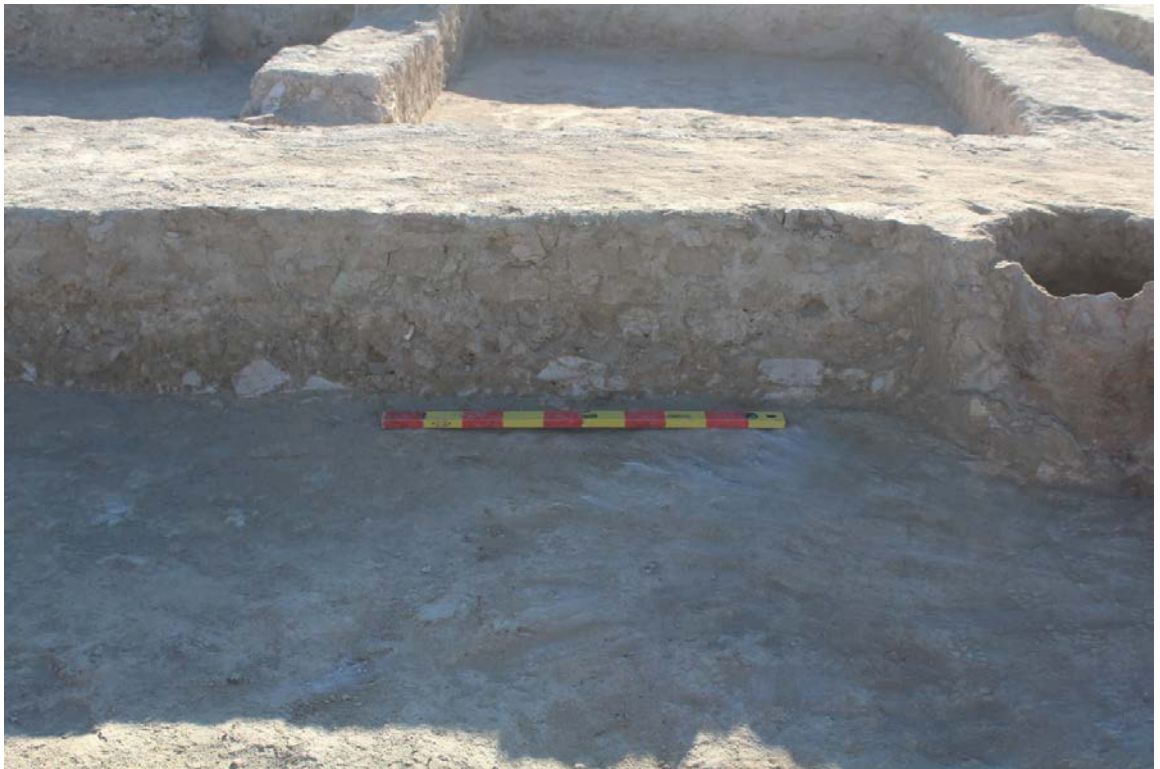
Photo 45. Excavation No.14. Room No.4. East wall

The eastern wall of the room is common with room No.6 1-1.2 m thick, preserved to a height of 0.6 m (photo 45). Partially preserved plaster. A center was attached to the wall, its upper part was destroyed, the center of the center with a diameter of 0.40 m, a preserved height of 0.65 m, and a wall 2 cm thick (Photo 46). It is likely that a ceramic vessel, the hum, was used as a hearth. Filling inside the hearth - earth and ash.

Element 414. The interior wall of the premises No.3, 4, 5, 6 (photo 45, 48, 50). The wall is oriented along the north - south line. Preserved to a height of 0.6 m, folded from standard brick raw (30 x 20 x 10 cm). Wall thickness 1-1.2 m. Partly preserved plaster.

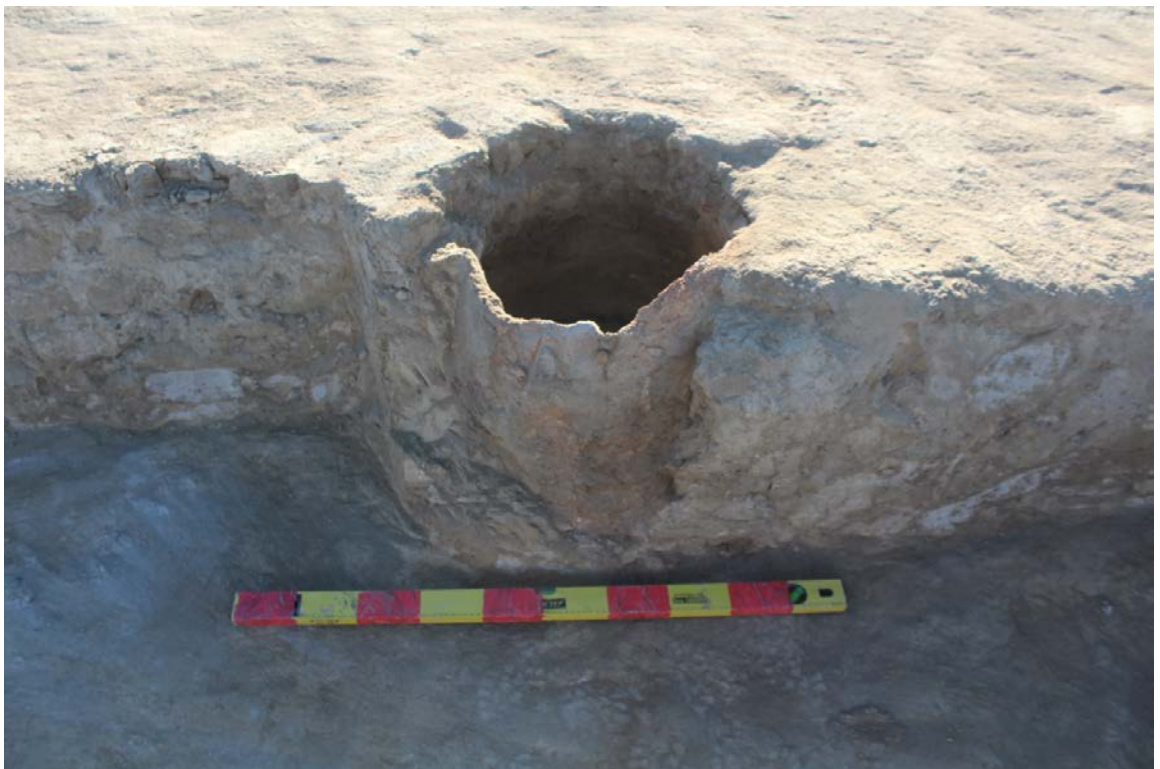
Photo 46. Excavation No.14. Room No.4. Hearth in the east wall

Element 413. The lesion in room 4 is mounted in the body of a small bollard (photo 46). The upper part of the center is destroyed, the diameter of the preserved body is 0.4 m, the height is 0.65 m. The center wall thickness is 2 cm. Probably, the center is made of a thick-walled ceramic hum-type vessel. The interior of the hearth is filled with ash.

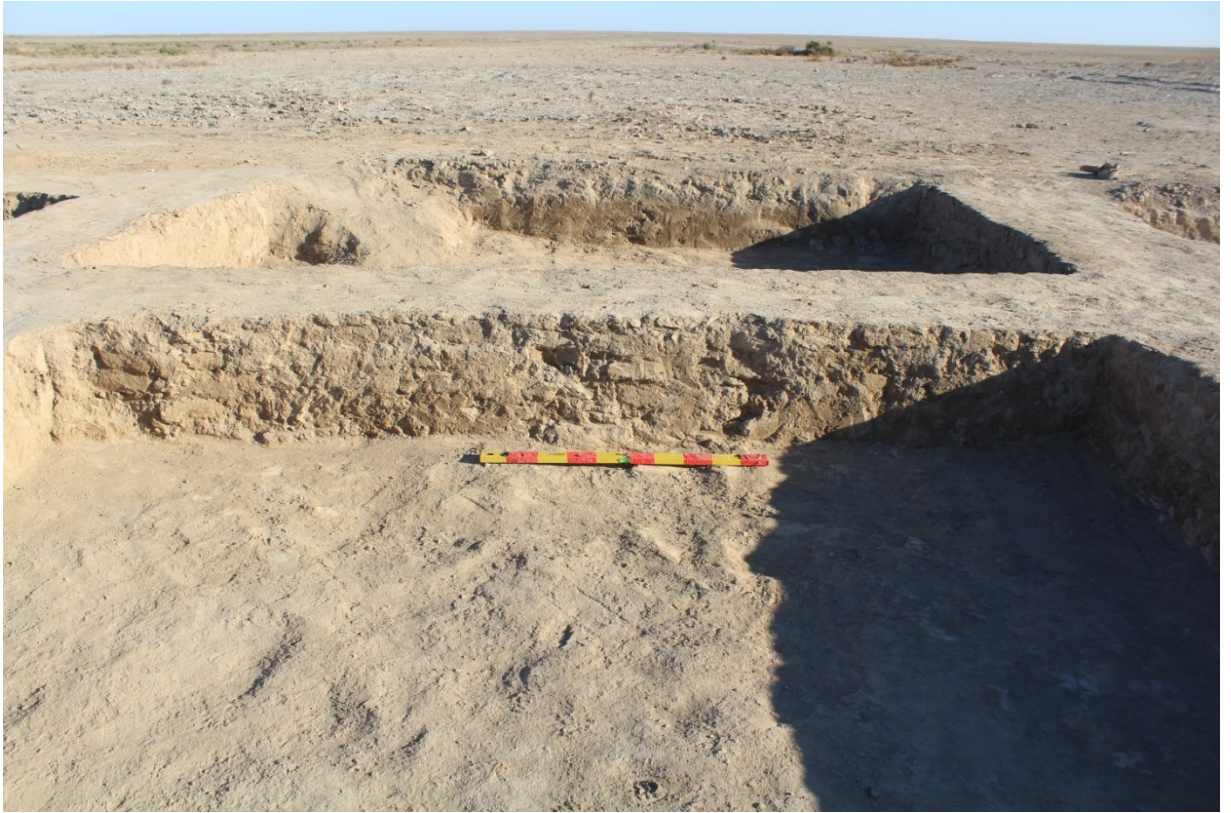
Photo 47. Excavation No.14. North wall of room No.4

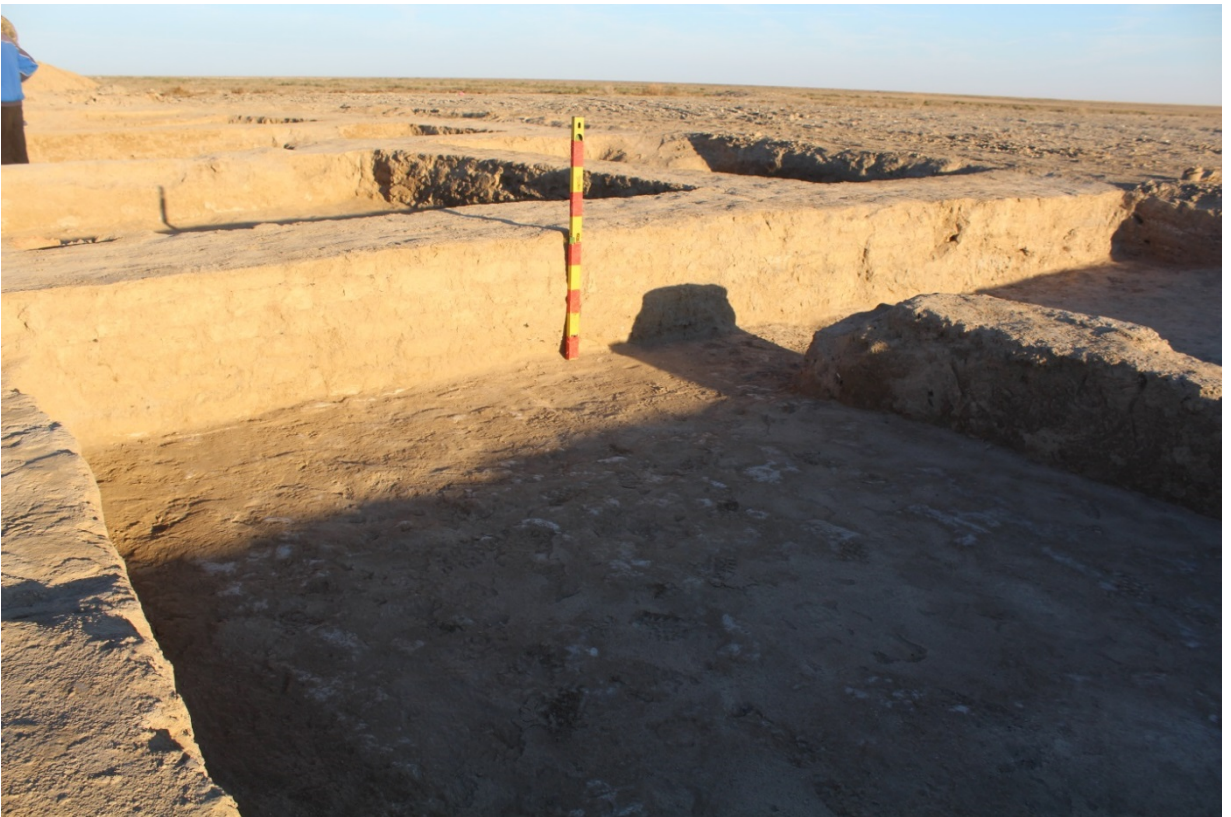
Photo 48. Excavation No.14. The western wall of room No.4. Northwest view

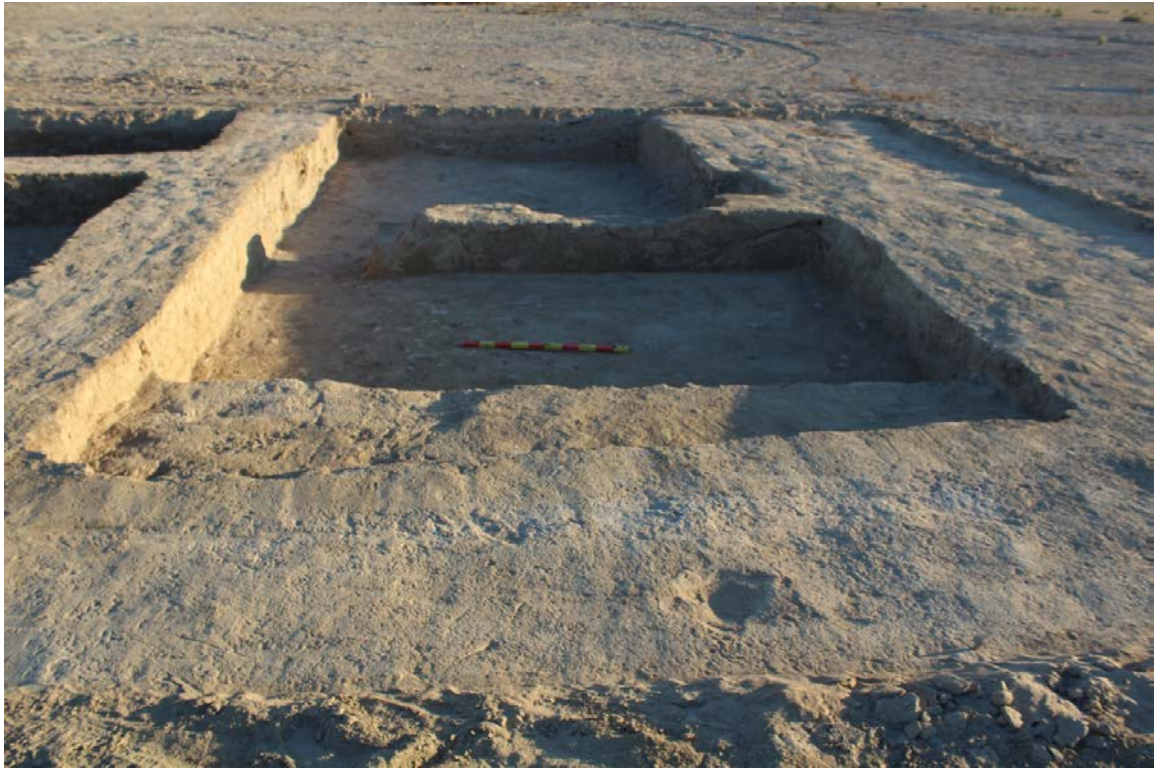
Photo 49. Excavation No.14. Room No.5. North view

Room No. 5, measuring 4.2 x 3.7 m, is located in the southwestern part of the excavation (photo 49). In the north wall, a passage 0.9 m wide is connected to room No. 6. When clearing the premises in the field layer, a lot of fragments of raw bricks and several fragments of *dastarhan* were revealed.

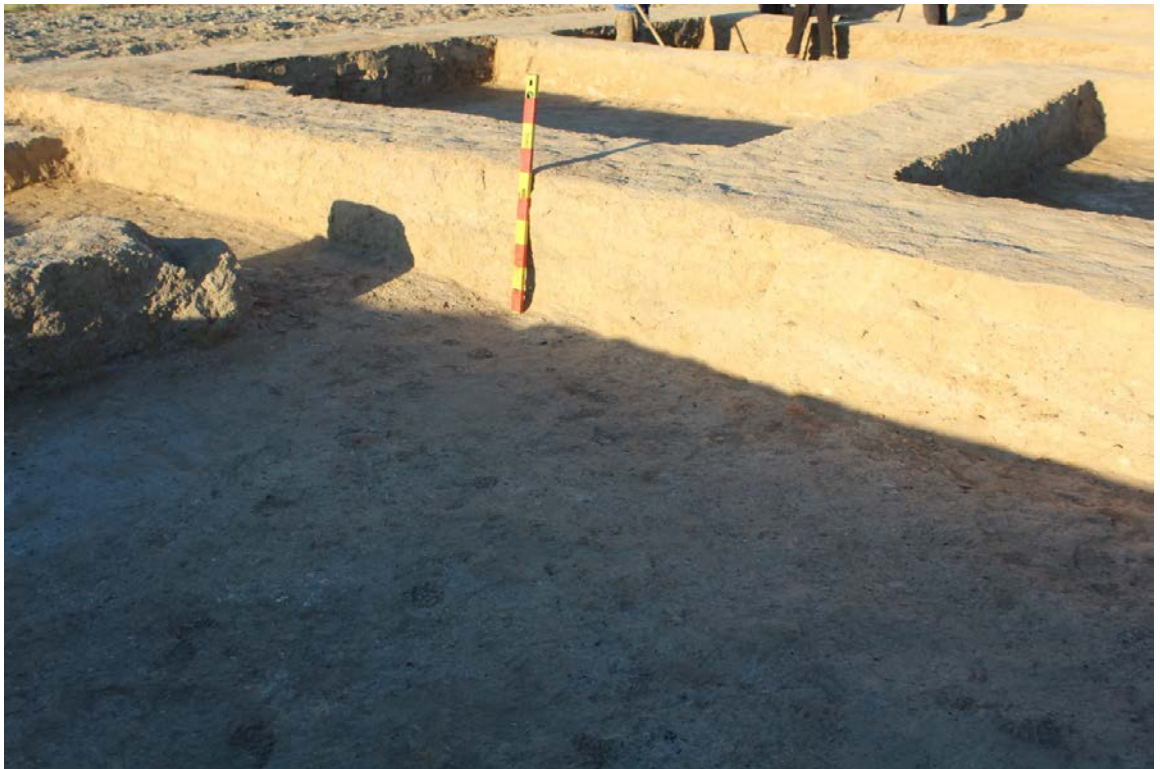
Photo 50. Excavation No.14. The western wall of room No.5. Southwest view

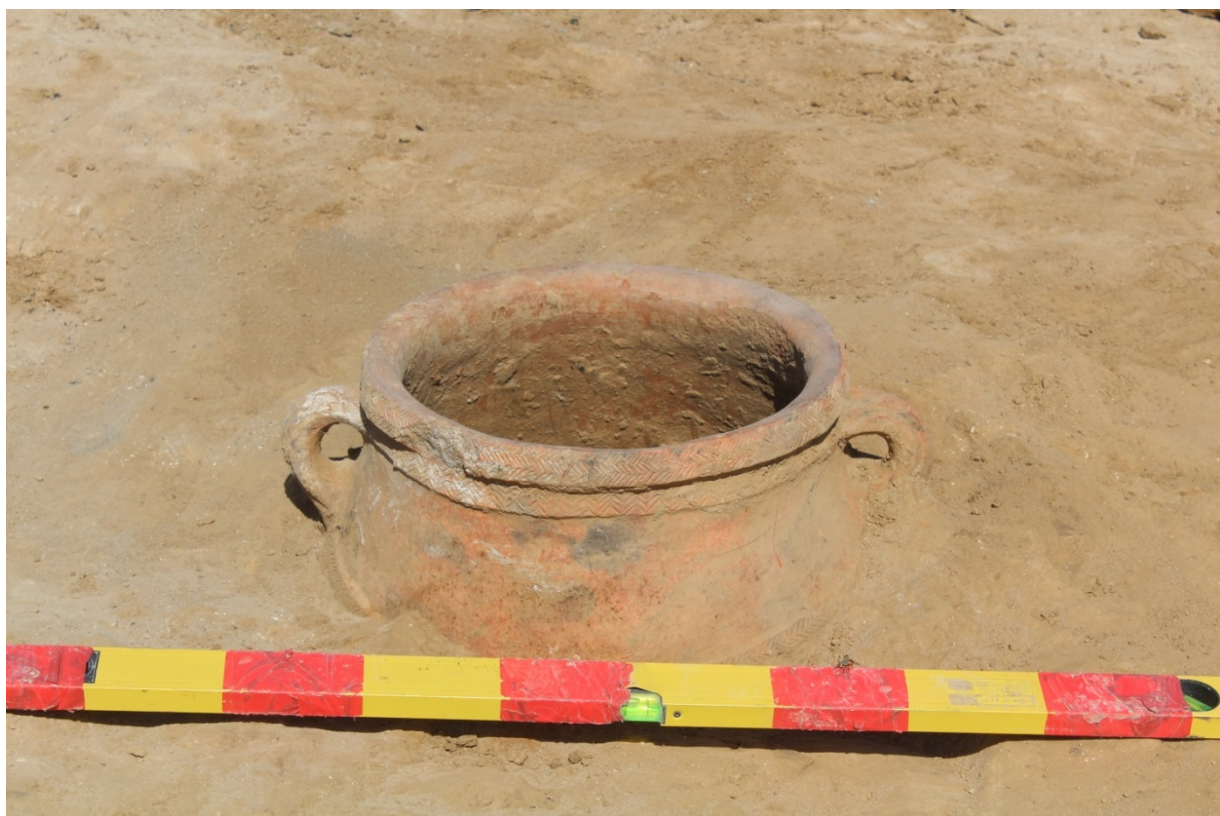
Photo 52. Excavation No.14. Large ceramic vessel - hum in room No.6

The hum is 0.70 m high, the diameter of the body is 0.65 m, the diameter of the corolla of the neck is 0.40 m, the bottom diameter is 0.25 m. Two loop-shaped handles are mounted under the hum at the sides of the body. The upper part of the body is girded with a thick roller decorated with "christmas ornament", the bottom of the corolla is also decorated with "christmas ornament".

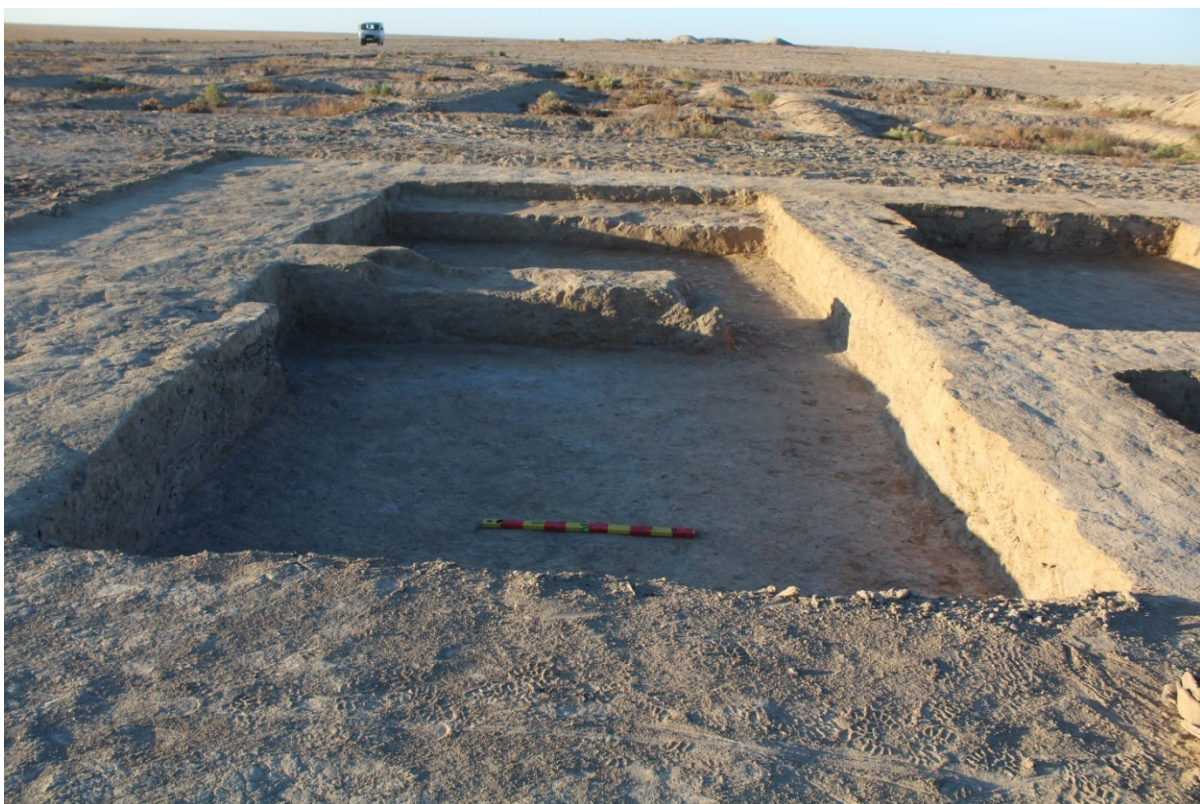
Photo 56. Excavation No.14. Room No.6. South view

Element 418. Room No.6 of 4.2 x 2.5 m in size (photo 56). When clearing the room interior details are not revealed. A large, wide-mouth vessel, hum, was dug into the floor. In the filling were found fragments of ceramics and kitchen remains - the bones of domestic animals. Handmade ceramic crockery: horizontal loop-shaped handles, flat ends, fragments of the sides of the body, rims in the oval-shaped cross-section and bent outward, rims with christmas-tree ornaments, a fragment of an ornamented kitchenware lid.

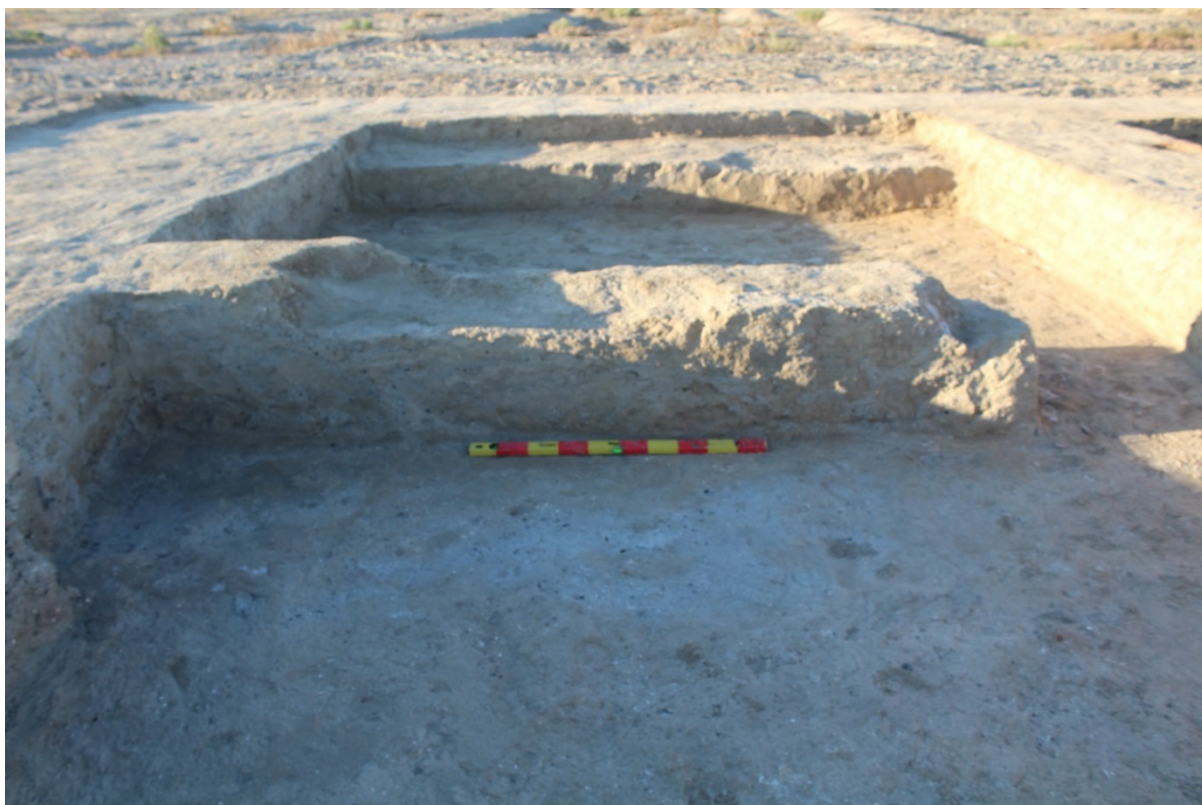
Photo 57. Excavation No.14. South wall of No.6

Element 416. The interior wall of rooms No.5 and No.6 (photo 57-58). The wall is made of mud brick with a size of 30 x 20 x 10 cm, preserved to a height of 0.6 m, and a wall thickness of 1-
