**PUBLIC FUND ARCHAEOLOGICAL SOCIETY OF KAZAKHSTAN,
REPUBLIC OF KAZAKHSTAN
THE SOCIETY FOR THE EXPLORATION OF EURASIA,
SWITZERLAND**

SCIENTIFIC REPORT

**Archaeological studies of the ancient settlement
Kesken-Kuyuk-Kala (Juvara) in 2018**

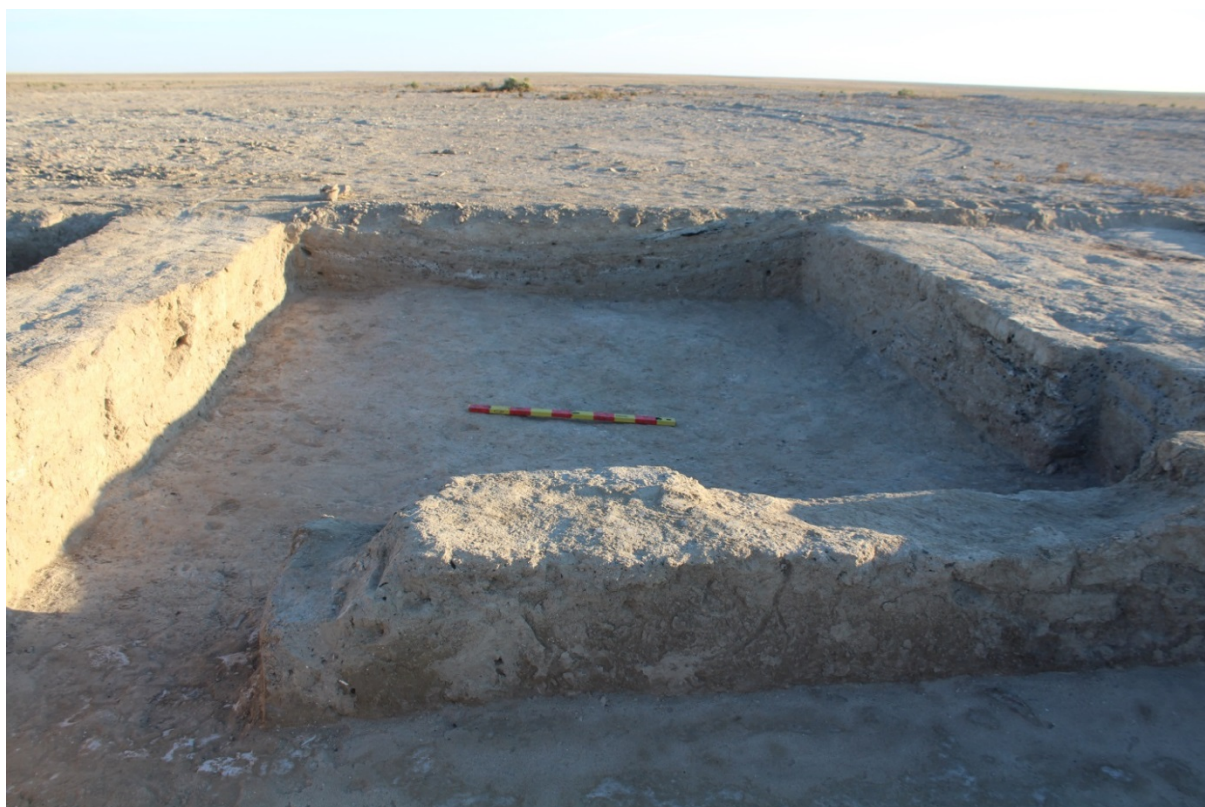
Photo 58. Excavation No.14. Room No.6. North view

Element 416. The interior wall of rooms No.5 and No.6 (photo 57-58). The wall is made of mud brick with a size of 30 x 20 x 10 cm, preserved to a height of 0.6 m, and a wall thickness of 1-

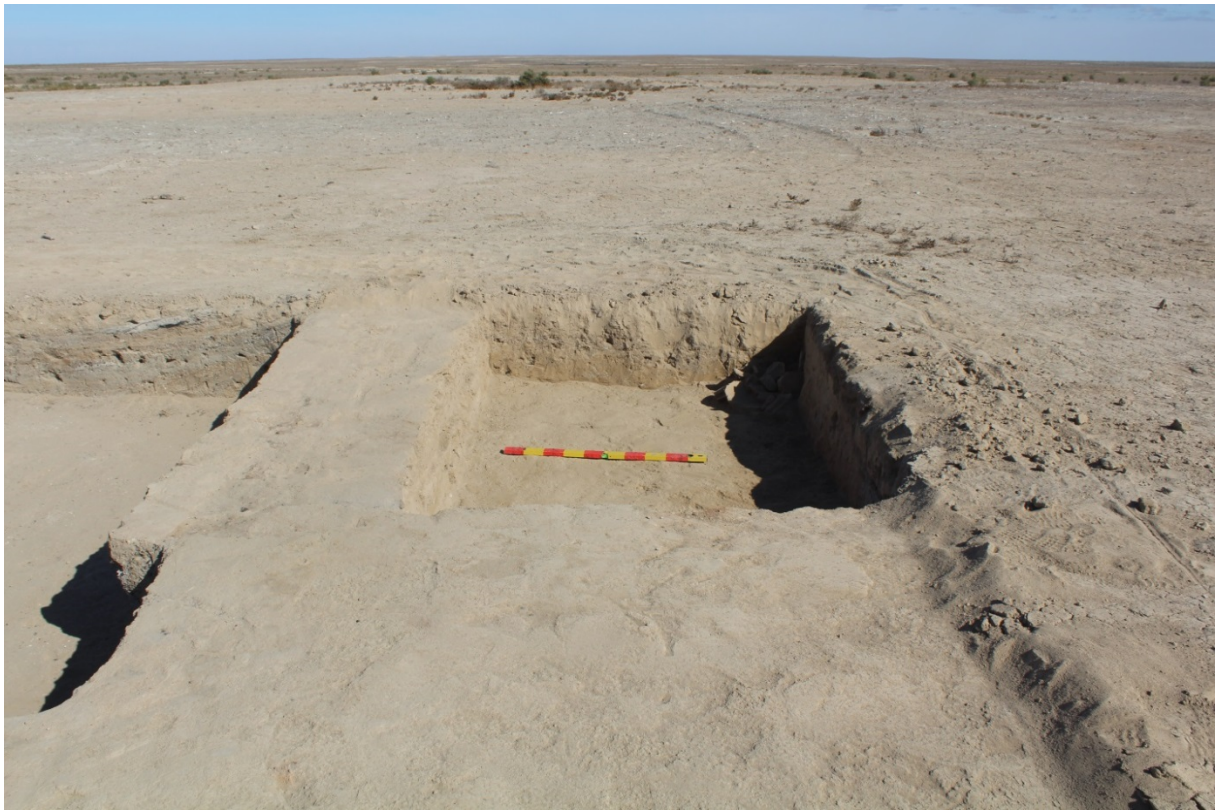
Photo 59. Excavation No.14. Part of the room No.7. North view

Room No.7 is located in the northwestern corner of the excavation (Photo 59-60). Most of the premises remained outside the excavation site. The size of the room within the excavation is 2.8 x 1.8 m. The room was filled with loose soil. The southern wall of the room within the excavation, 1.5 m long, 0.8 m thick, the preserved height is 0.5 m, oriented along the east-west line. The western wall of the room is common with room No.6 (photo 61). The wall is oriented along the north-south line, the preserved height is 0.5 m (4 rows of brickwork 30x20x10 cm), the wall thickness is 1 m. The

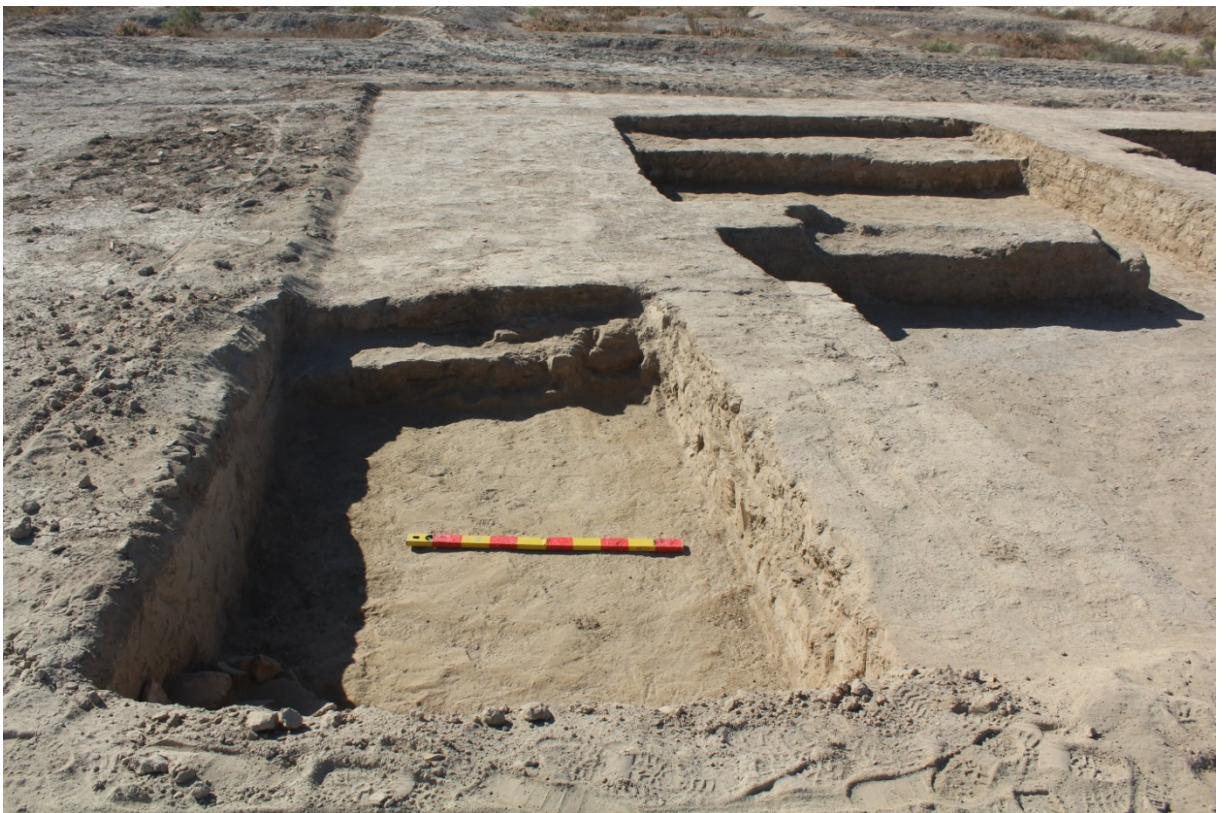
Photo 60. Excavation No.14. Part of the room No.7. North view

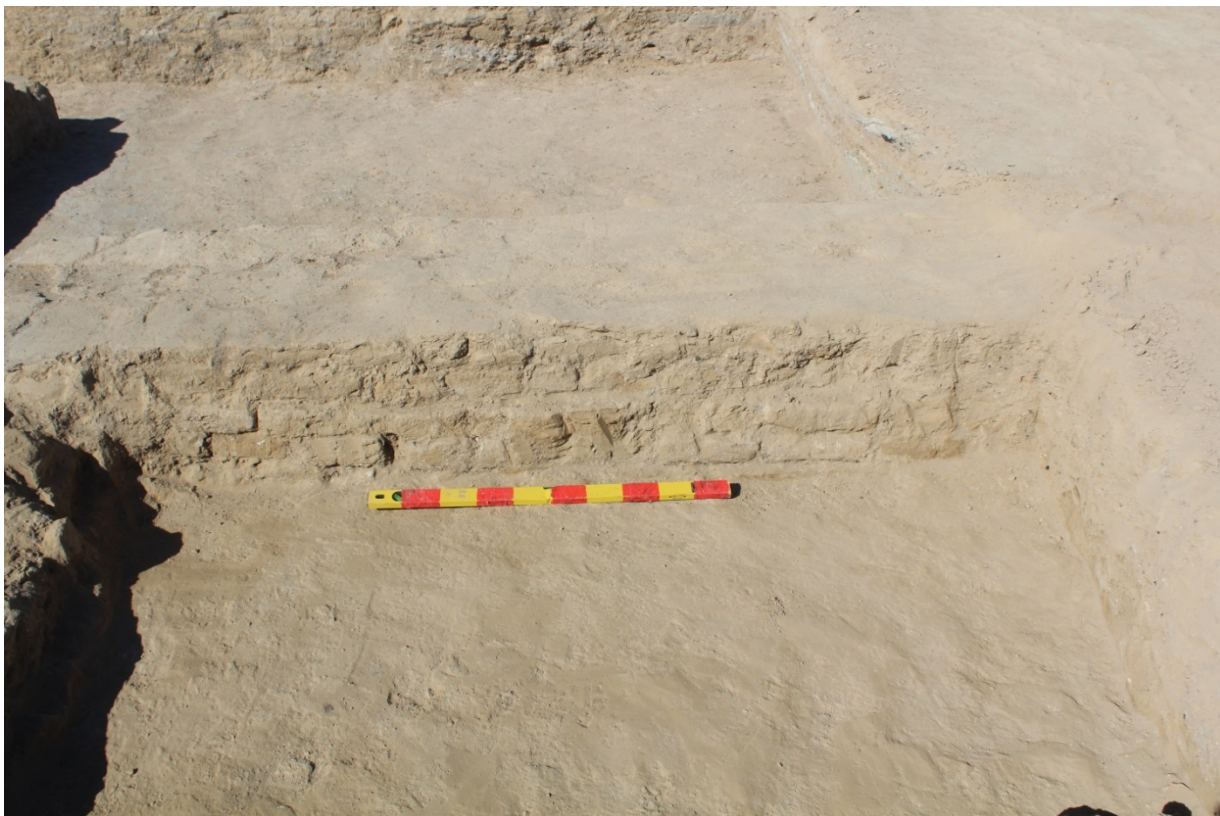
Photo 61. Excavation No.14. West wall of room No.7

Element 419. The wall between rooms No.6 and No.7 (photo 61) was preserved to a height of 0.5 m - 4 rows of 30 x 20 x 10 cm brick masonry. The wall thickness is 1 m, and the plaster is partially preserved.

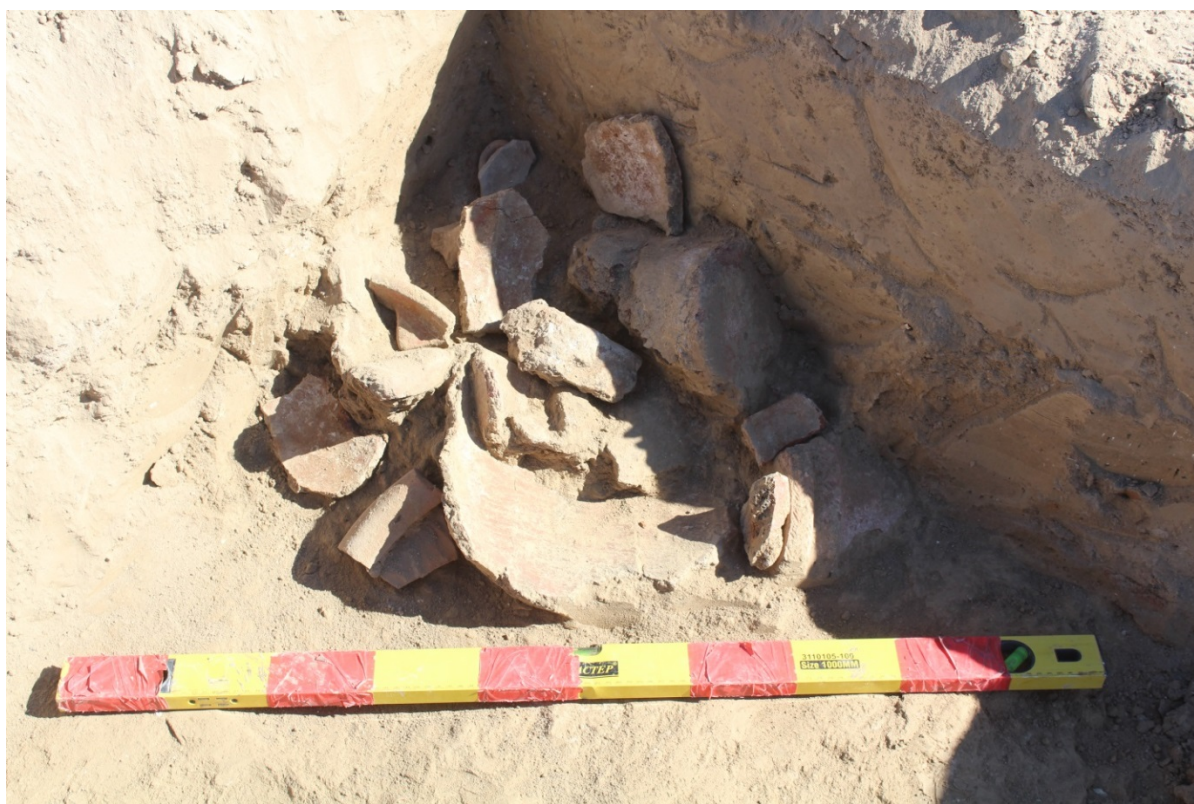
Photo 62. Excavation No.14. The accumulation of fragments of ceramics on the floor of room No.7

Element 421. Room No.7. The accumulation of fragments of ceramics of large thick-walled vessels on the floor (photo 62).

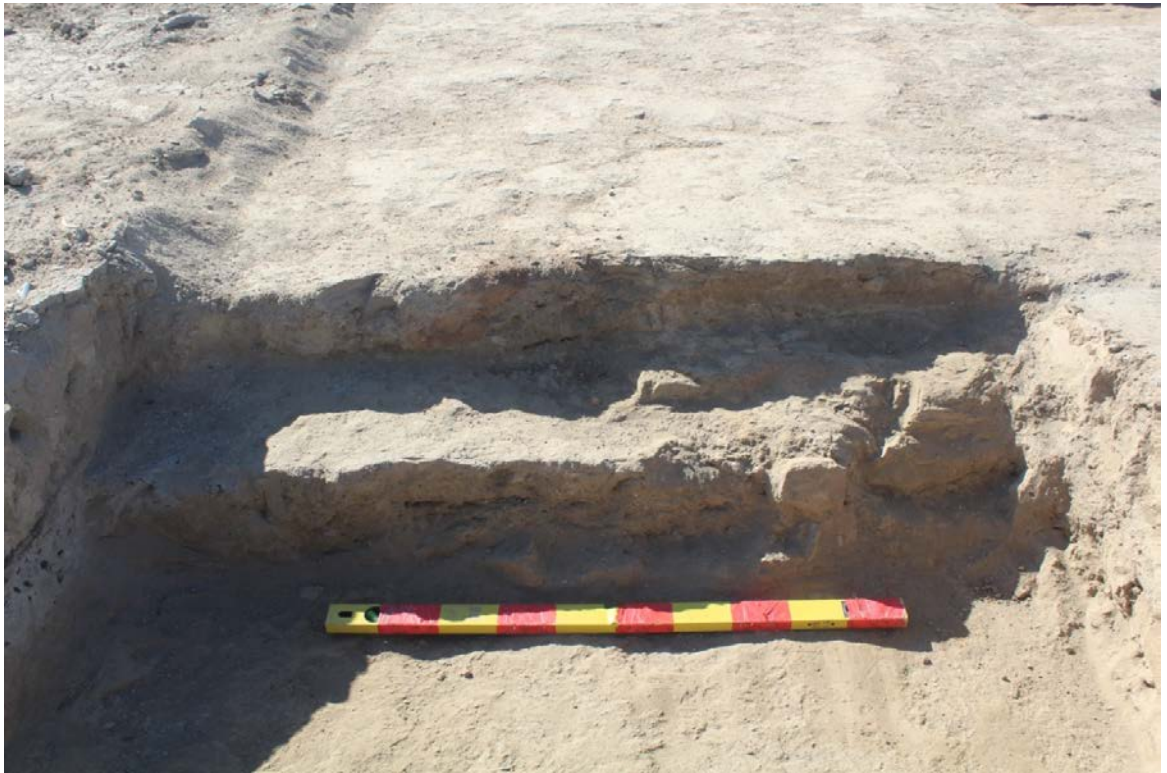
Photo 63. Excavation No.14. South wall of room No.7

walls were plastered. An accumulation of ceramics was found on the floor, mainly from large thick-walled vessels (photo 63).

Element 422. Room r No.7. The south wall is oriented along the east-west line. Within the excavation, the length of the wall is 1.5 m, the thickness is 0.8 m, the preserved height is 0.5 m (photo 63).

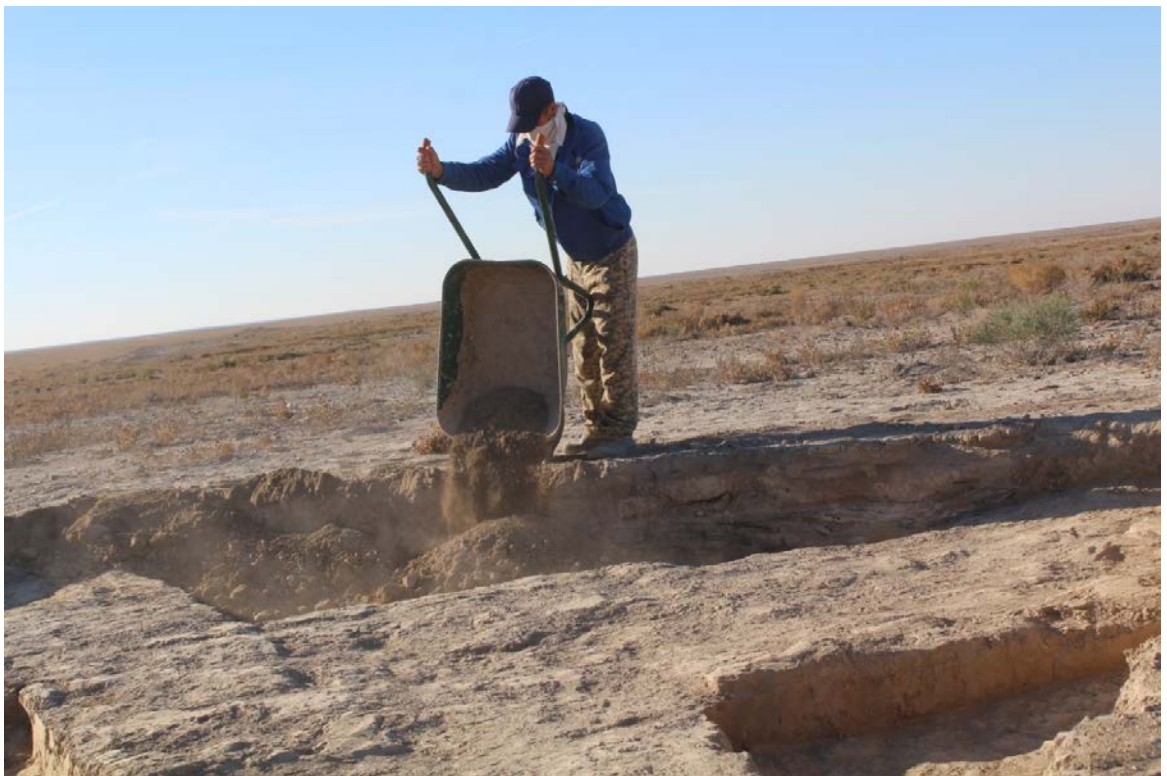
Photo 64. Excavation No.14. Archaeological conservation of identified structures

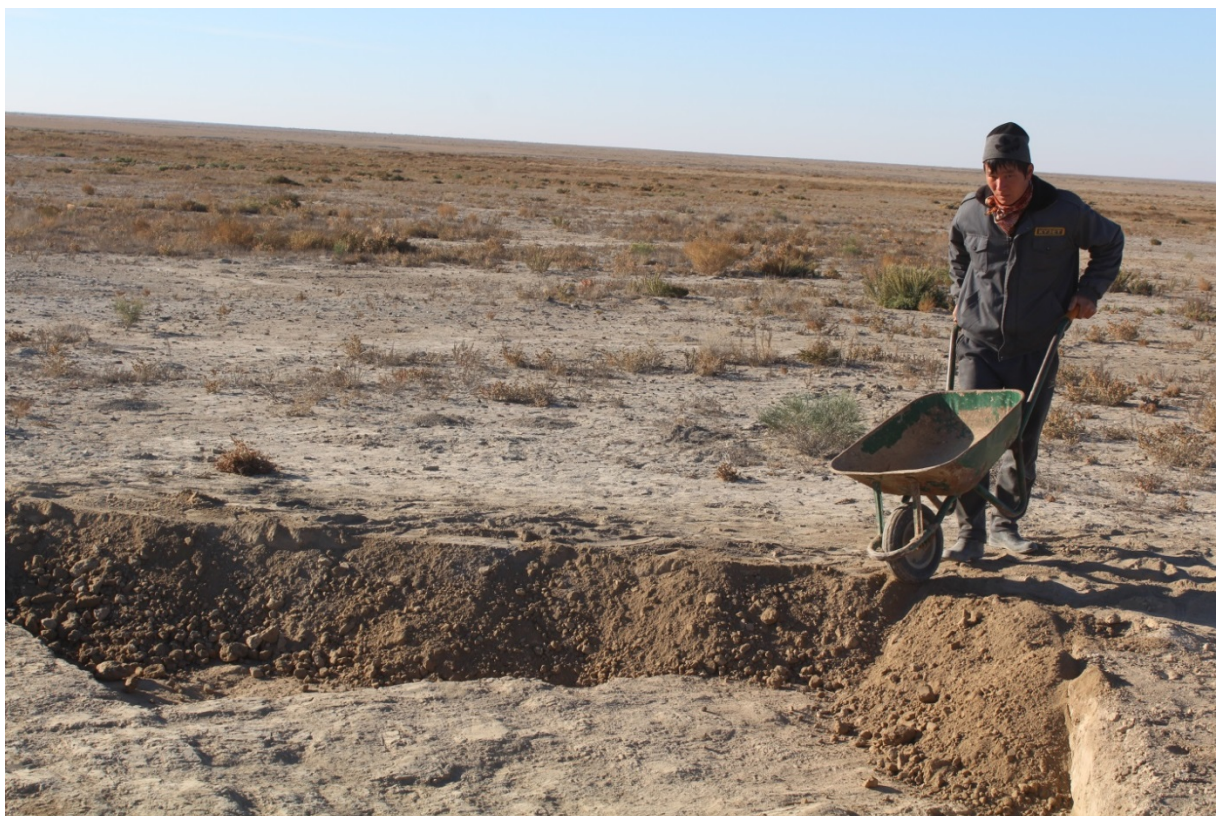
Photo 65. Excavation No.14. Archaeological conservation of identified structures

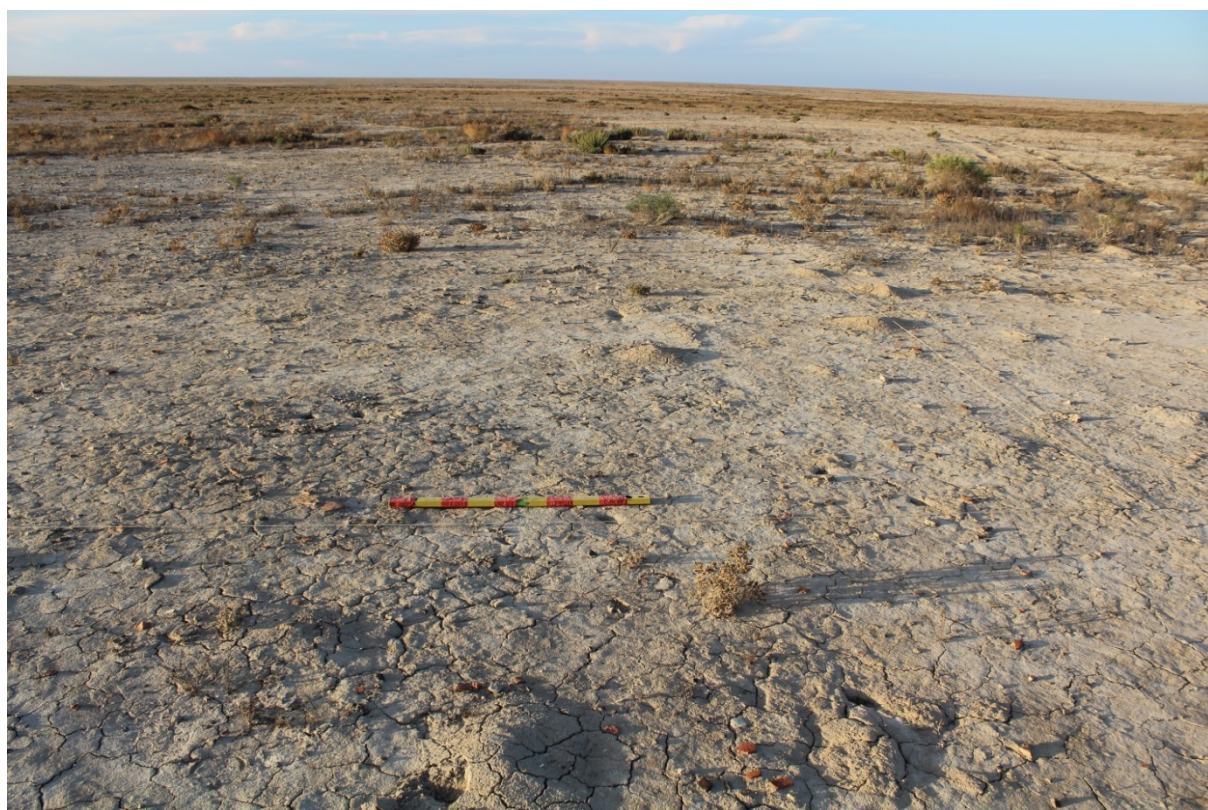
Photo 66. Excavation No.15. General view of the site before the start of excavation. North view

Excavation No.15 - exploration, was laid on the territory of the rabad in its central part closer to shahristan. The size of the excavation was 5x5 m. The surface was cleaned of dry vegetation before the start of work and leveled; no traces of building structures were observed (photo 66).

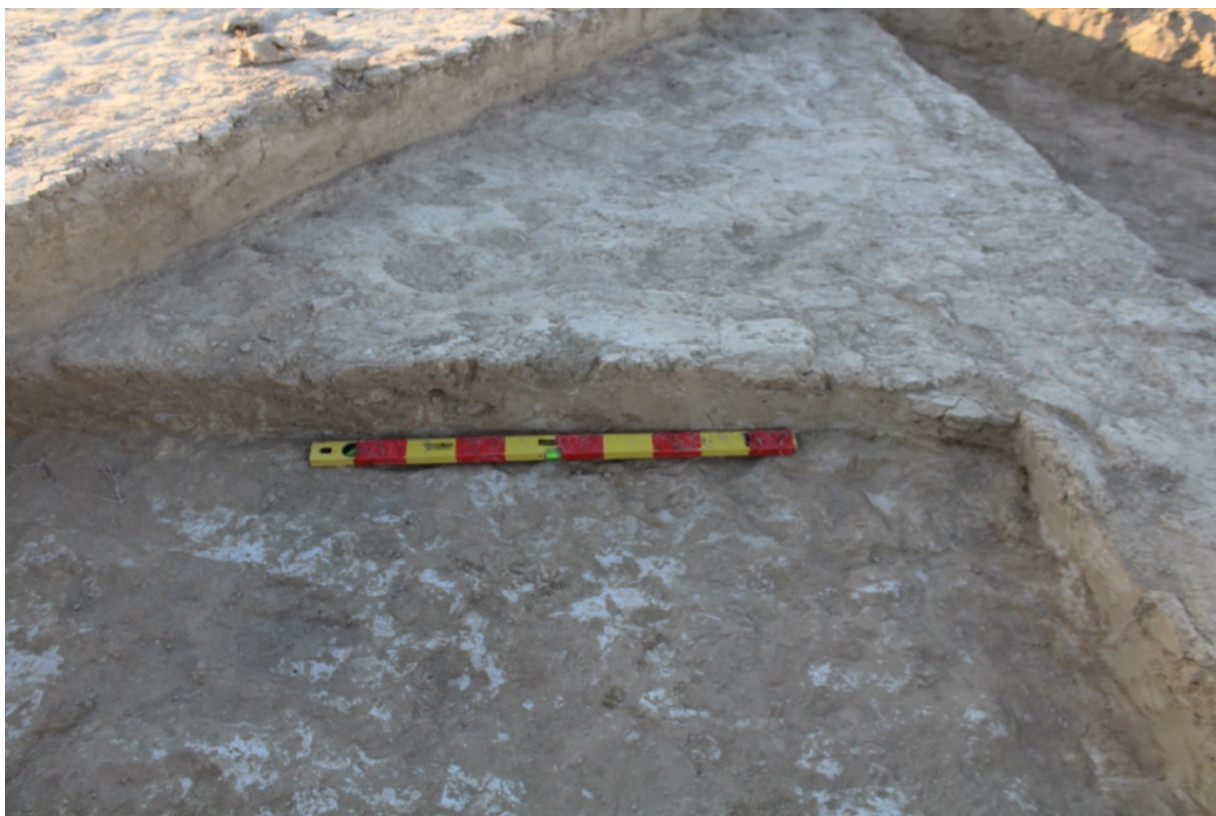
Photo 71. Excavation No.15. Brickwork

At a depth of 0.20 m were found remnants of building structures - the walls of the premises. The walls are oriented along the northwest - southeast line (photos 71-74). Here, raw brick of a different format was used: rectangular with a size of 30 x 14 x 10 and square - 33 x 30 x 10 cm. The total width of the wall is from 0.8 m to 1 m. The preserved wall height of 0.25 m is two rows of masonry.

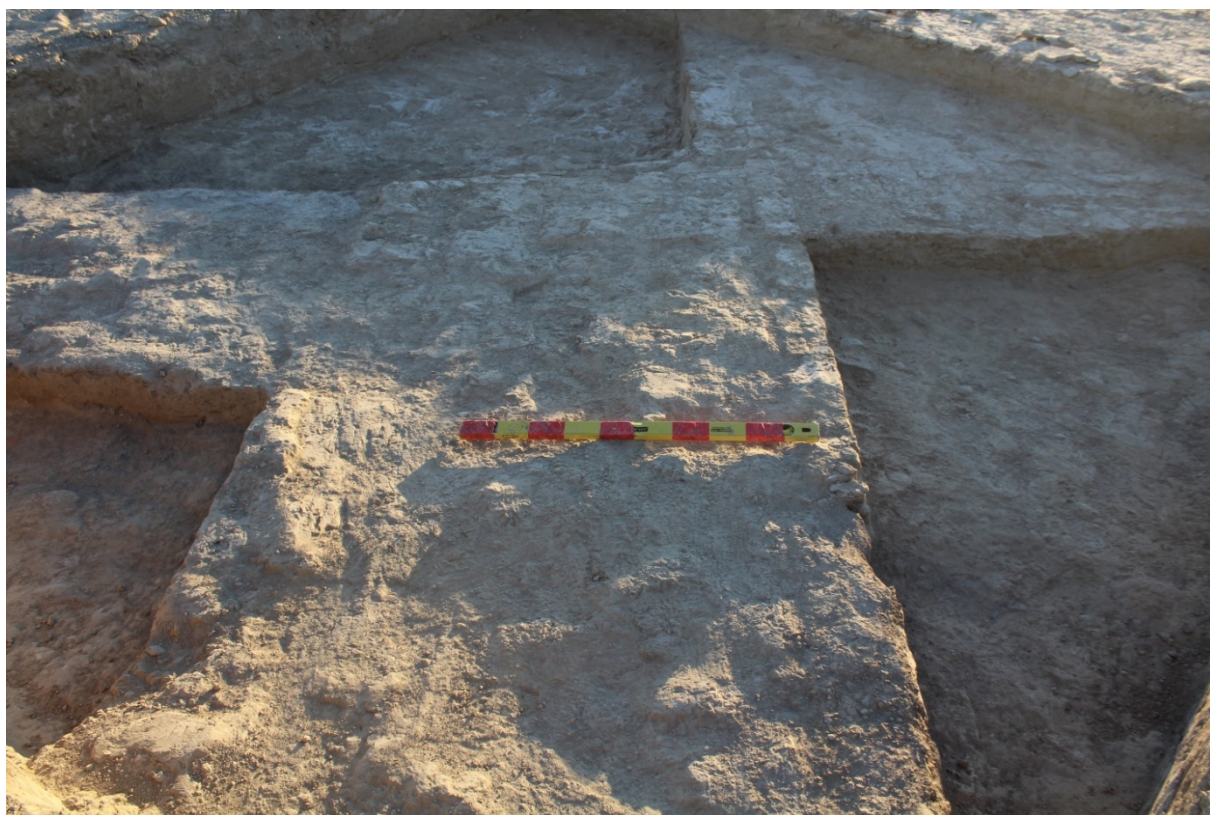
Photo 72. Excavation No.15. Brickwork

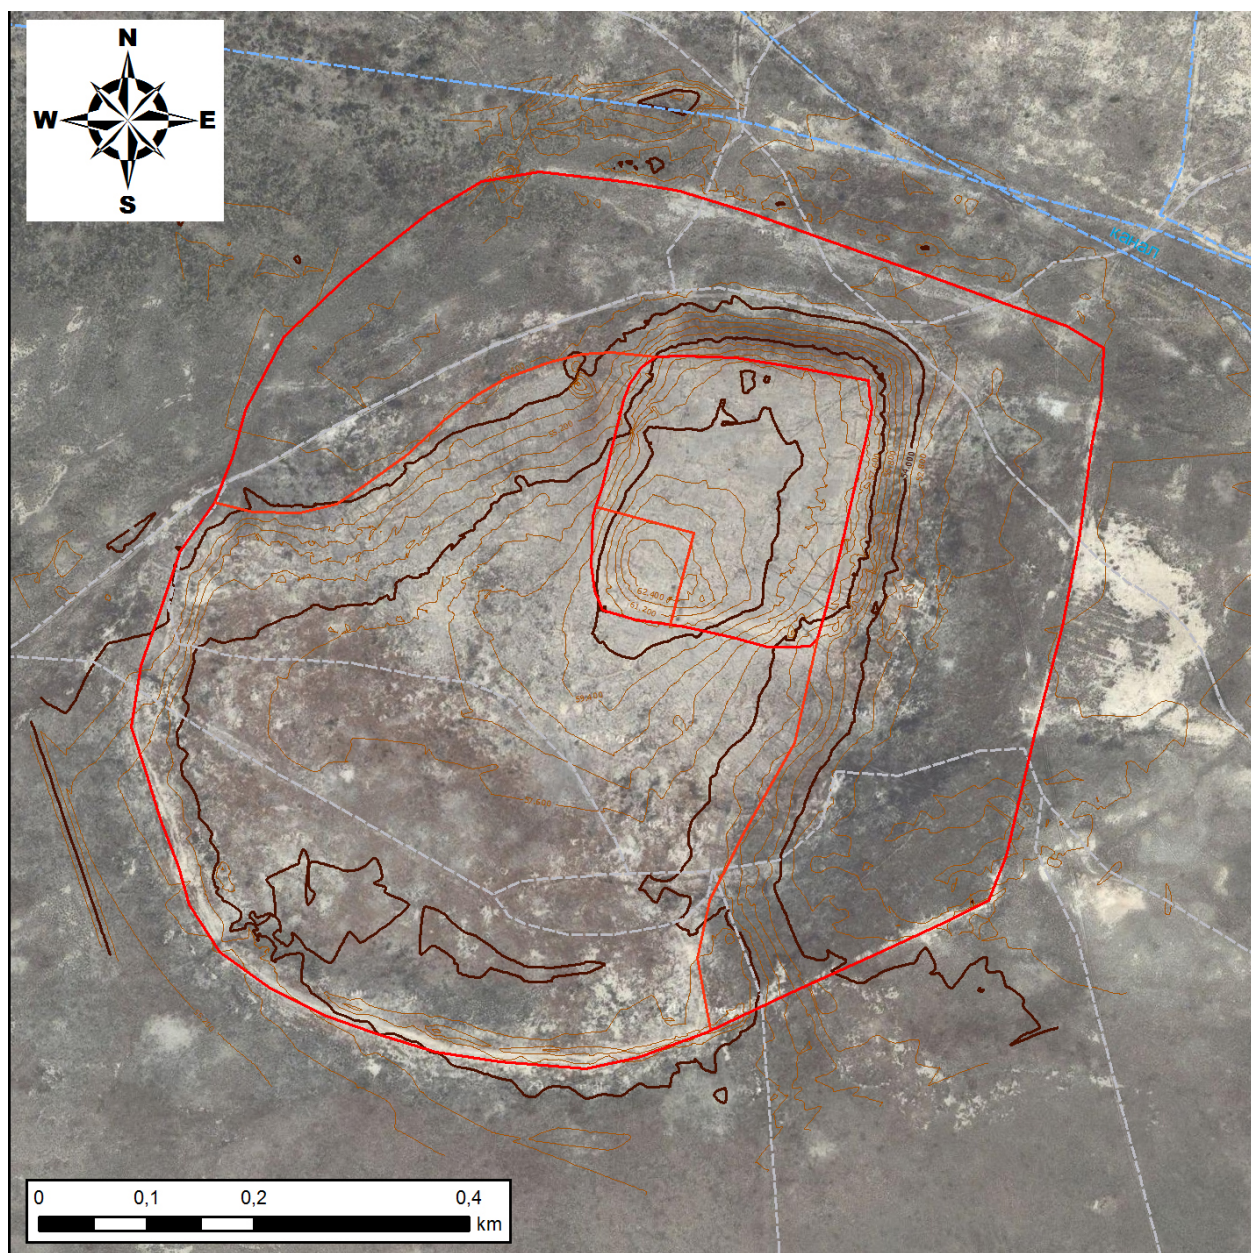
Drawing 1. Topoplan castle Kesken-Kuyuk-Kala

The settlement Kesken-Kuyuk-Kala is located on the left bank of the dried-up delta channel in the Kazaly district of the Kyzylorda region (coordinates of the site of the settlement are: latitude 45°31'6.11 "C, longitude 61°27'31.56" B). The mound is a swollen mound of 830 x 710 m, stretching from east to west. Along the perimeter, the hillfort is surrounded by a wall that has turned into a shaft 2 m high. In the topography there is a square in terms of shahristan 220 x 220 m in size, towering over the general level of the hill mound by 3 meters (Drawing 1). On its surface can be traced "street network" and building blocks. In the southwest corner of shahristan there is a 60 x 60 m square citadel in plan.

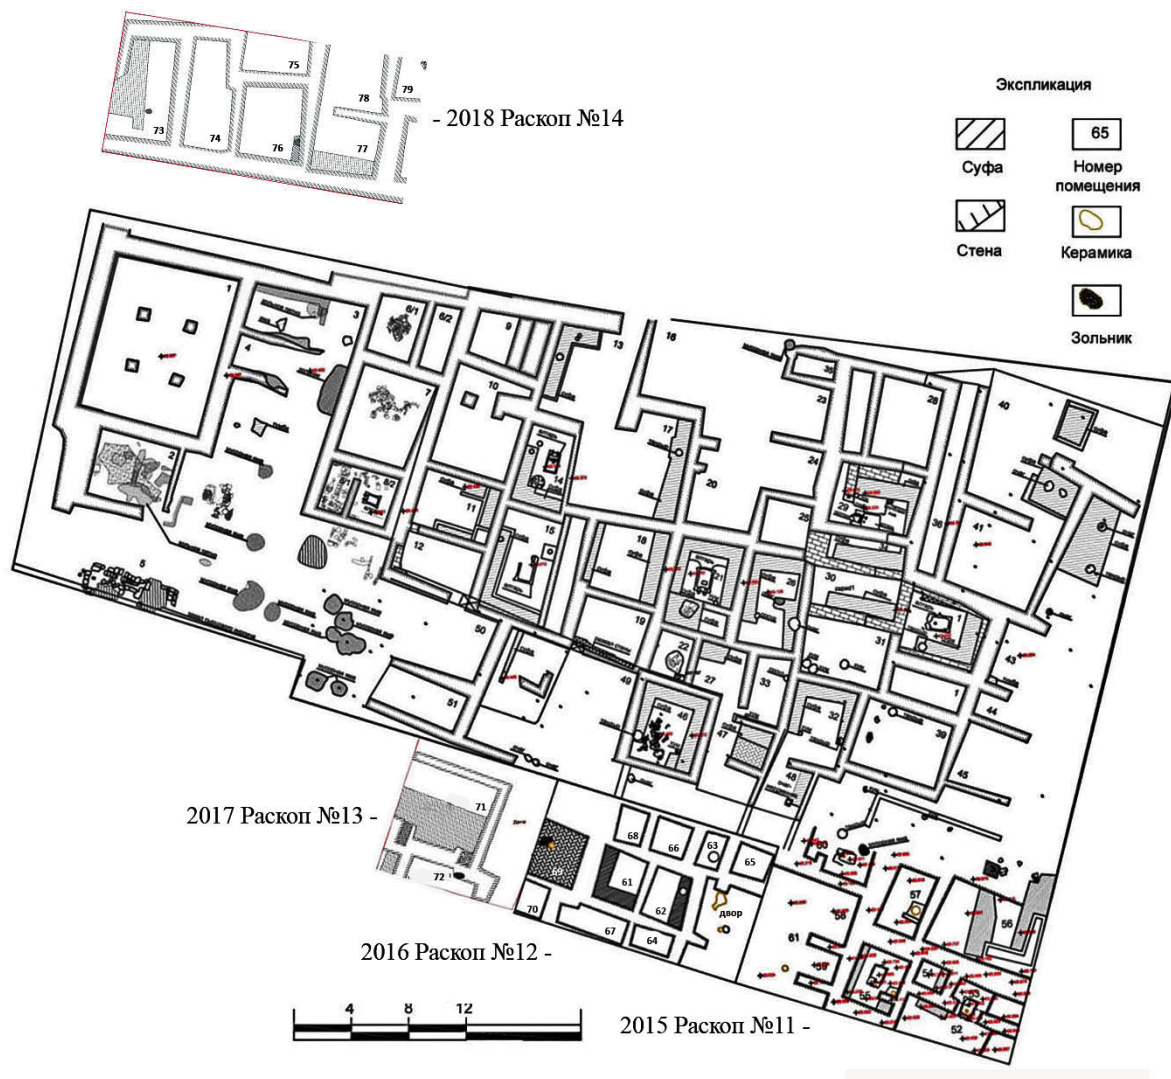
Drawing 2. The plan of the investigated quarter

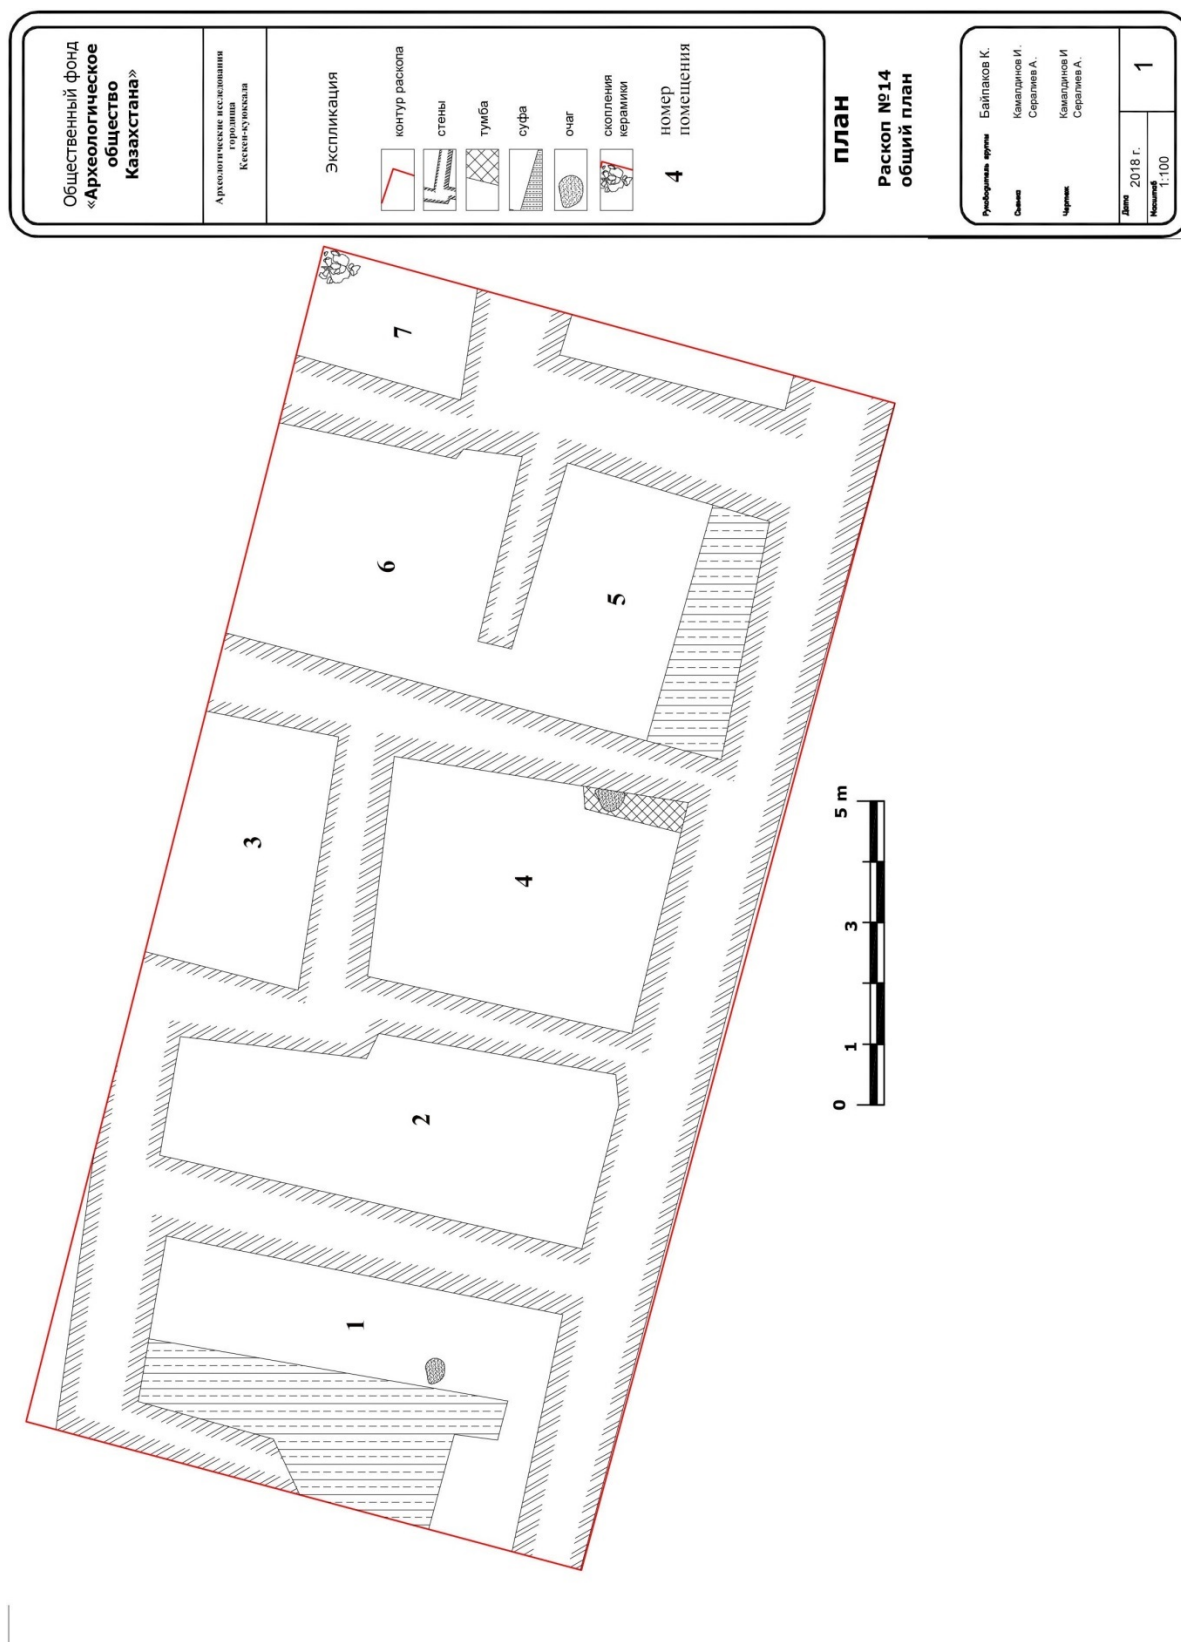
Drawing 3. Plan of excavation No.14

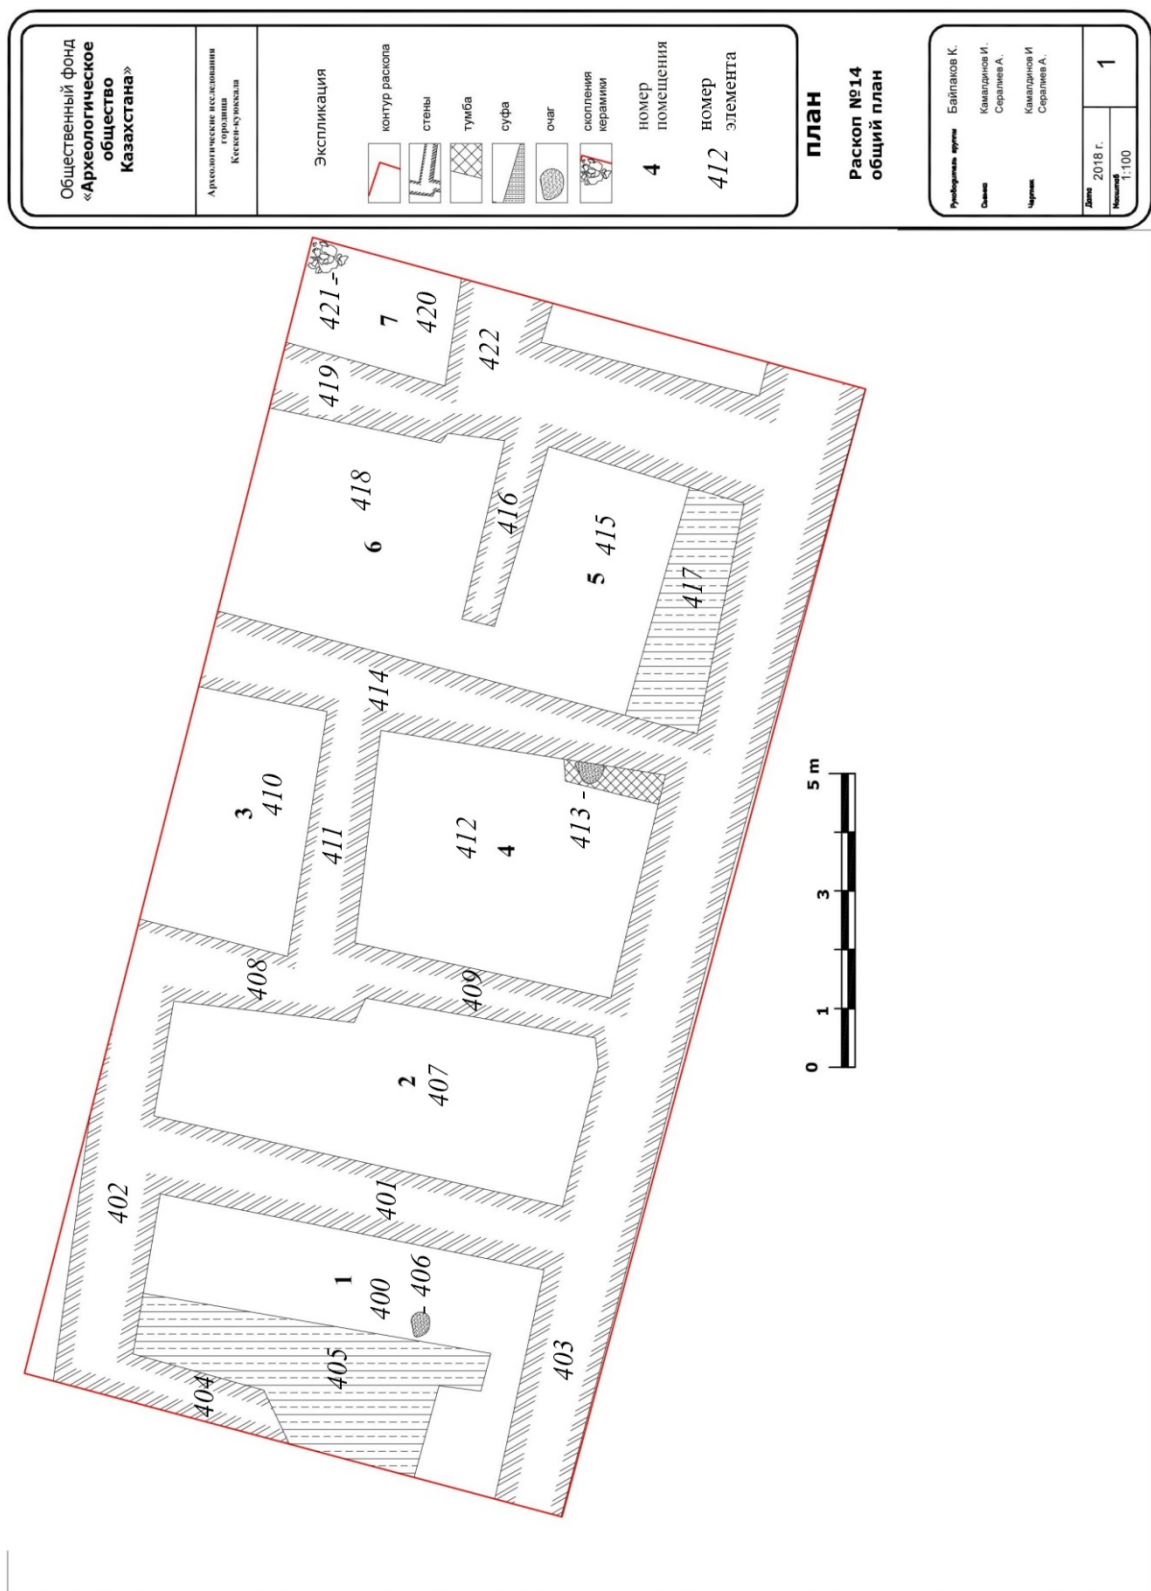
Drawing 4. Plan of excavation No.14 with the indication of the elements

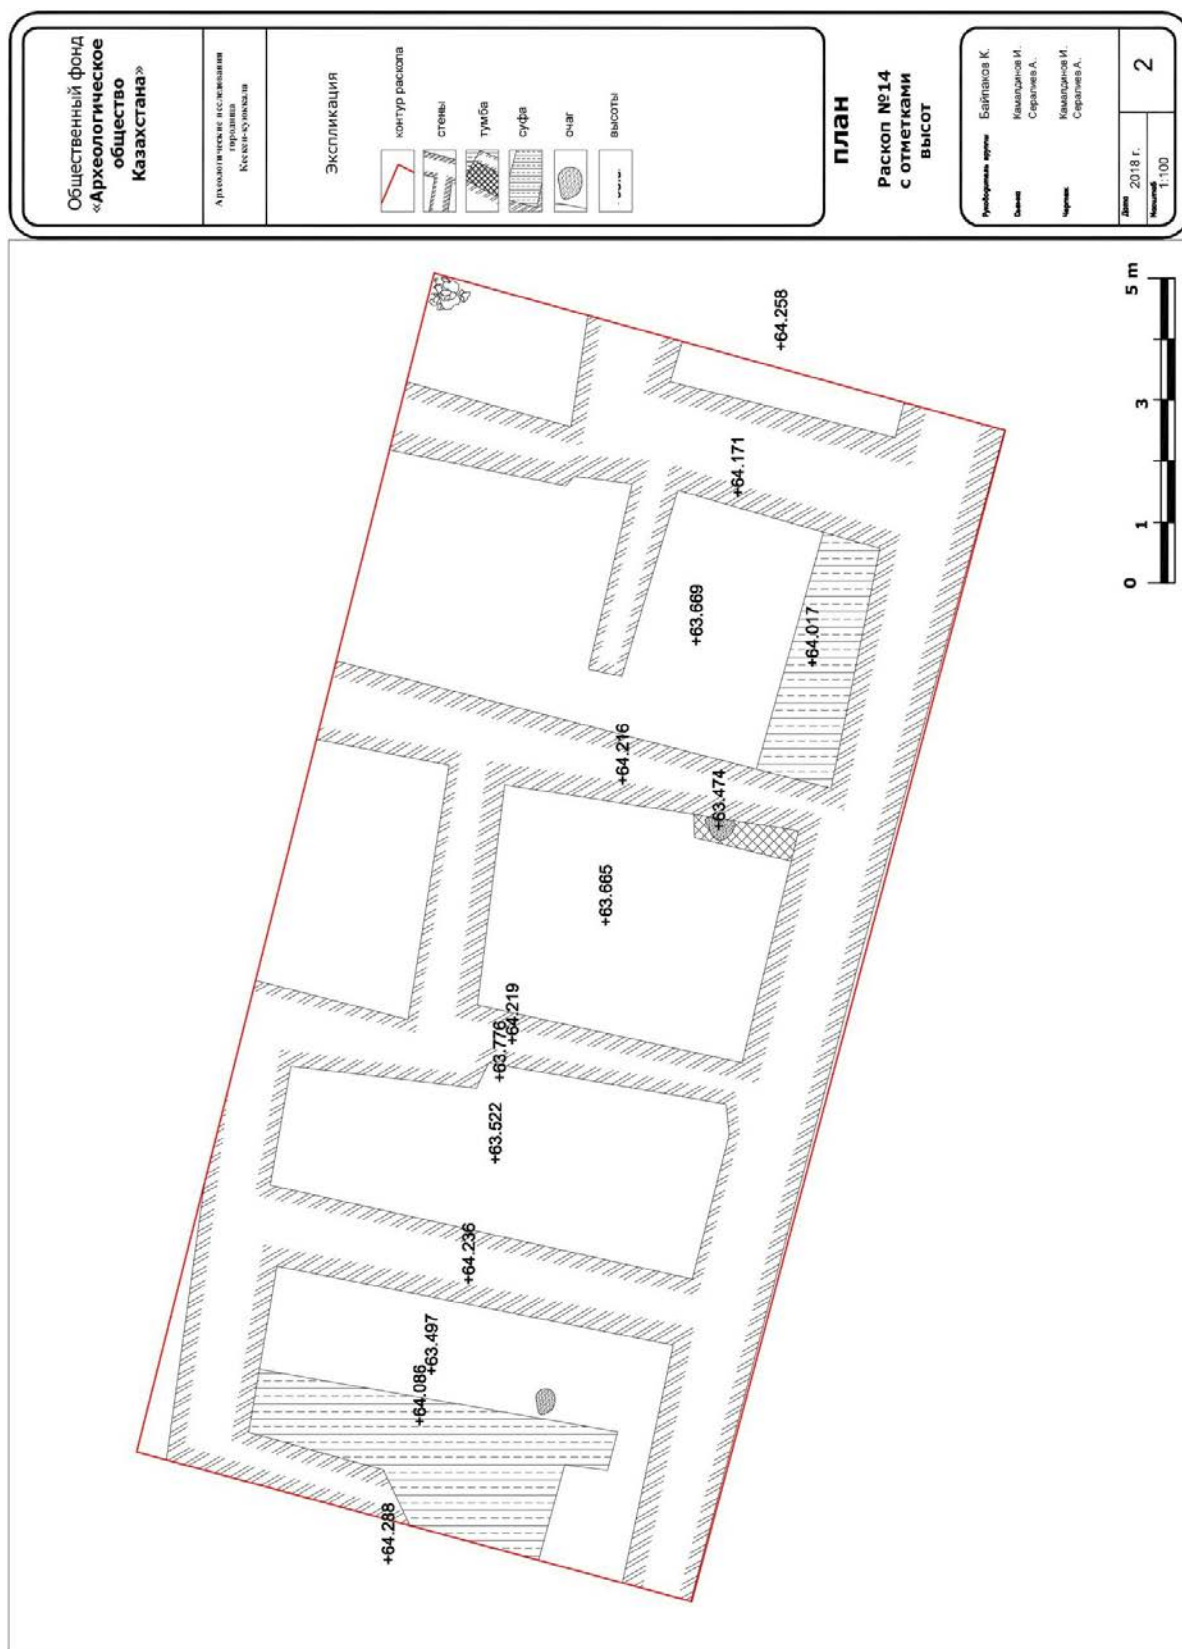
Drawing 5. Plan of the excavation No.14 with elevation marks

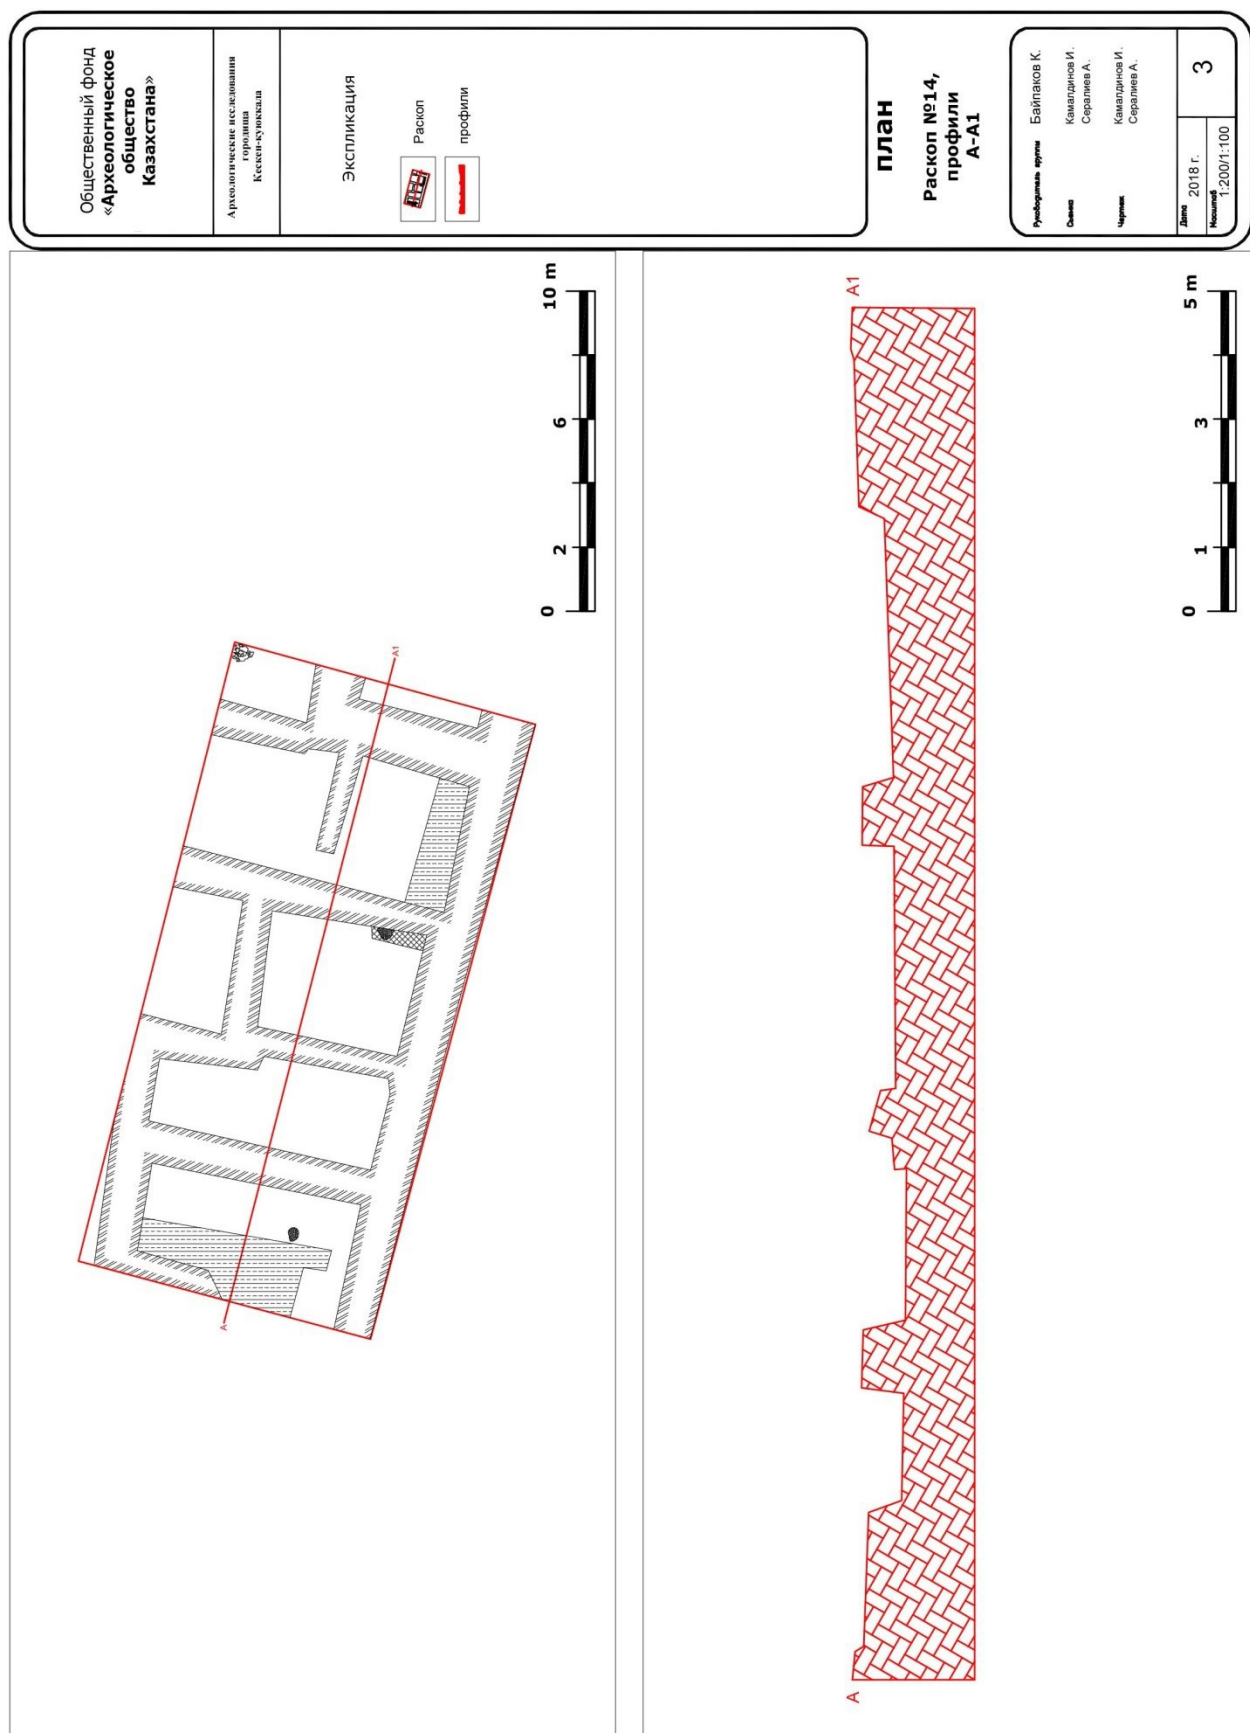
Drawing 6. Excavation No.14. Plan and cut (from east to west)
