**PUBLIC FUND ARCHAEOLOGICAL SOCIETY OF KAZAKHSTAN,
REPUBLIC OF KAZAKHSTAN
THE SOCIETY FOR THE EXPLORATION OF EURASIA,
SWITZERLAND**

SCIENTIFIC REPORT

**Archaeological studies of the ancient settlement
Kesken-Kuyuk-Kala (Juvara) in 2018**

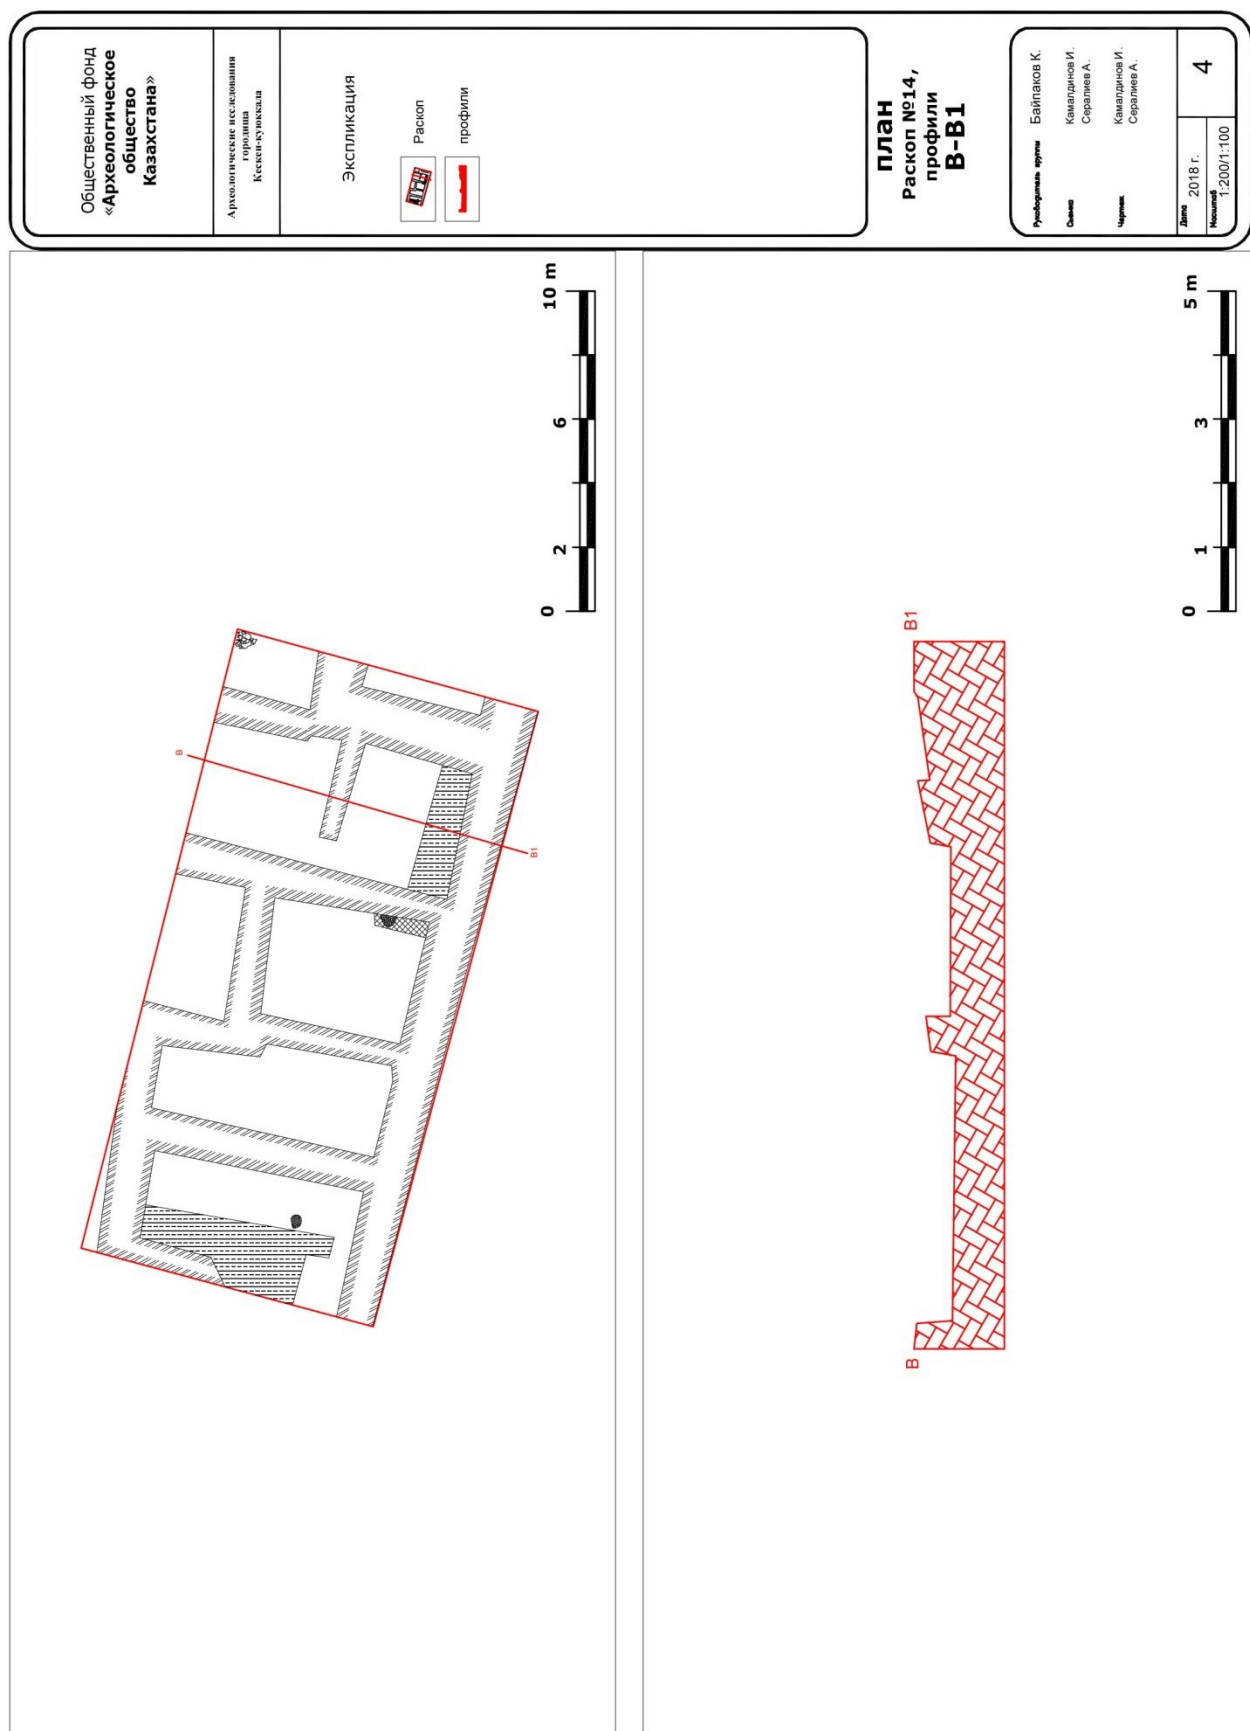
Drawing 7. Excavation No.14. Plan and cut (from south to north)

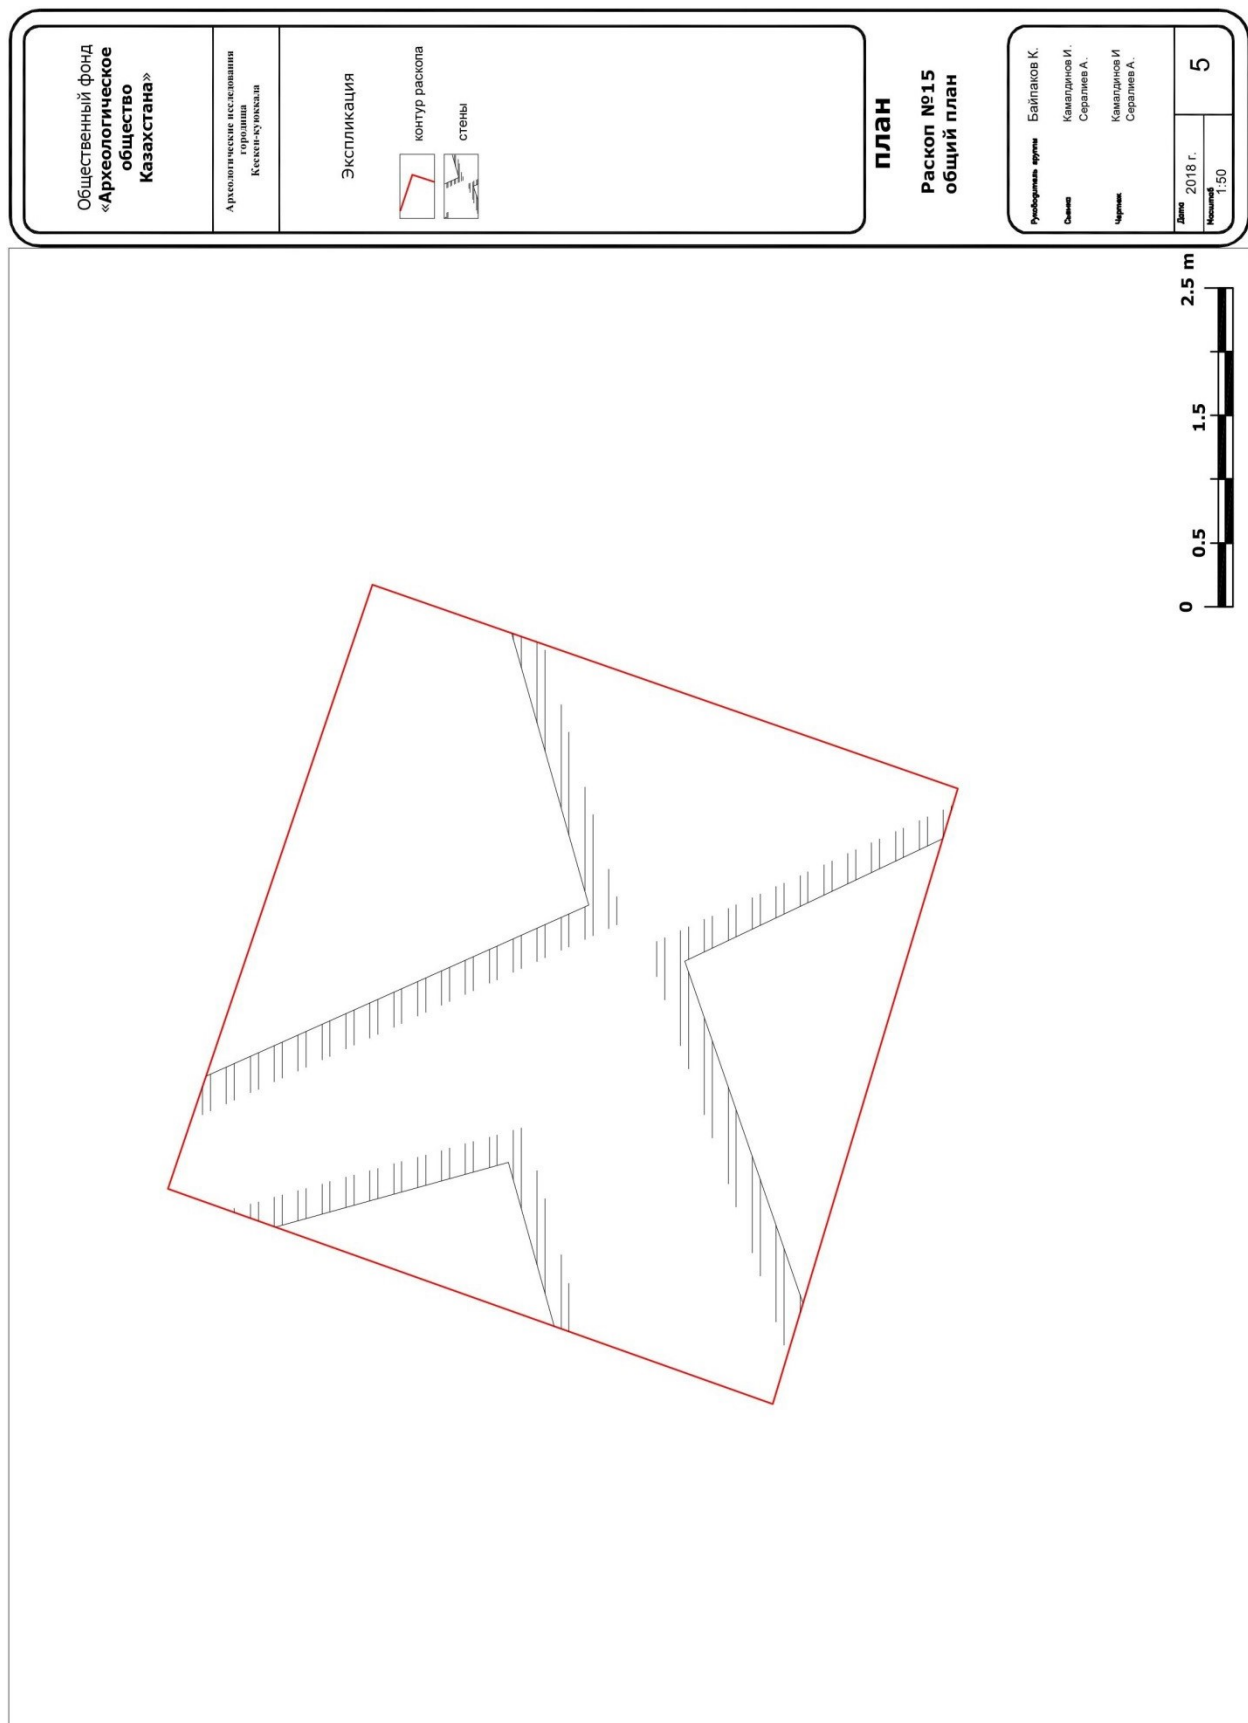
Drawing 8. Excavation No.15. Plan

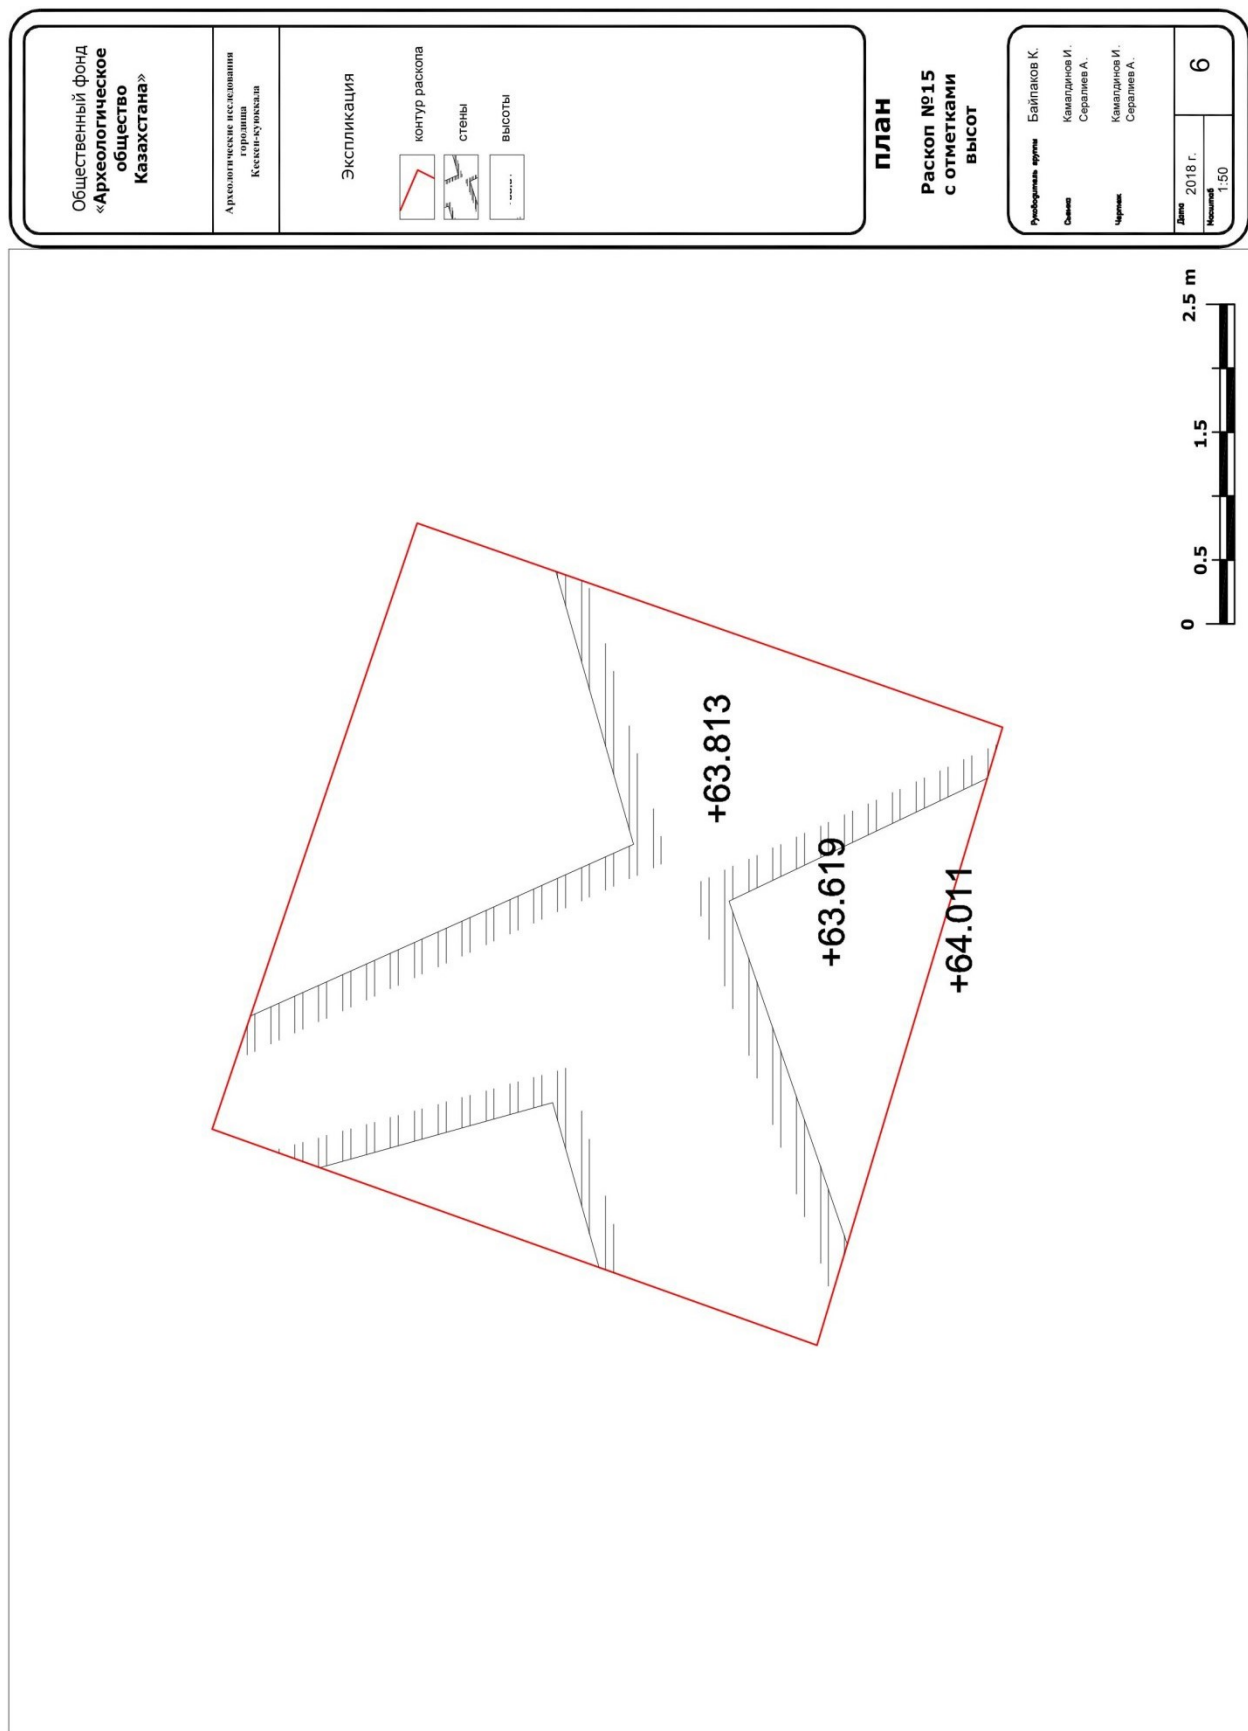
Drawing 9. Excavation No.15. Plan with elevations

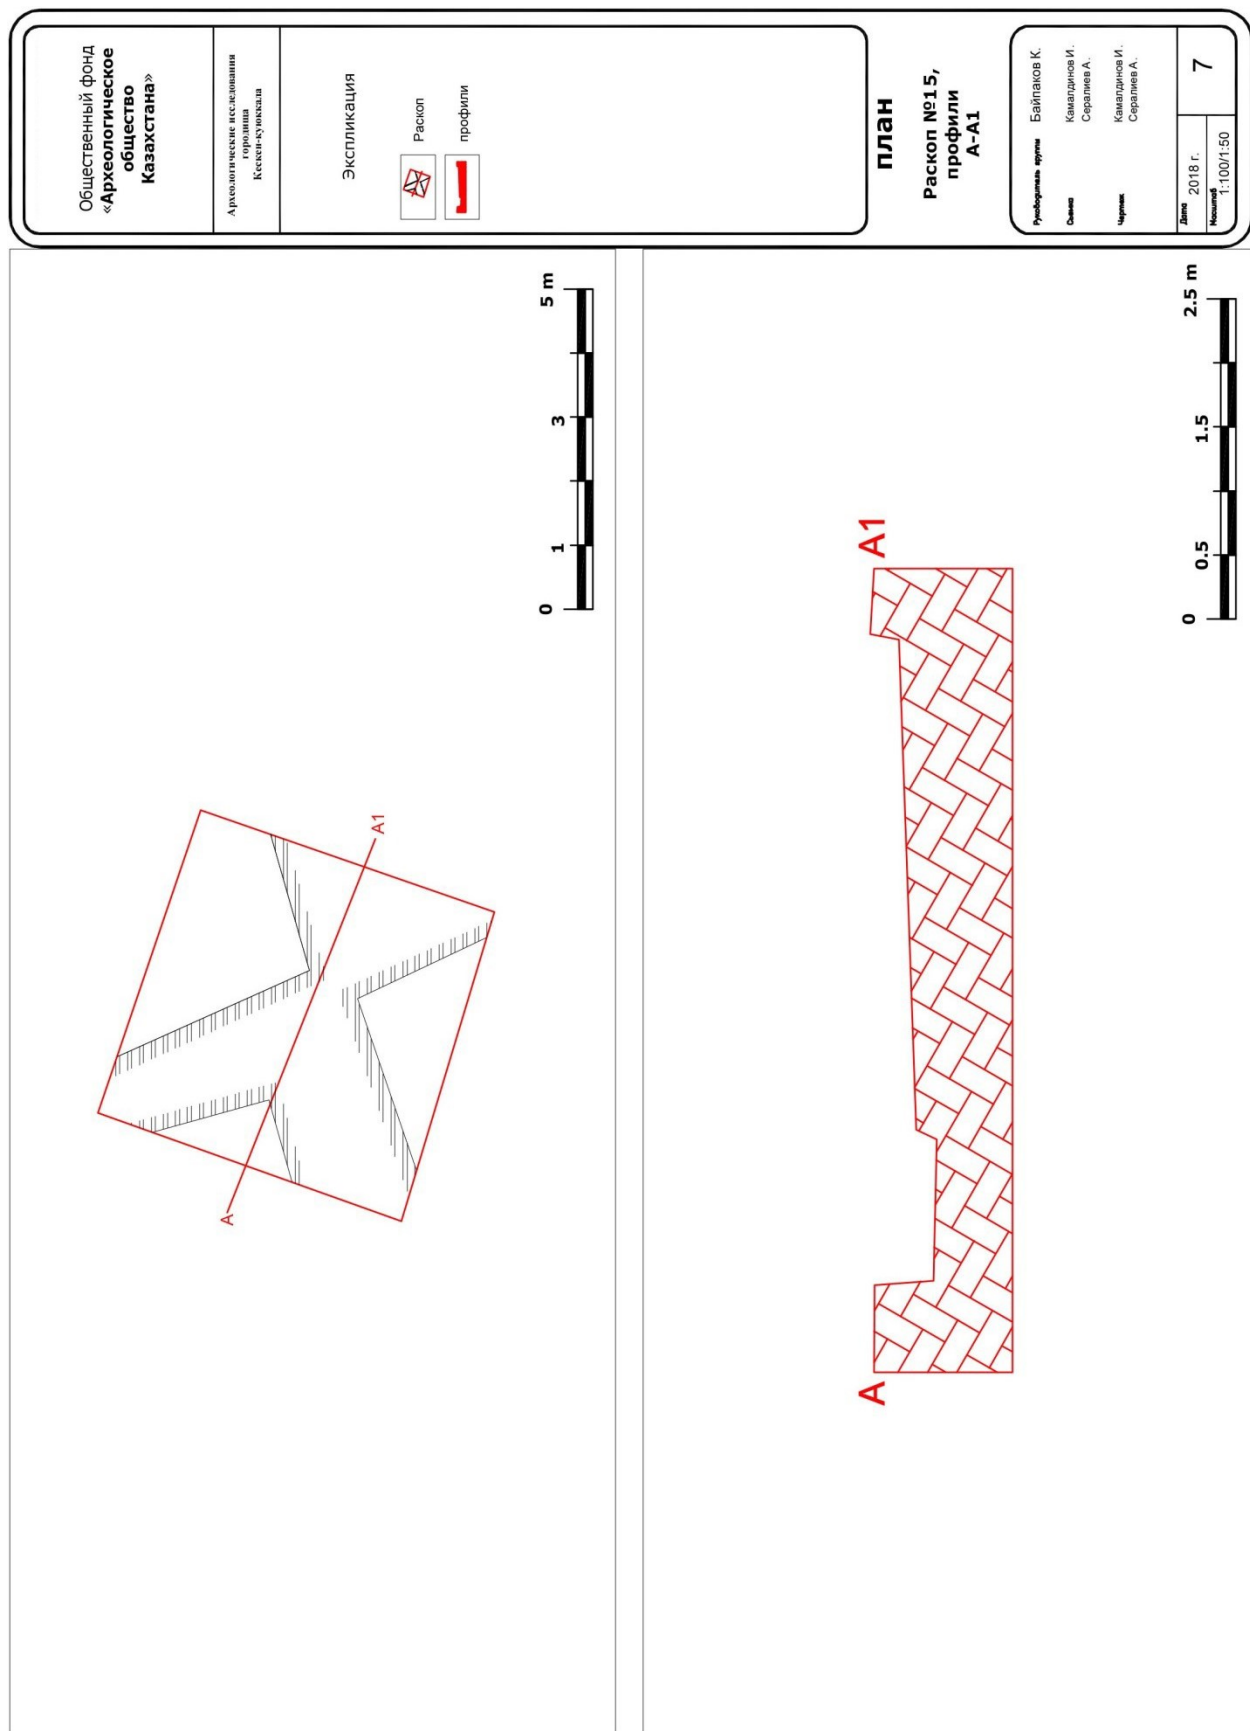
Drawing 10. Excavation No.15. Plan. Section 1

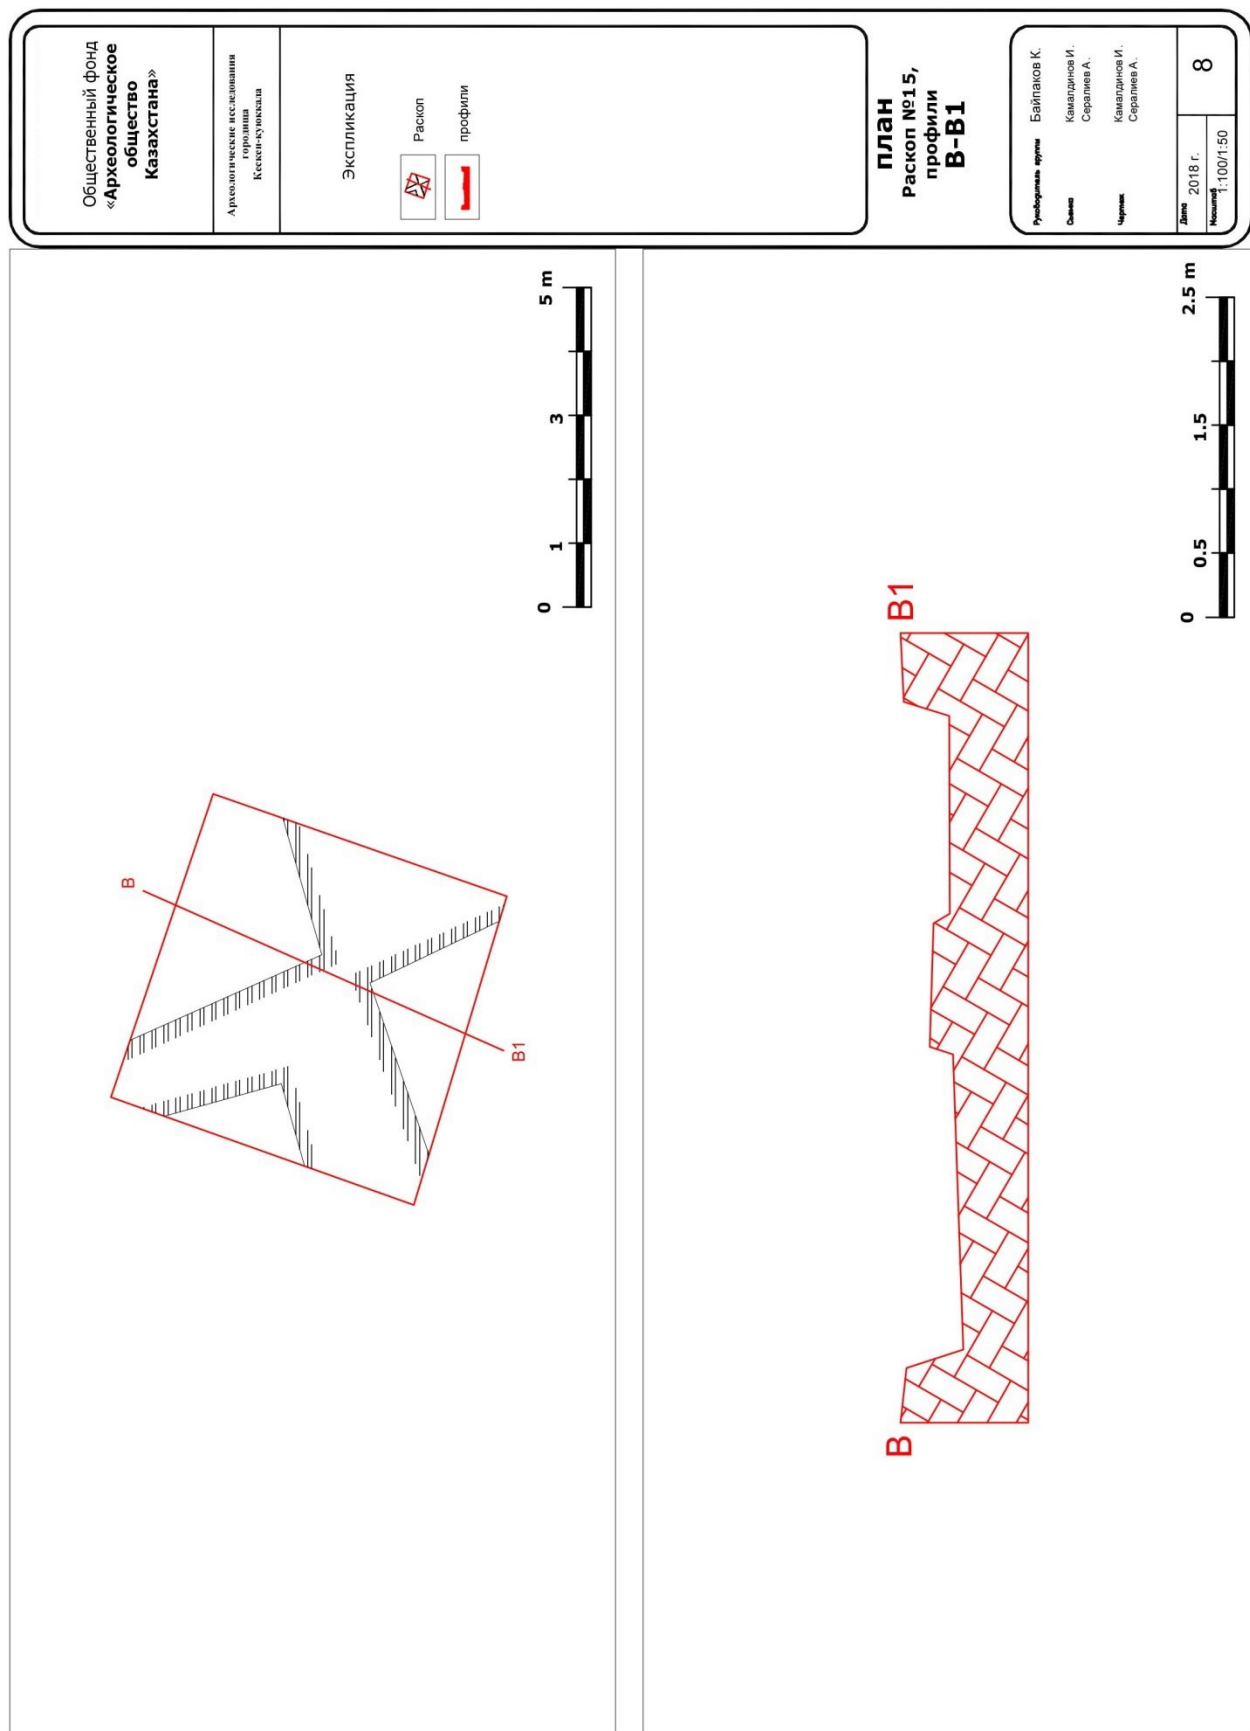
Drawing 11. Excavation No.15. Plan. Section 2

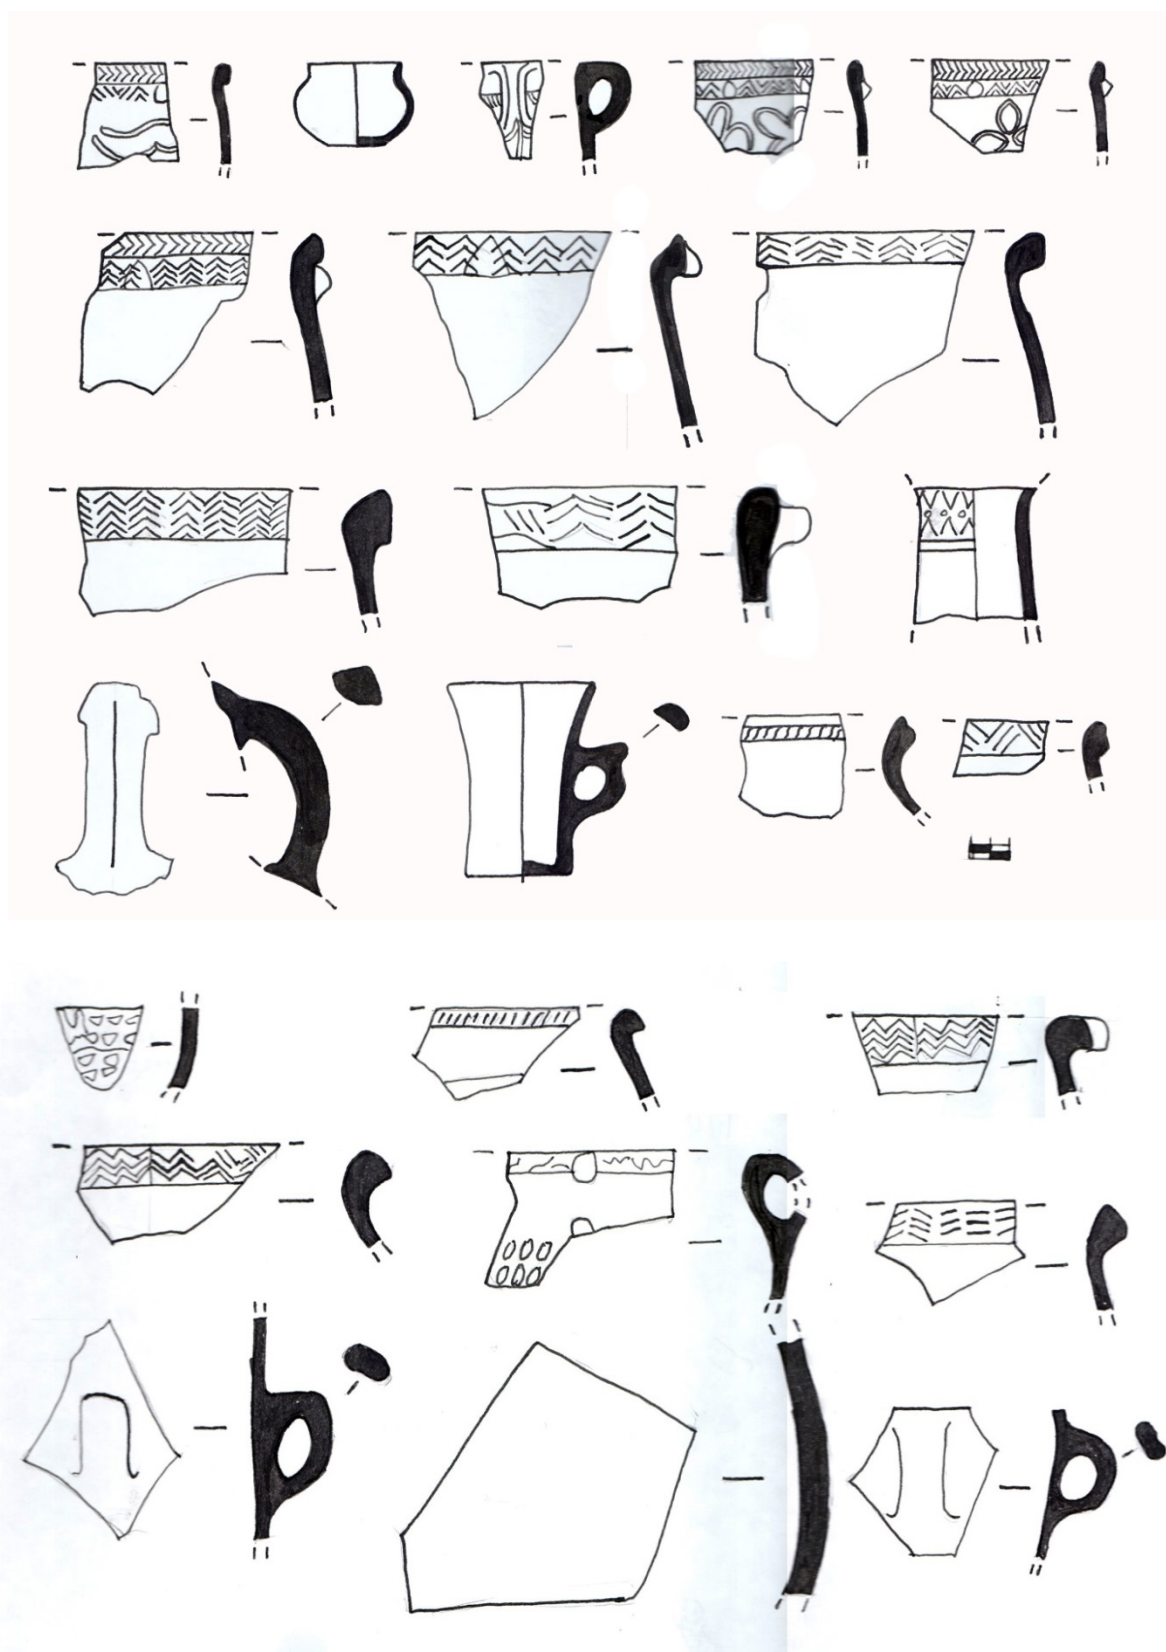
Figure 1. Fragments of sidewalls, handles, rims of ceramic vessels

Fragments of the rims of the molded vessels of the boiler type. The vessels are made of medium-mixed loose dough with admixtures of fine and coarse sand and inclusions of mica, roasting in a break of dark gray color. Outside are covered with red engobe, the edges of the rims are thickened, rectangular in cross section of the shape, wall thickness is 1 cm. Sometimes the edge of the corolla is decorated outside with oblique lines or “christmas tree”. Wall thickness from 1 cm to 2 cm.

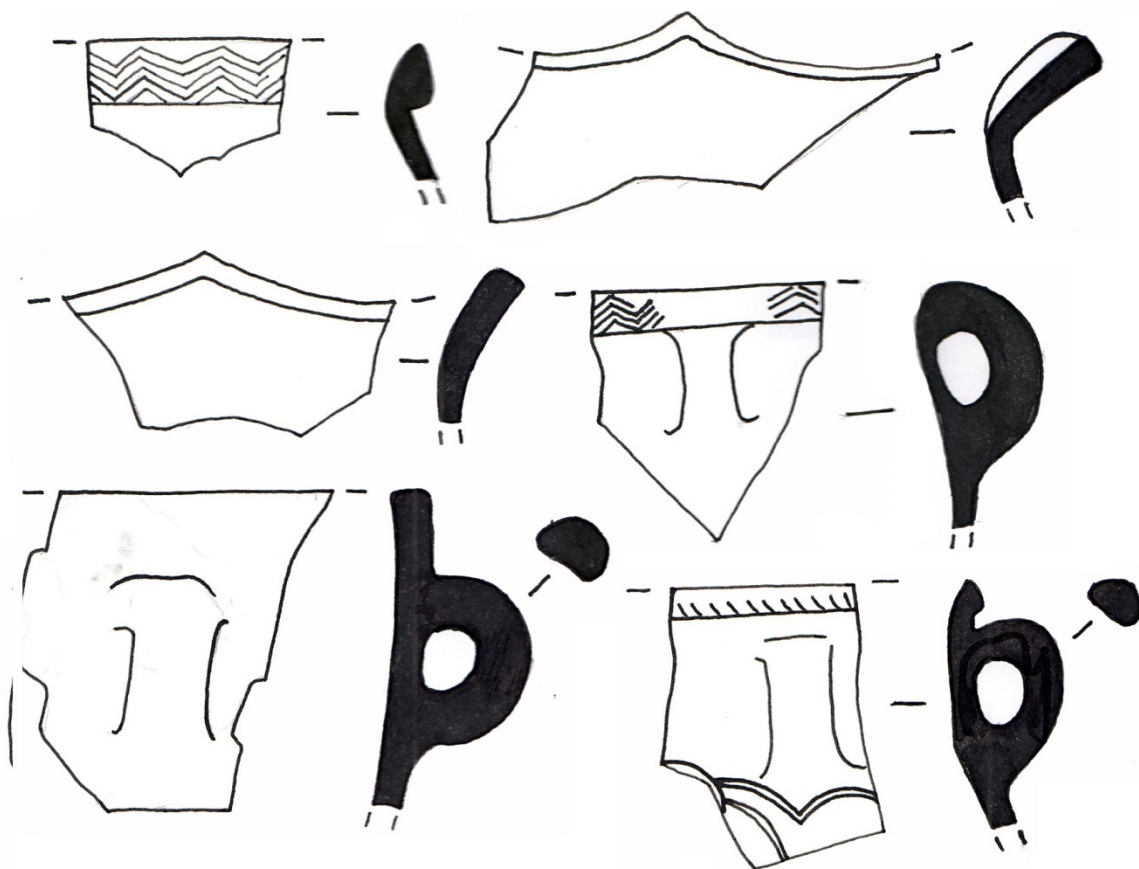
Figure 2. Fragments of the rims, handles, sidewalls of ceramic vessels
