Society for the Exploration of Eurasia, Switzerland

LLC RUTRUM

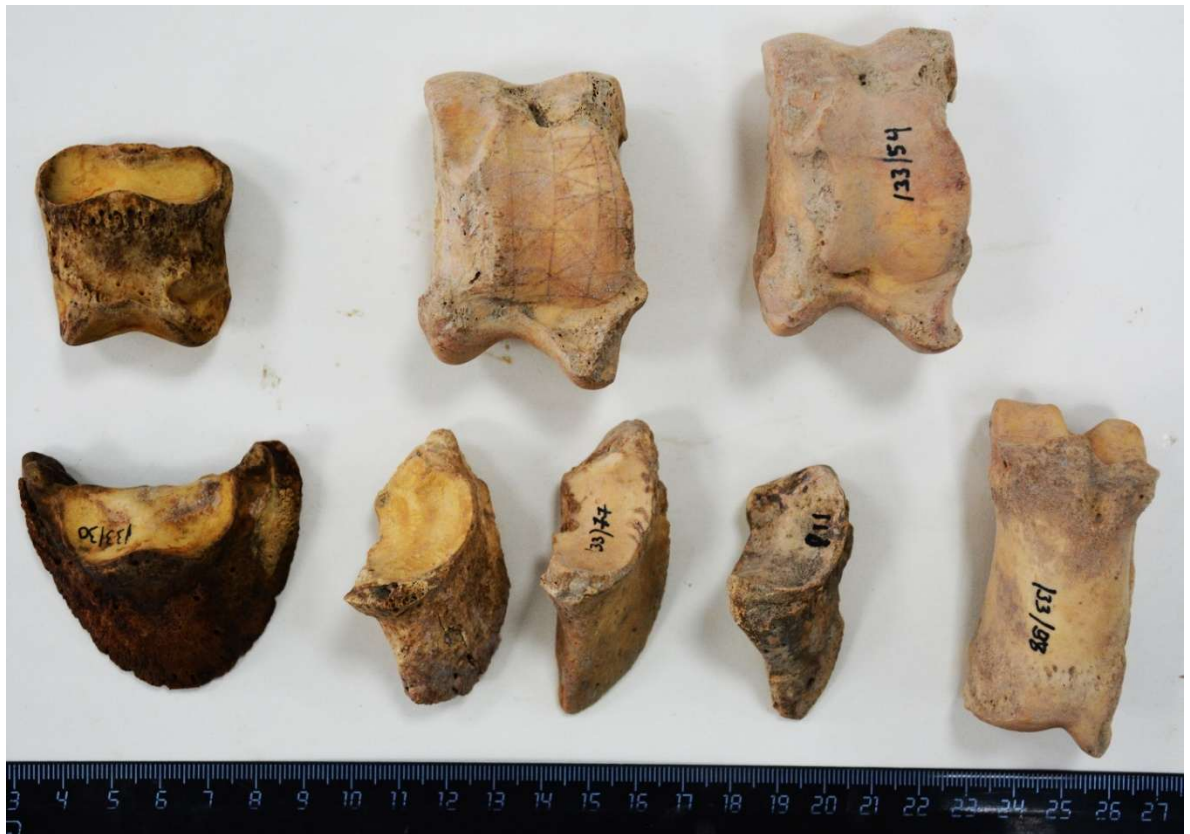
Figure 19. Kessken Kuyuk-kala site. Excavation 2025. Phalanges of the Horse and cattle, as well as talus bones of cattle. Traces of ornamented incisions are observed on the plantar surface of the talus.

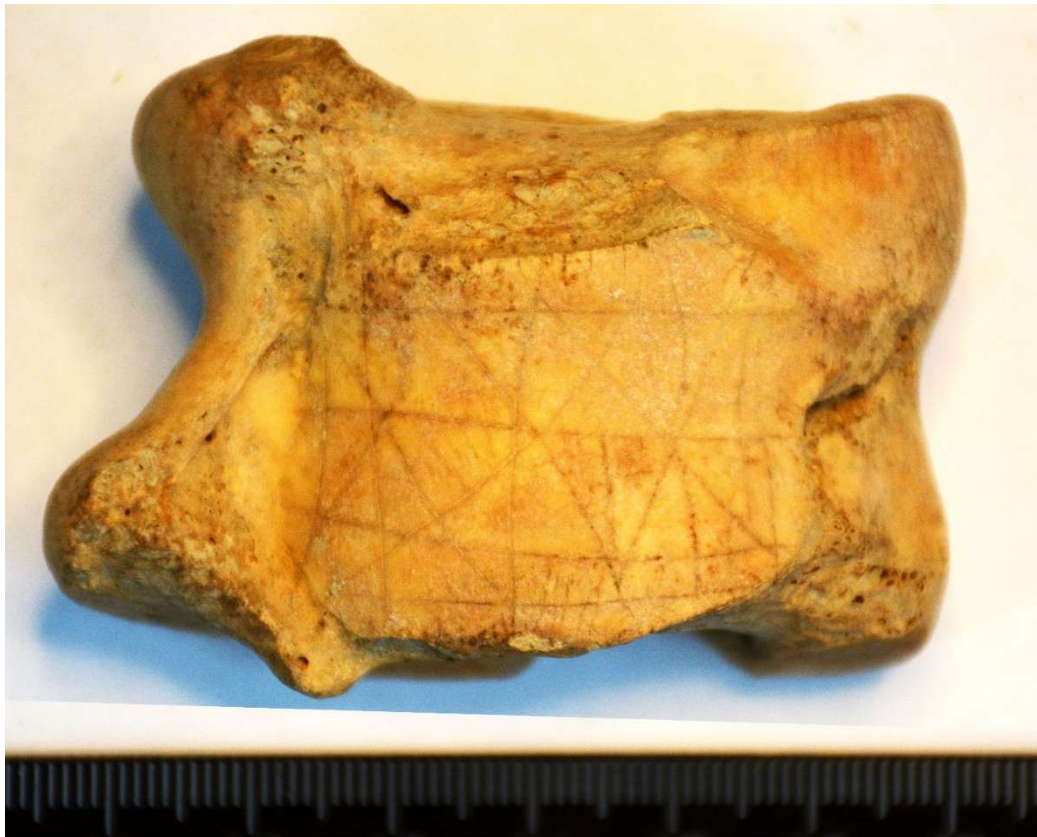
Figure 20. Kessken Kuyuk-kala site. Excavation 2025. Left talus of large cattle. Geometric ornamental incisions are recorded on the plantar surface.

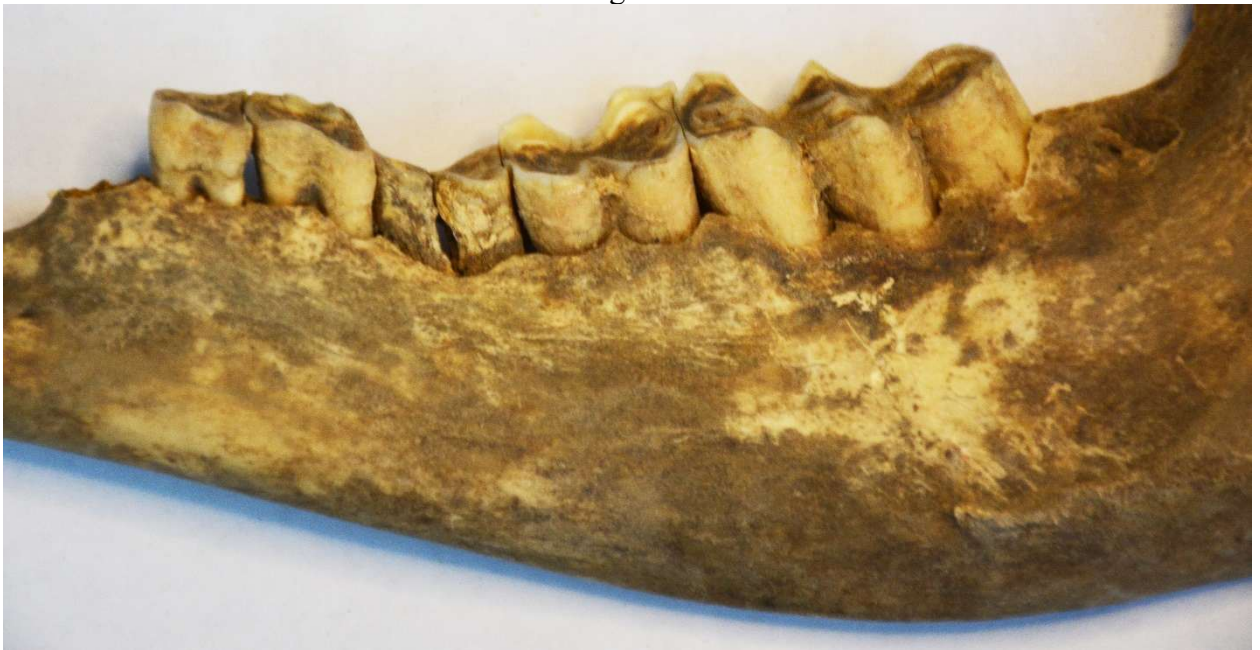
Figure 25. Kessken Kuyuk-kala site. Excavation 2025. Left ramus of the mandible of a small ruminant (small ruminants). Pathological wear of the occlusal surface of the first molar (m1).

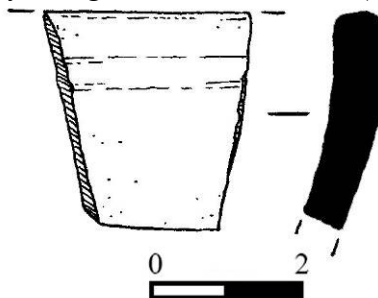
Figure 1. Ks_25_R1_0_1

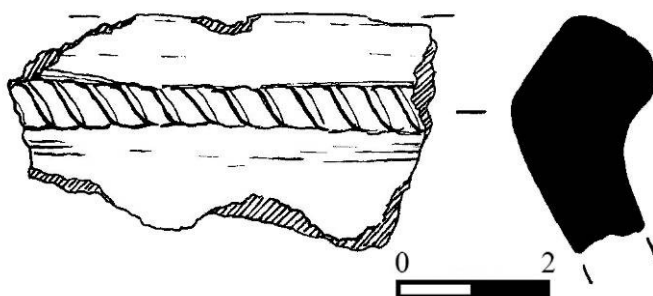
Figure 2. Ks_25_R1_0_2

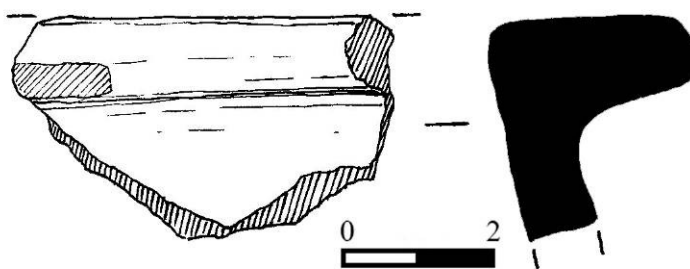
Figure 3. Ks_25_R1_0_3

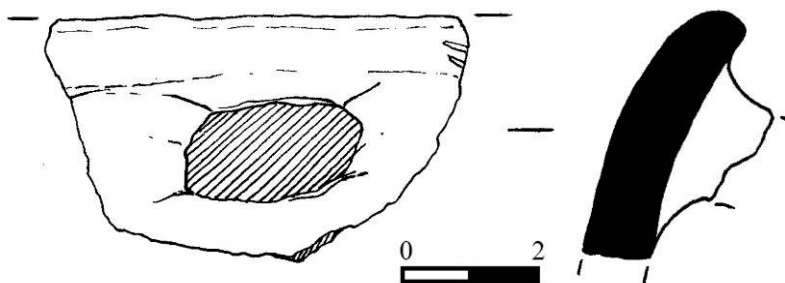
Figure 4. Ks_25_R1_0_4

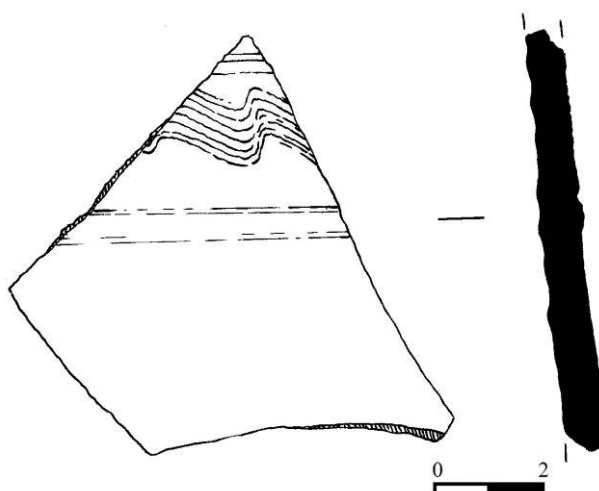
Figure 5. Ks_25_R1_0_5

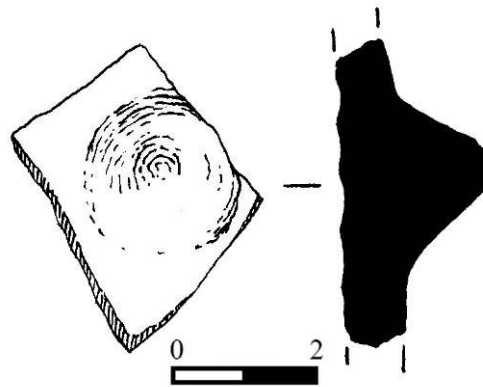
Figure 6. Ks_25_R1_0_6

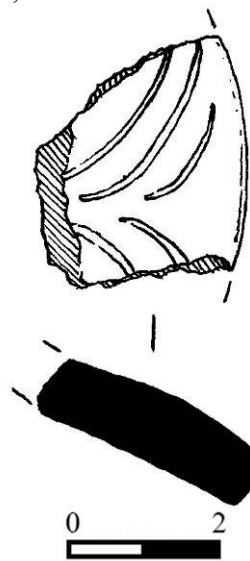
Figure 7. Ks_25_R1_0_7

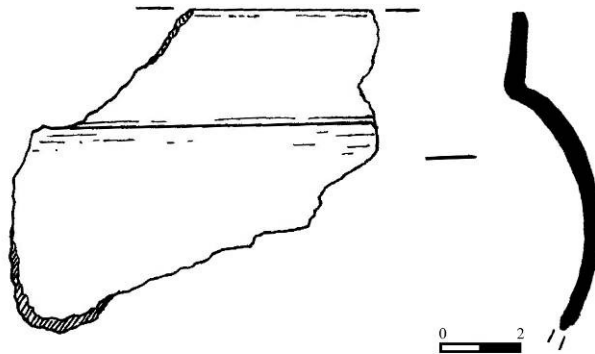
Figure 9. Ks_25_R1_1_1

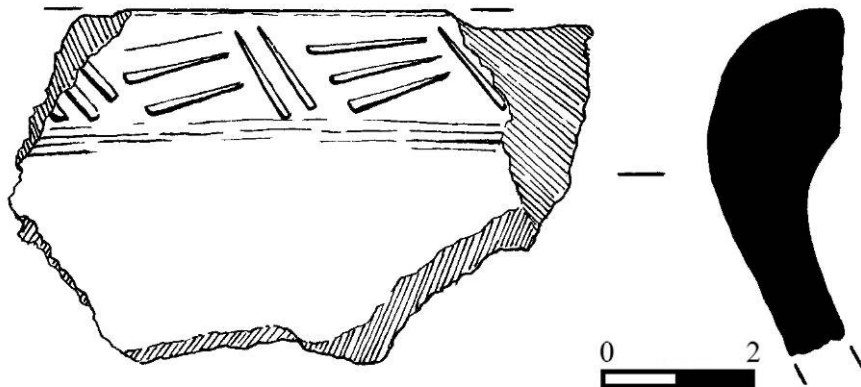
Figure 10. Ks_25_R1_1_10

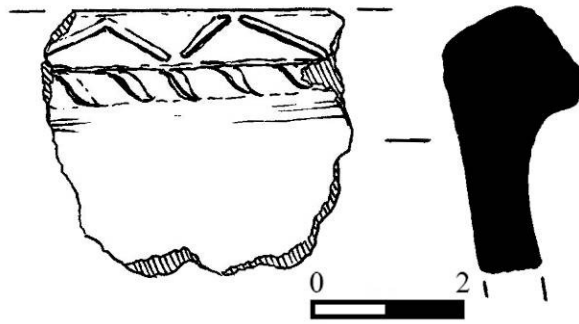
Figure 11. Ks_25_R1_1_3

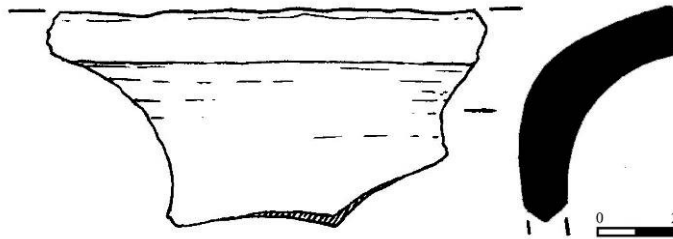
Figure 12. Ks_25_R1_1_4

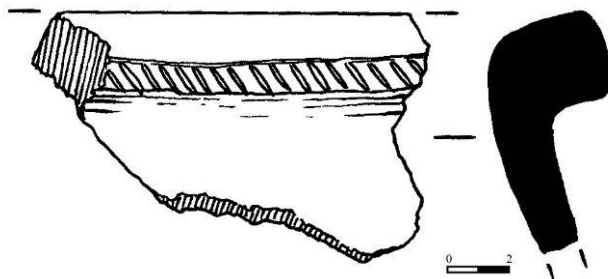
Figure 13. Ks_25_R1_1_5

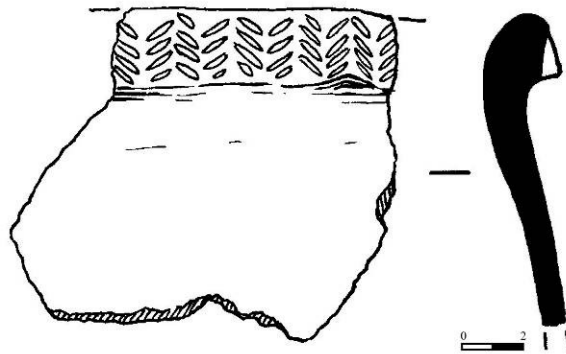
Figure 14. Ks_25_R1_1_6

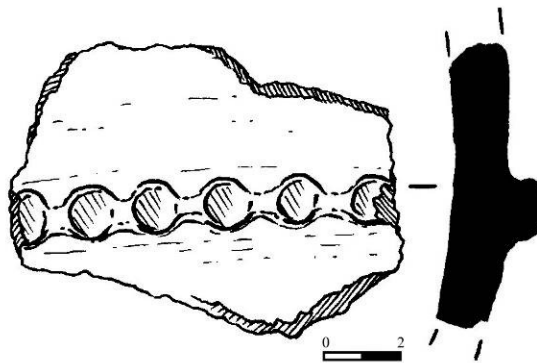
Figure 15. Ks_25_R1_1_7

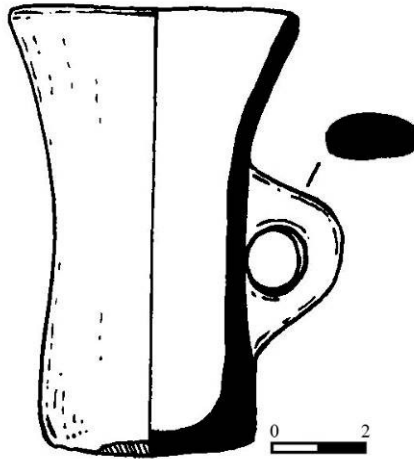
Figure 19. Ks_25_R1_4_1

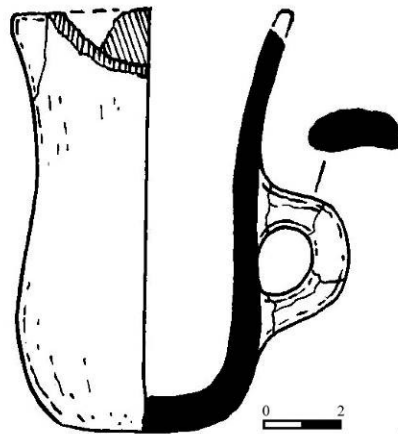
Figure 20. Ks_25_R1_4_2

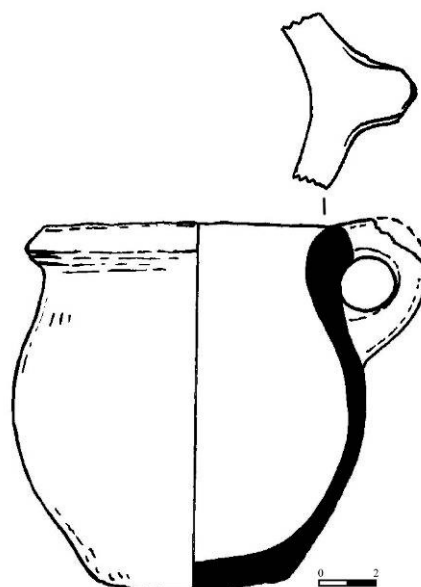
Figure 21. Ks_25_R1_4_3

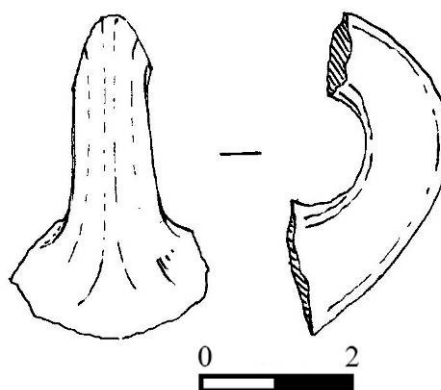
Figure 23. Ks_25_R1_10_1

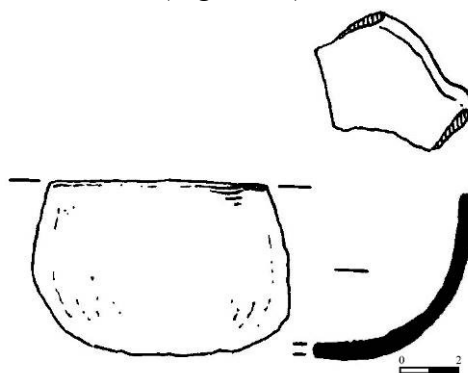
Figure 26. Ks_25_R1_35_1

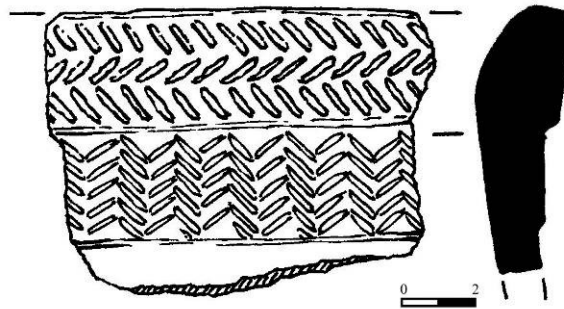
Figure 27. Ks_25_R1_35_2

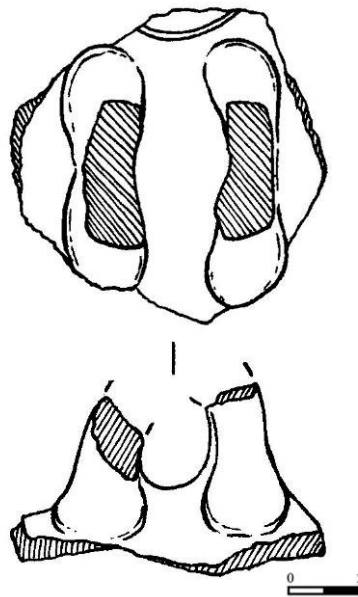
Figure 28. Ks_25_R1_35_3

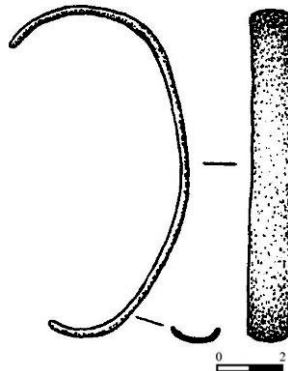
Ks_25_R1_43***Whole or half-complete vessels***

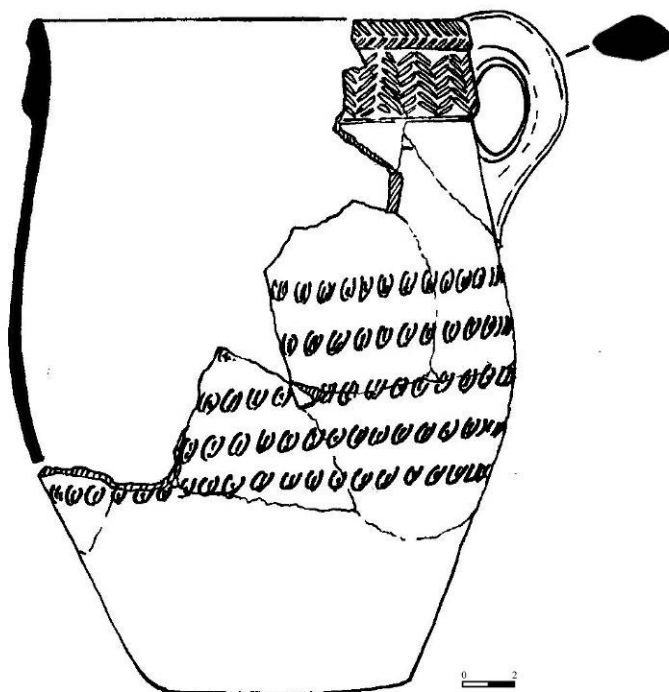
Figure 30. Ks_25_R1_43_1

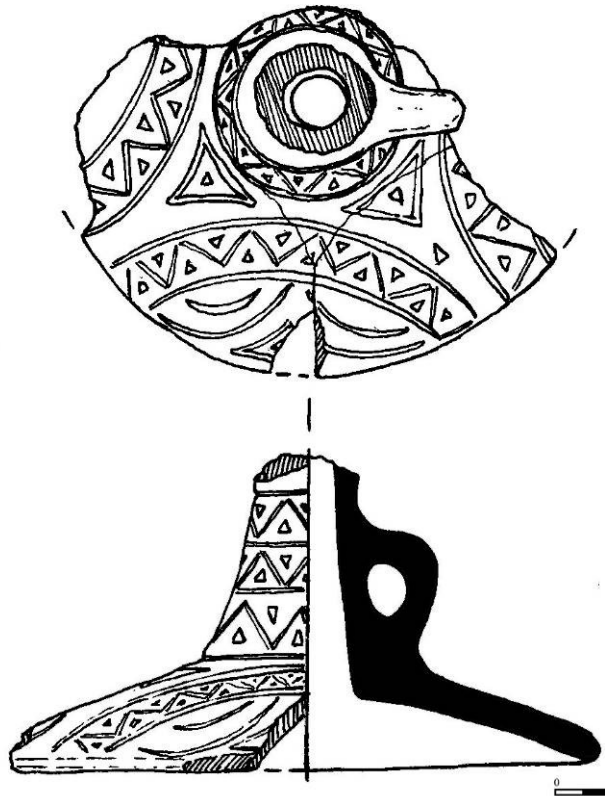
Figure 31. Ks_25_R1_43_2

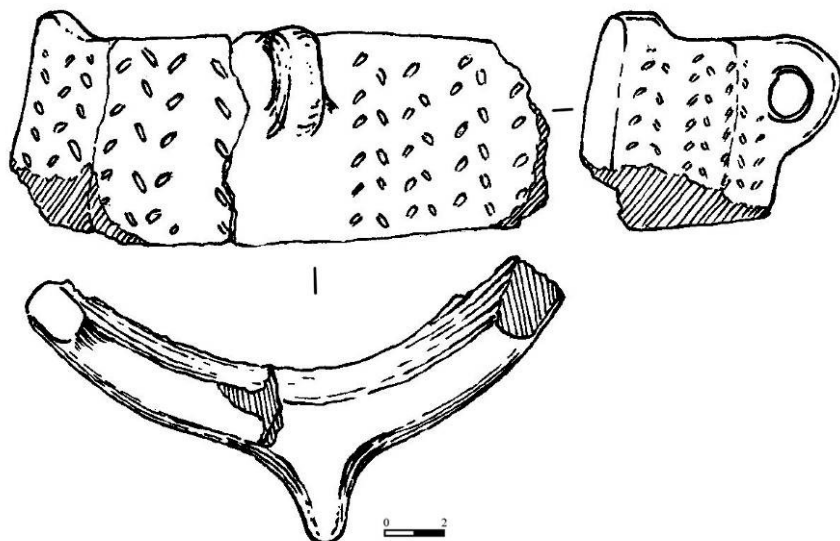
Figure 32. Ks_25_R1_43_3

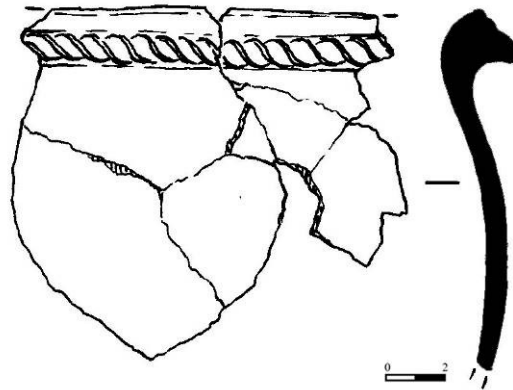
Figure 33. *Ks_25_Sh_0_1*

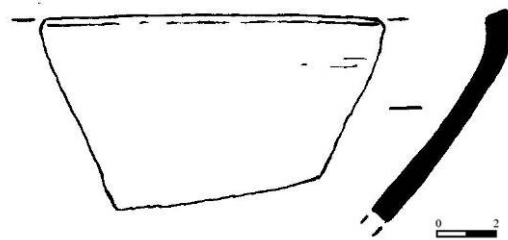
Figure 34. *Ks_25_Sh_0_2*

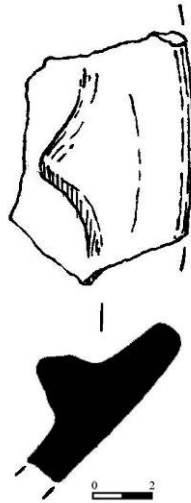
Figure 35. Ks_25_Sh_0_3

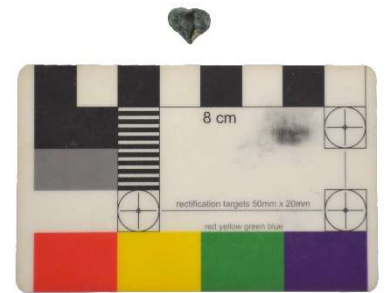
3 Fragment of a rod from a copper needle
KS_25_0_2
Fragment of a rod from a copper needle (possibly a pin) found during stratigraphic survey. Length: 1.3 cm; thickness: 0.2 cm. The rod is coated with green oxide.

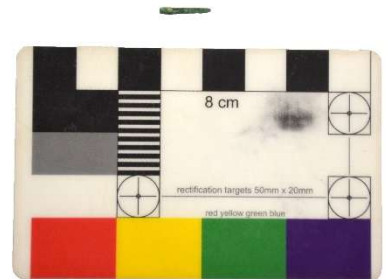
4 Fragment of a bronze belt plaque
KS_25_0_3
Fragment of a bronze belt plaque, measuring 1.3×0.7 cm, with a thickness of 0.2–0.3 cm. Portions of the plaque and the rod are missing. Remnants of ornamentation are partially preserved on the exterior of the plaque.

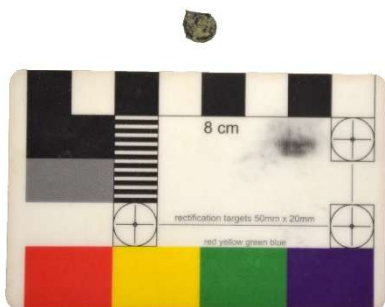
5 Fragment of a green glass bead
KS_25_0_4
Fragment of a spherical green glass bead; diameter 0.5 cm, height 0.3 cm, perforation diameter 0.2 cm.

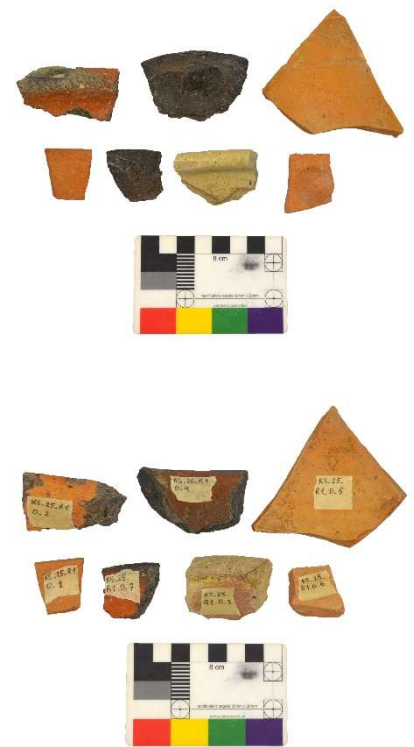
diameter 22 cm, wall thickness 0.8–0.9 cm. (KS_25_1_0_3)

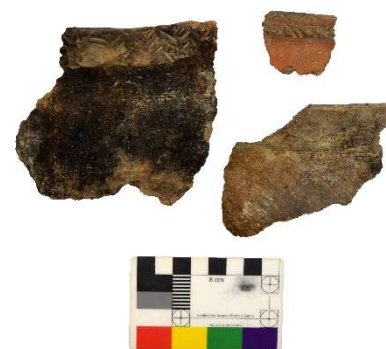
Rim fragment from a hand-made small pot, produced from a moderately mixed, loose, red fabric with numerous visible inclusions of fine and coarse sand, mica, and minerals in the break; due to uneven firing, the fabric color varies to gray and dark tones. The surface of the vessel is covered on both the exterior and interior with a layer of brown engobe; banded burnishing with a sheen is also present

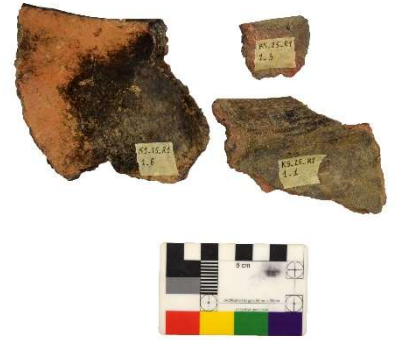
- 9 Rim fragment from a hand-built vessel of the vase type. KS_25_1_1_4
 Rim fragment from a large hand-built vessel of the jar type. KS_25_1_1_5
 Rim fragment from a small hand-built vessel of the jar type. KS_25_1_1_6
 Wall fragment from a large hand-built vessel. KS_25_1_1_7

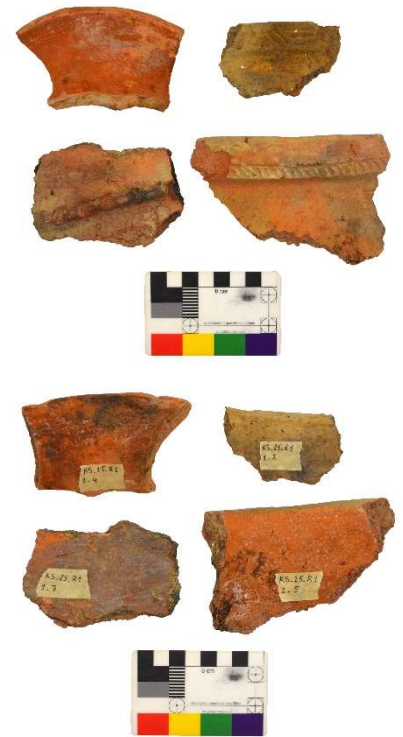
alternating lines forming a 'fir-tree' motif. A small projection is present on the exterior of the rim, presumably a pseudo-handle. Rim diameter is 17 cm; wall thickness is 0.6–0.7 cm. (KS_25_1_1_6)

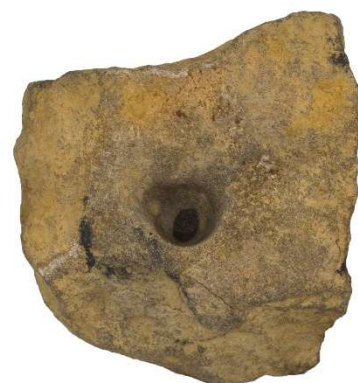
11 Bone artifact
made from
tubular bone.
KS_25_1_1_9

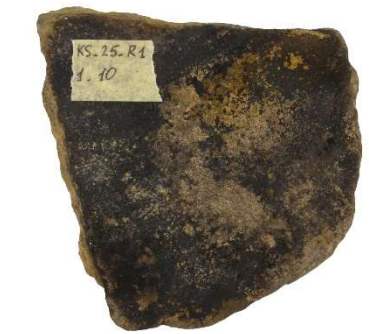
12 Gaming
asyk—
astragalus.
KS_25_1_1_8

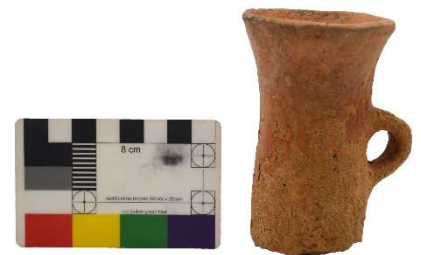
everted rim; the rim cross-section is flattened and oval-shaped. The rim diameter measures 6.2 cm, and the body diameter is approximately 4.3 cm. The vessel walls transition into a flat base with a diameter of 4.3 cm. Attached laterally is a loop-shaped vertical handle of flattened oval cross-section, measuring 1.9 cm in width and 0.6 cm in thickness. The height of the mug is 9.8 cm.

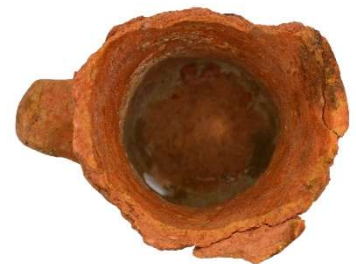
15 Archaeological
ly complete
hand-built
vessel
KS_25_1_4_3.

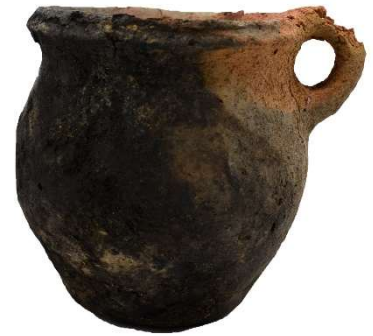
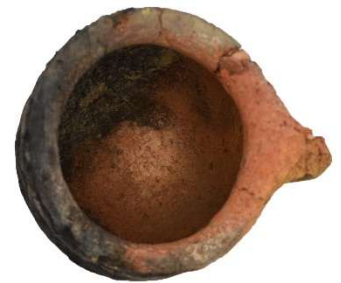
16 Half-complete
hand-built cup.
KS_25_1_5_1

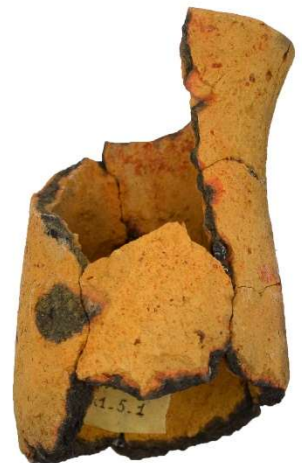
- 17 Fragment of a loop-shaped handle from a vessel, presumably from a mug, manufactured from well-kneaded, dense red clay of pinkish-beige hue with minor inclusions of fine sand particles. The surface of the handle is partially covered with a layer of red engobe, and areas of glossy burnishing are also evident. The handle exhibits a sub-triangular cross-section, with a width of 1 cm and a thickness of 1.1 cm.

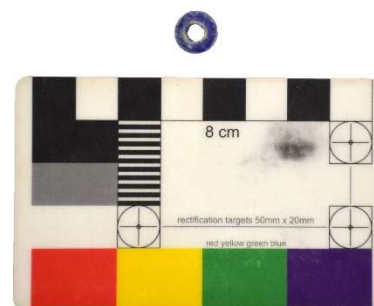
- 18 Spherical glass paste bead. Within the child's burial (late construction period), a spherical blue glass paste bead was found in the mandibular region during the cleaning of the child's skeleton; it measures 1 cm in diameter, 0.7 cm in height, and possesses a perforation diameter of 0.4 cm.

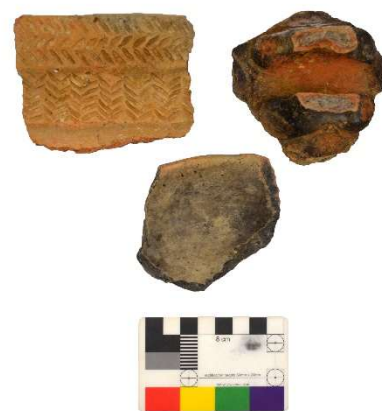
the color of the paste within the sherd varies to gray. The surface of the vessel is coated with a layer of light engobe on the exterior and partially on the interior. The rim of the vessel is straight, with thickened edges. The exterior is adorned with wide horizontal bands composed of small, inclined lines, forming vertical and horizontal 'fir-tree' ornaments. The width of the upper band is 2.8 cm; the width of the lower band is 2.5 cm. The rim diameter measures 34 cm, and the wall thickness of the vessel is 1.1 cm. (KS_25_1_35_2)

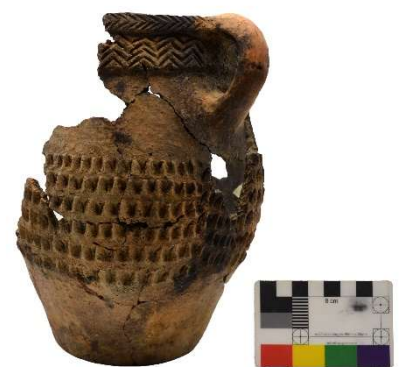
and a thickness of 1.6 cm. The vessel body is slightly swollen at the central section; on the exterior, there is ornamentation consisting of alternating, linearly arranged nail impressions. The vessel walls taper to a flat base with a diameter of 10.6 cm, wall thickness of 0.6–0.9 cm, and vessel height of 22.5 cm.

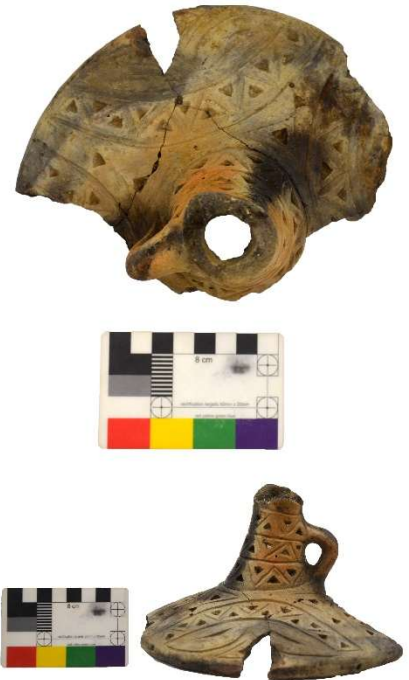
23 Fragment of a ceramic object, presumably a portable stand for cauldrons. KS_25_1_43_3

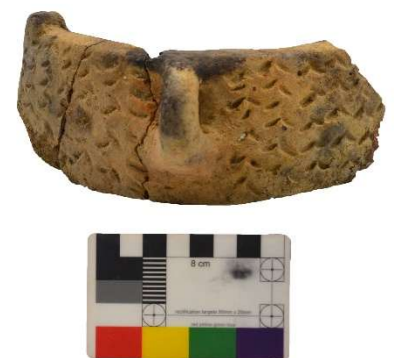
object exhibits ornamentation consisting of alternating impressed small notches distributed across the entire surface. The edges of the object are subrectangular in cross-section, with the walls expanding towards the base. The height of the stand is 6.5 cm; the thickness at the upper section is 1.3 cm, and at the lower section is 3 cm.

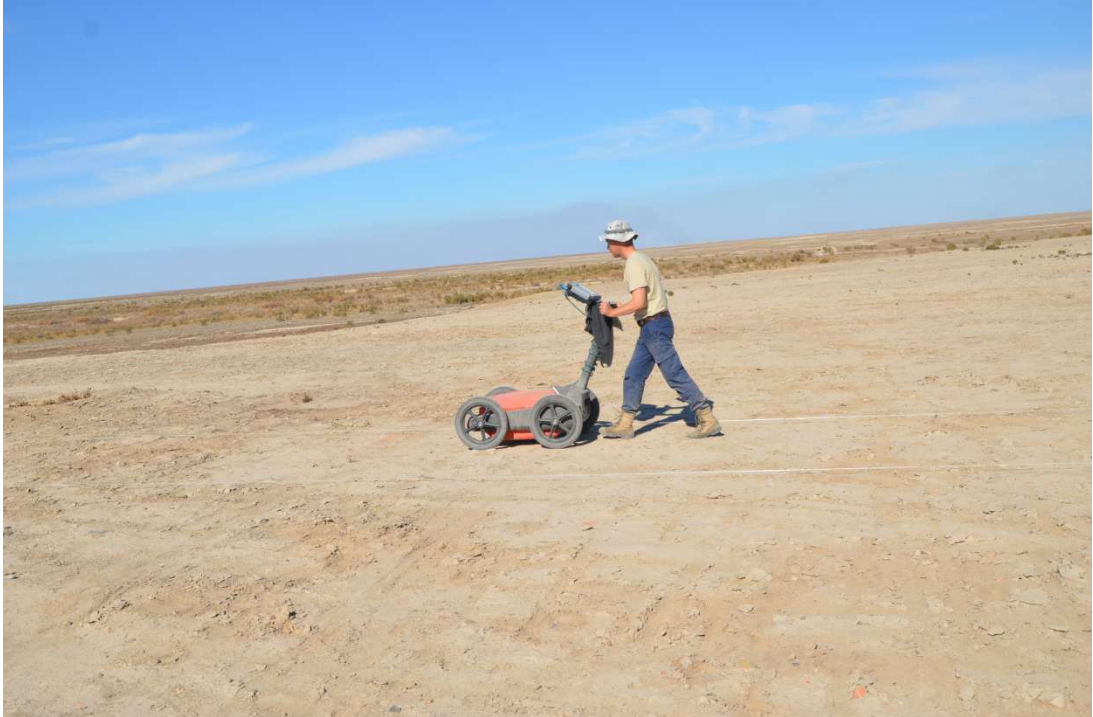
Figure 1. Geomagnetic survey in the area of the planned excavations prior to marking the research site at the location of the presumed citadel. Work in progress.

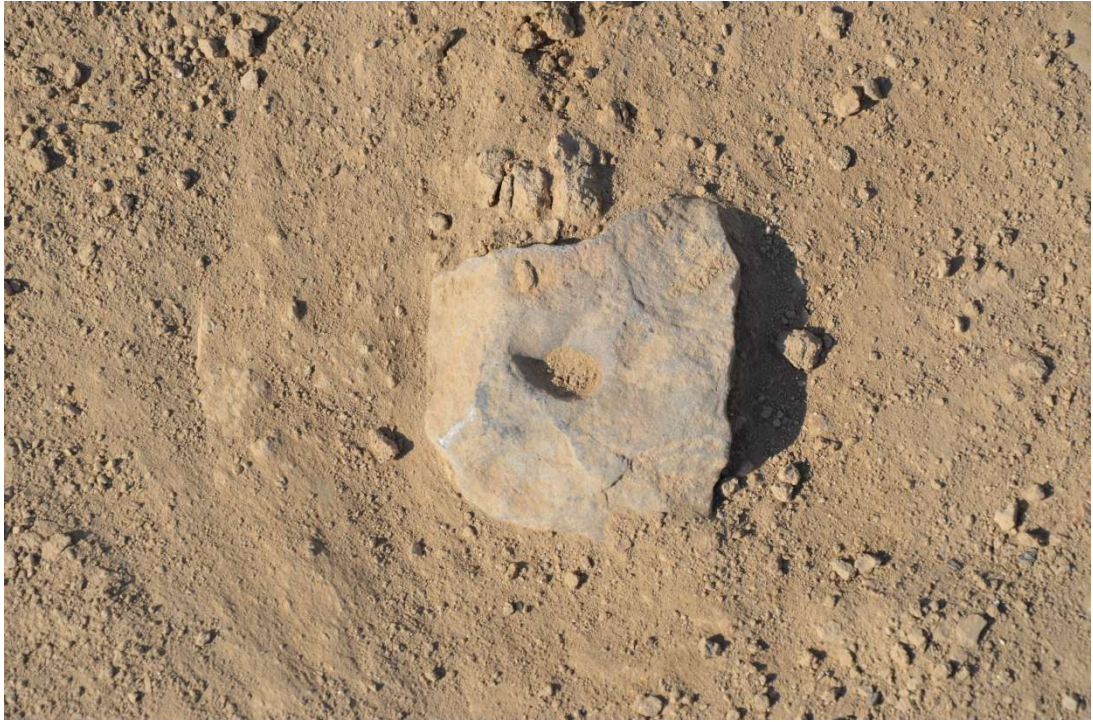
Figure 21. Element 1. Stone millstone in a loose, cloddy layer in the central part of the Excavation. Top view.

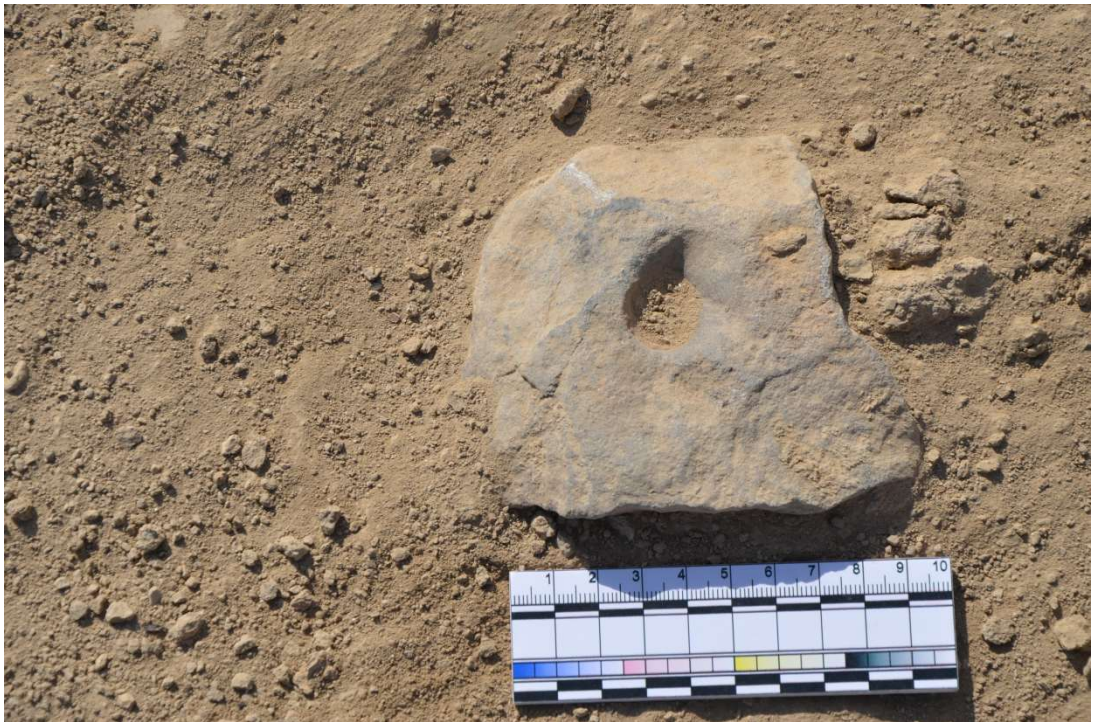
Figure 22. Element 1. Stone millstone in a loose, cloddy layer in the central part of the Excavation. Top view.

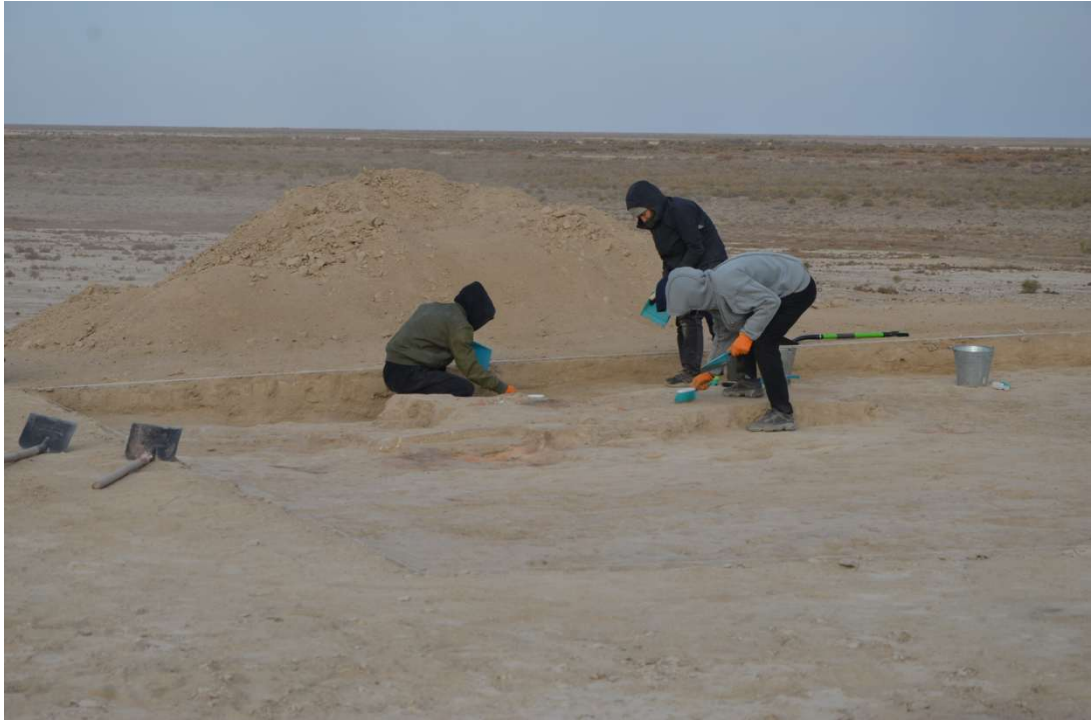
Figure 23. Element 1. Process of cleaning a loose, cloddy layer in the western part of the Excavation. View to the west.

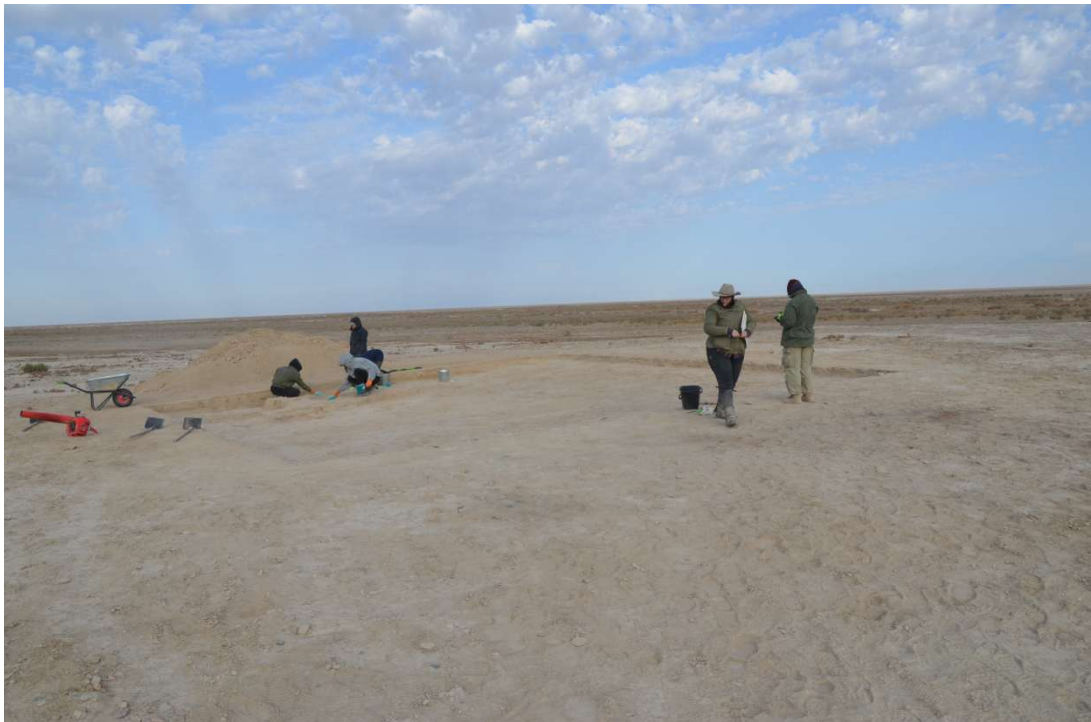
Figure 24. Element 1. Process of cleaning a loose, cloddy layer in the western part of the Excavation. View to the west.

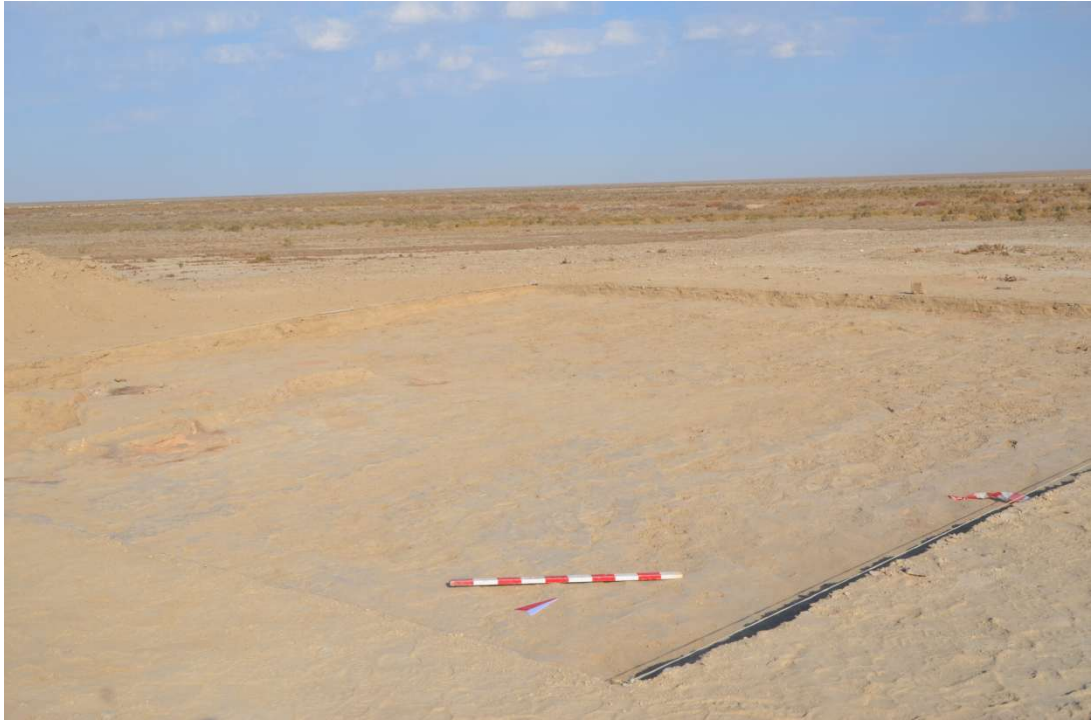
Figure 25. Element 1. Excavation surface following the removal and cleaning of the loose, lumpy layer in the western part of the excavation. View to the northwest.

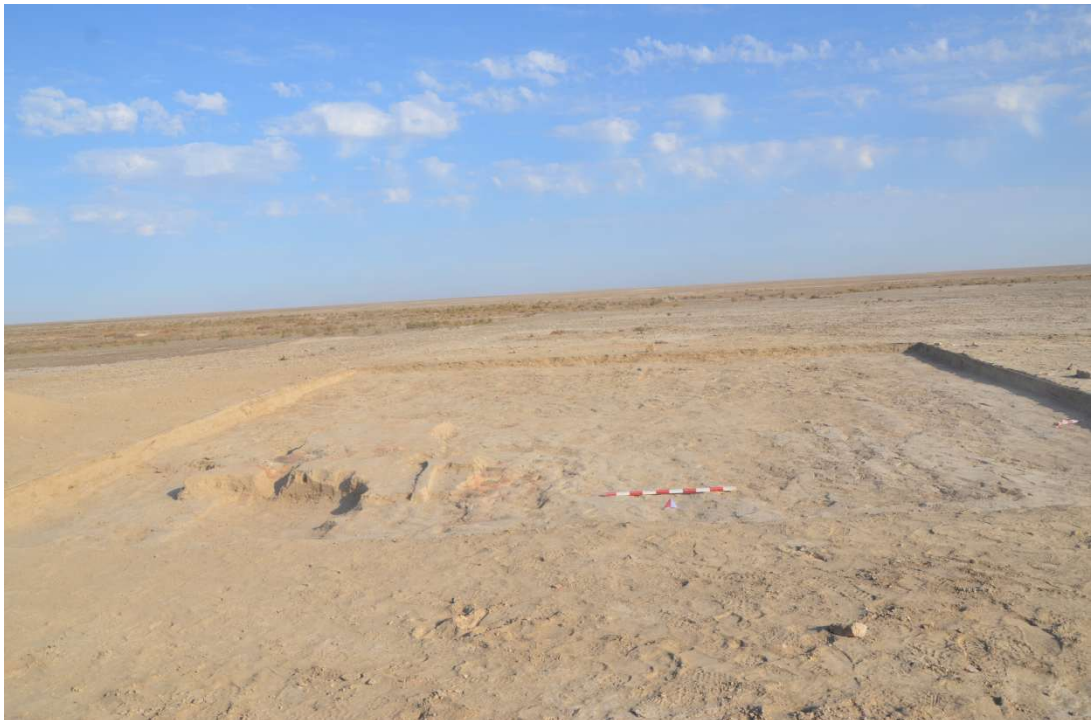
Figure 26. Element 1. Excavation surface following the removal and cleaning of the loose, lumpy layer in the western part of the excavation. View to the north.

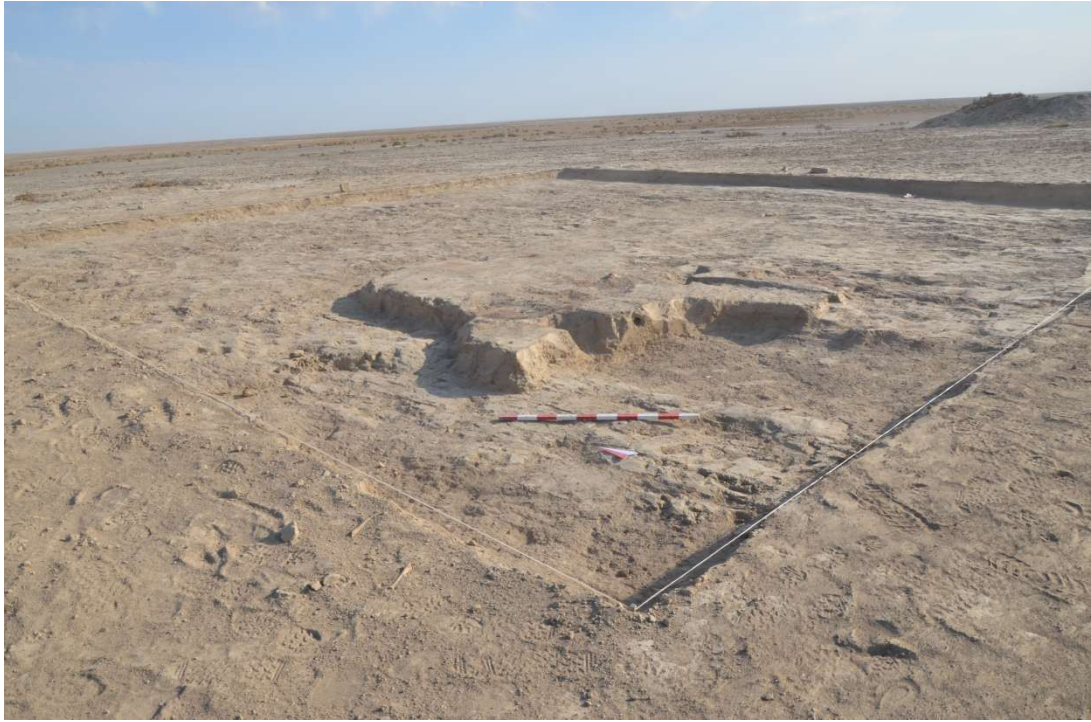
Figure 27. Element 1. Excavation surface following the removal and cleaning of the loose, lumpy layer in the western part of the excavation. View to the northeast.

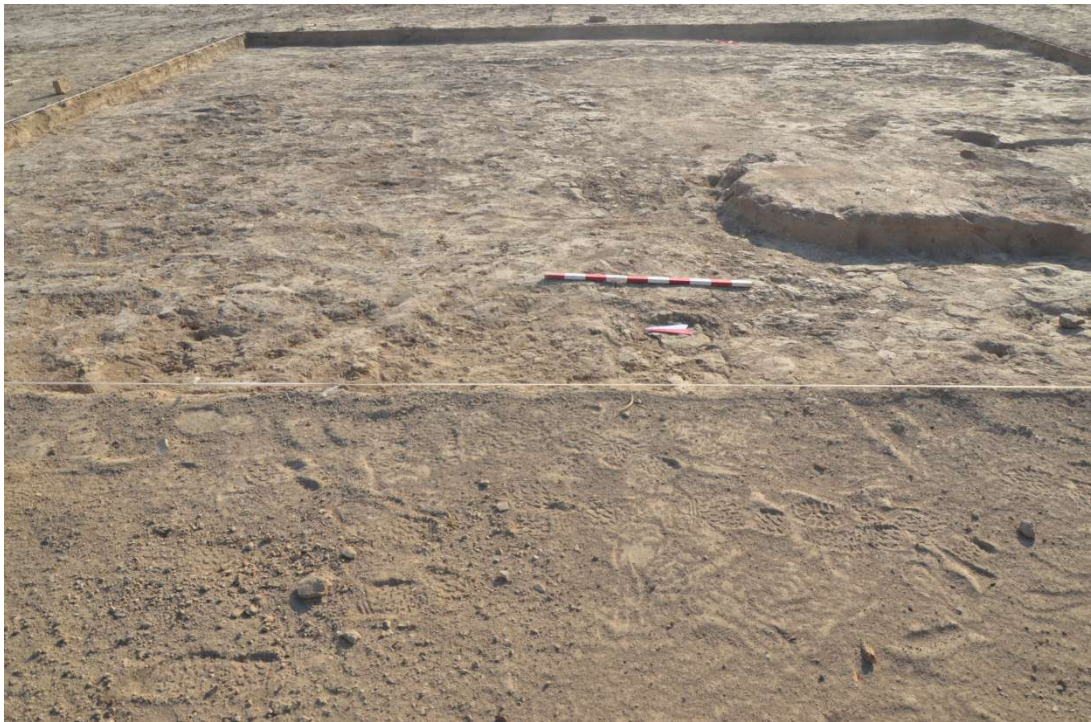
Figure 28. Element 1. Excavation surface following the removal and cleaning of the loose, lumpy layer in the western part of the excavation. View to the east.

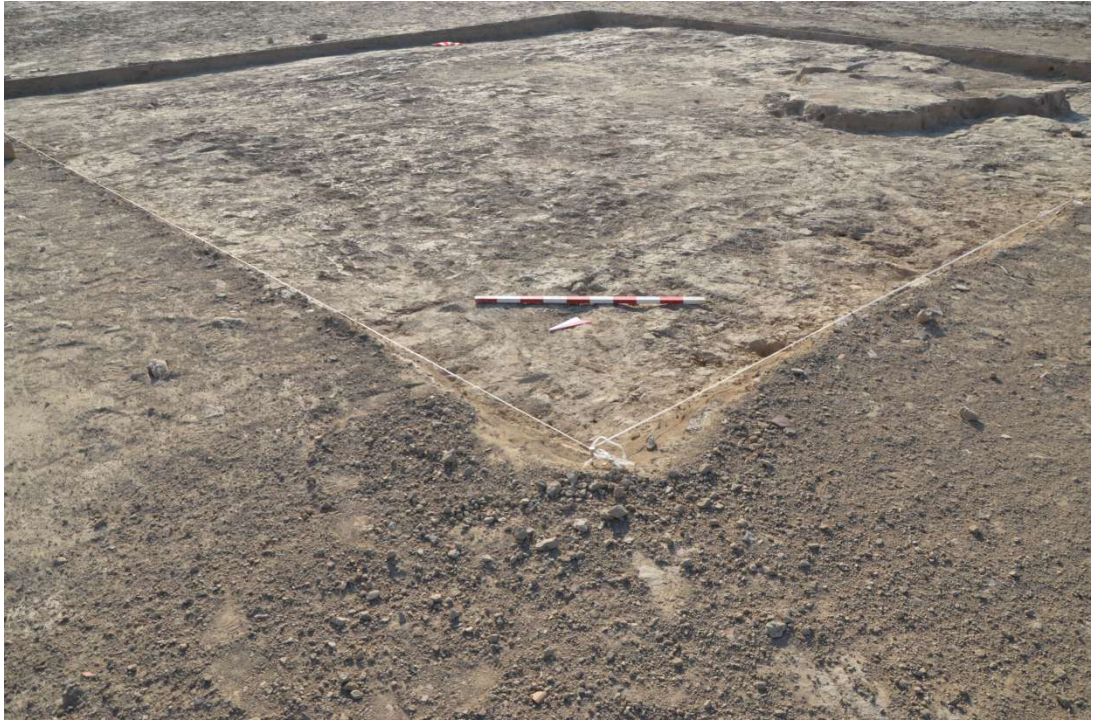
Figure 29. Element 1. Excavation surface after removal and cleaning of the loose, cloddy layer in the western part of the excavation. View to the southeast.

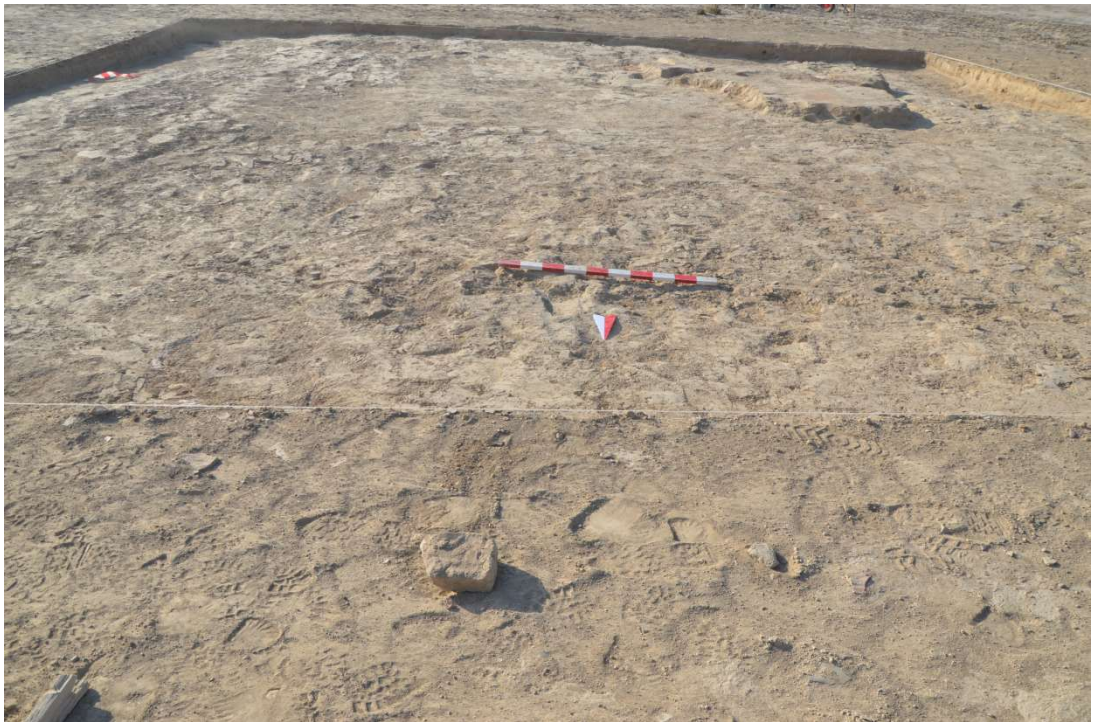
Figure 30. Element 1. Excavation surface after removal and cleaning of the loose, cloddy layer in the western part of the excavation. View to the south.

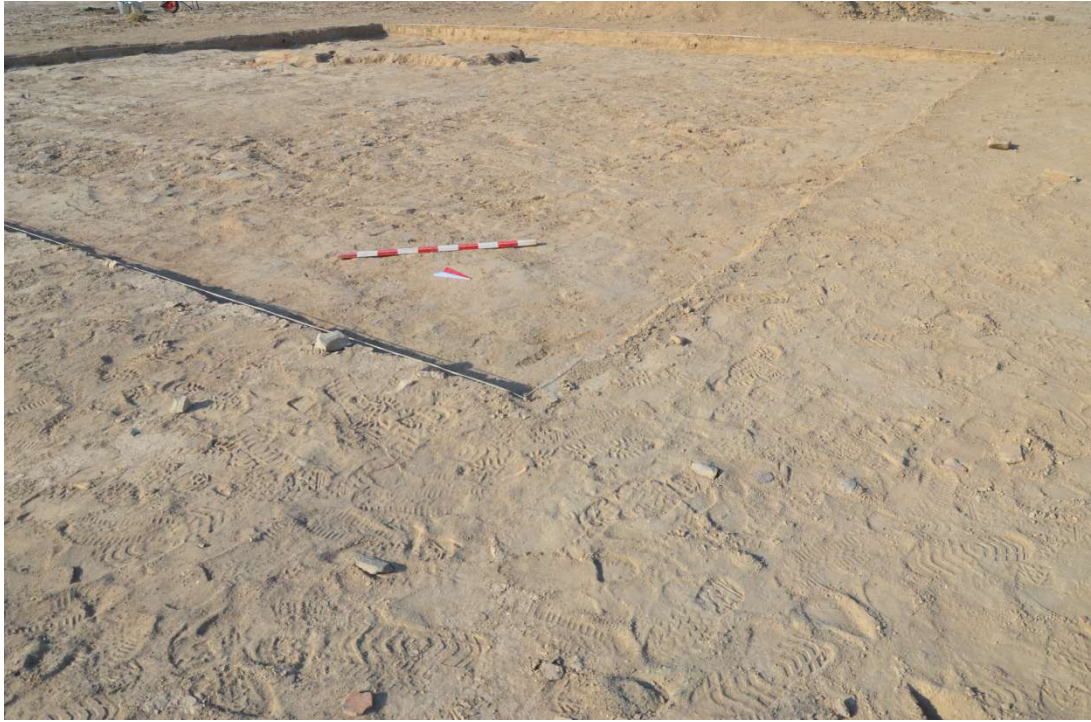
Figure 31. Element 1. Excavation surface after removal and cleaning of the loose, cloddy layer in the western part of the excavation. View to the southwest.
