Society for the Exploration of Eurasia, Switzerland

LLC RUTRUM

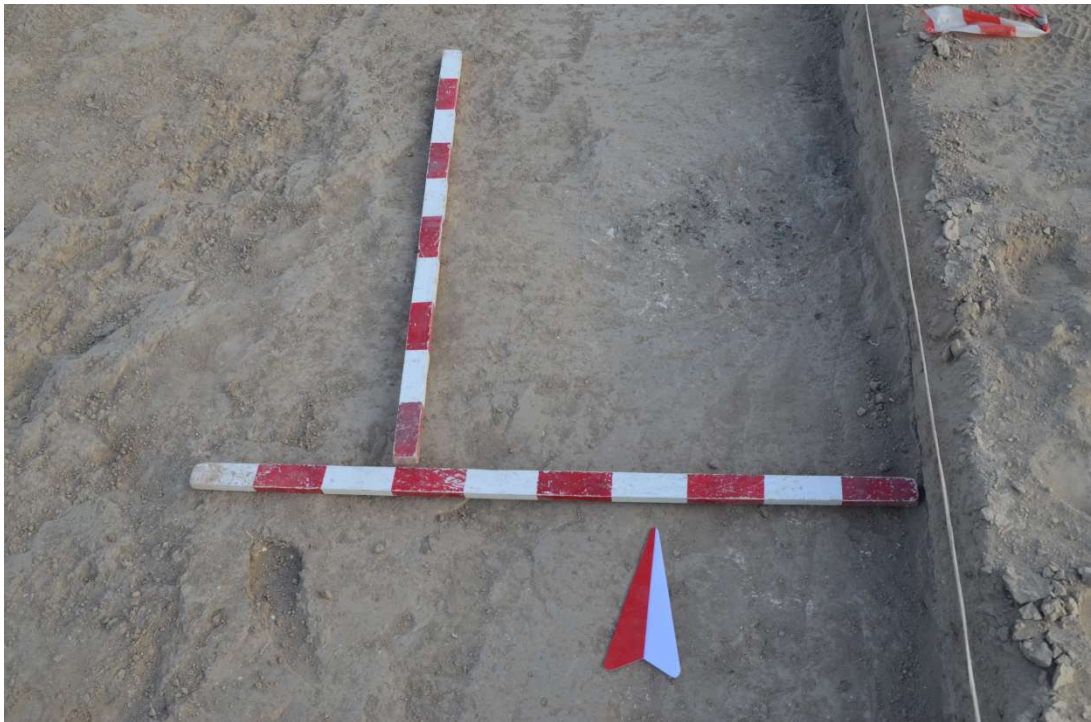
Figure 32. Element 3. Ash and charcoal stain in the eastern part of the excavation (late construction period). View to the north.

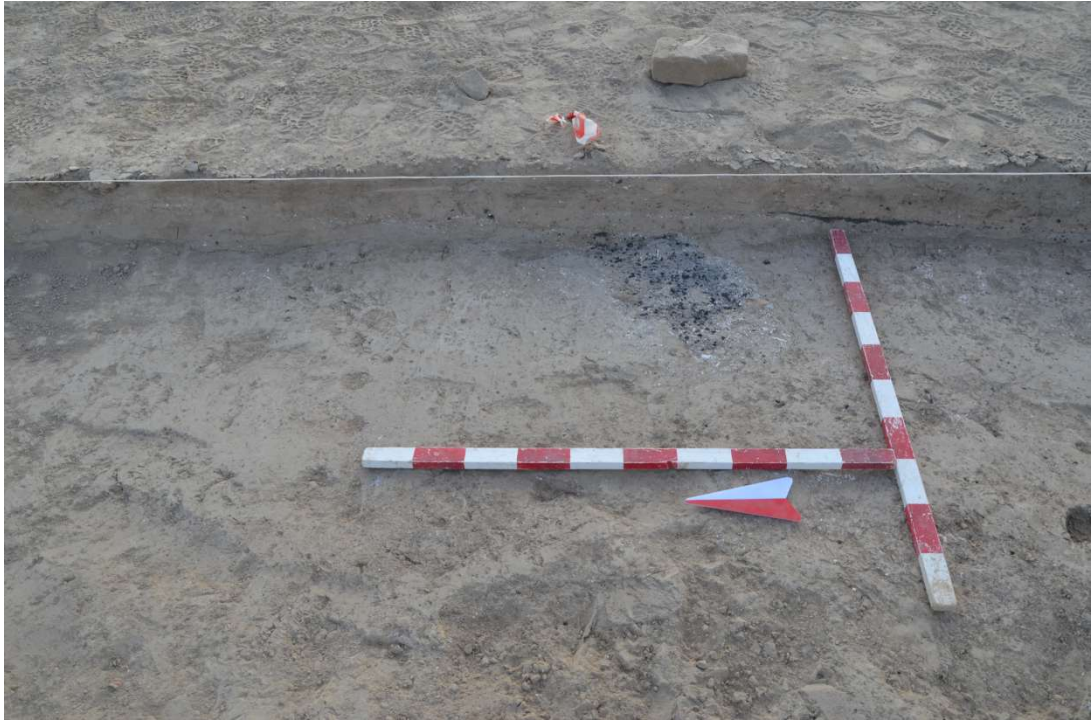
Figure 33. Element 3. Ash and charcoal stain in the eastern part of the excavation (late construction period). View to the east.

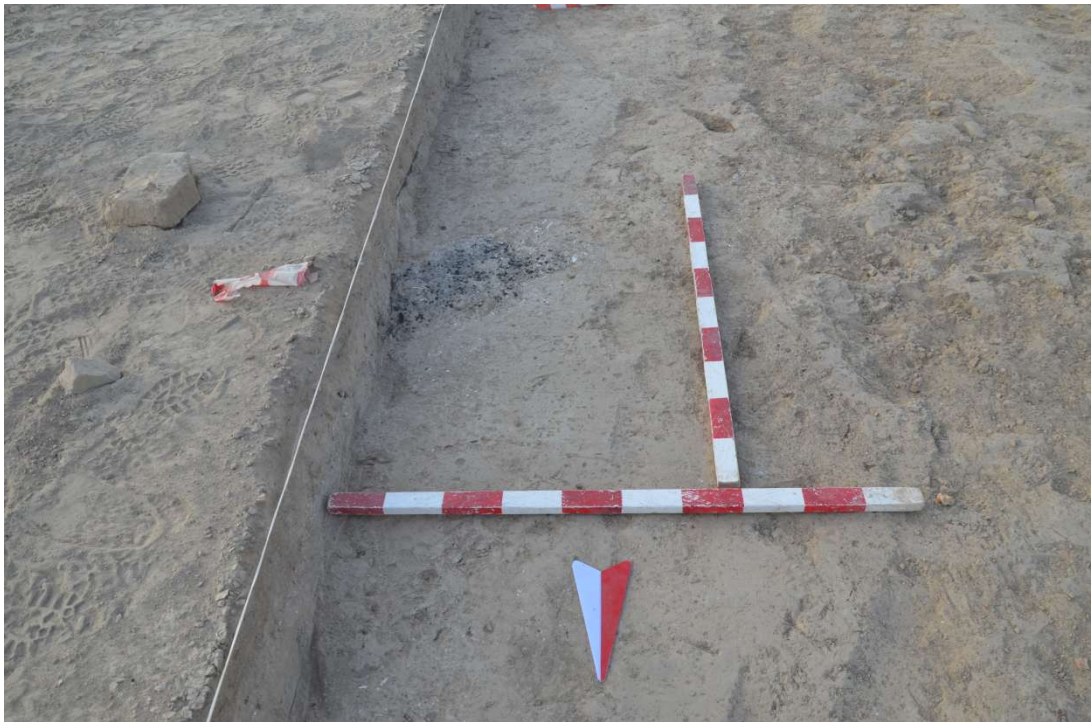
Figure 34. Element 3. Ash and charcoal stain in the eastern part of the excavation (late construction period). View to the south.

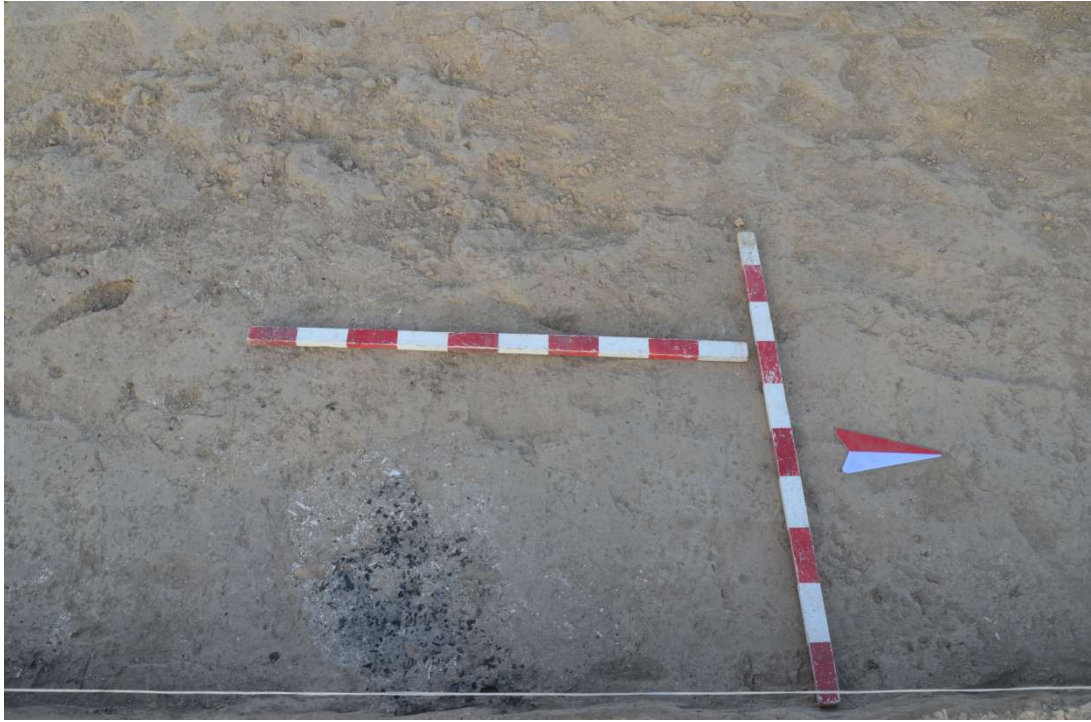
Figure 35. Element 3. Ash and charcoal stain in the eastern part of the excavation (late construction period). View to the west.

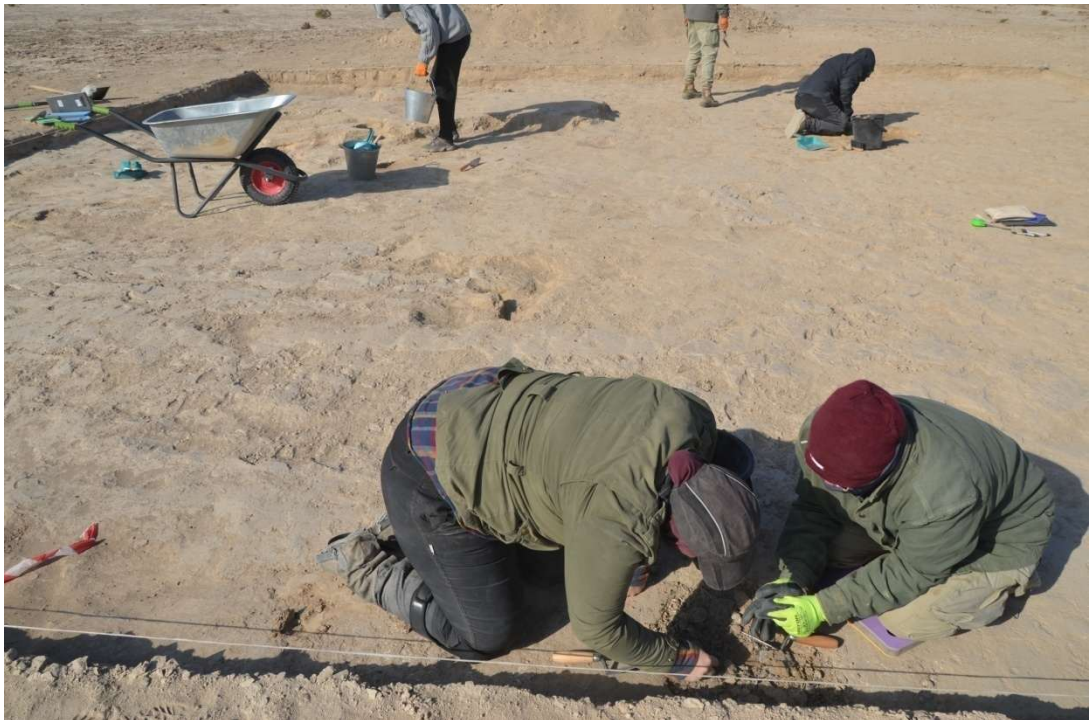
Figure 36. Element 3. Cleaning of the ash-cinder stain in the eastern part of the excavation (Late construction period). View to the west.

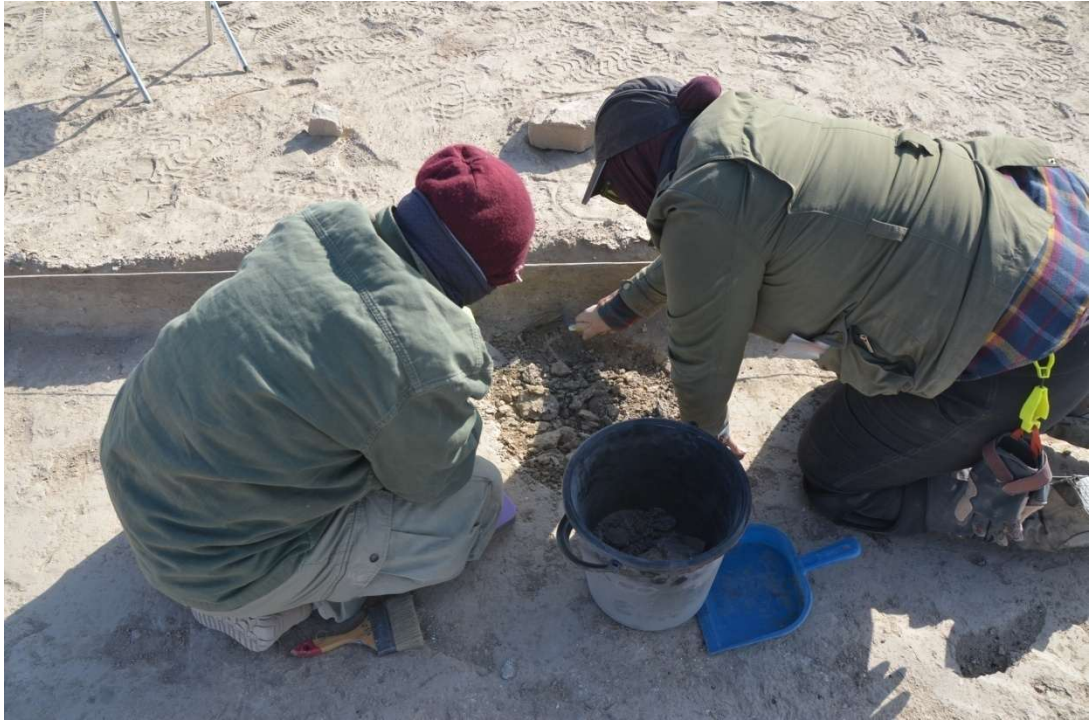
Figure 37. Element 3. Cleaning of the ash-cinder stain in the eastern part of the excavation (Late construction period). View to the west.

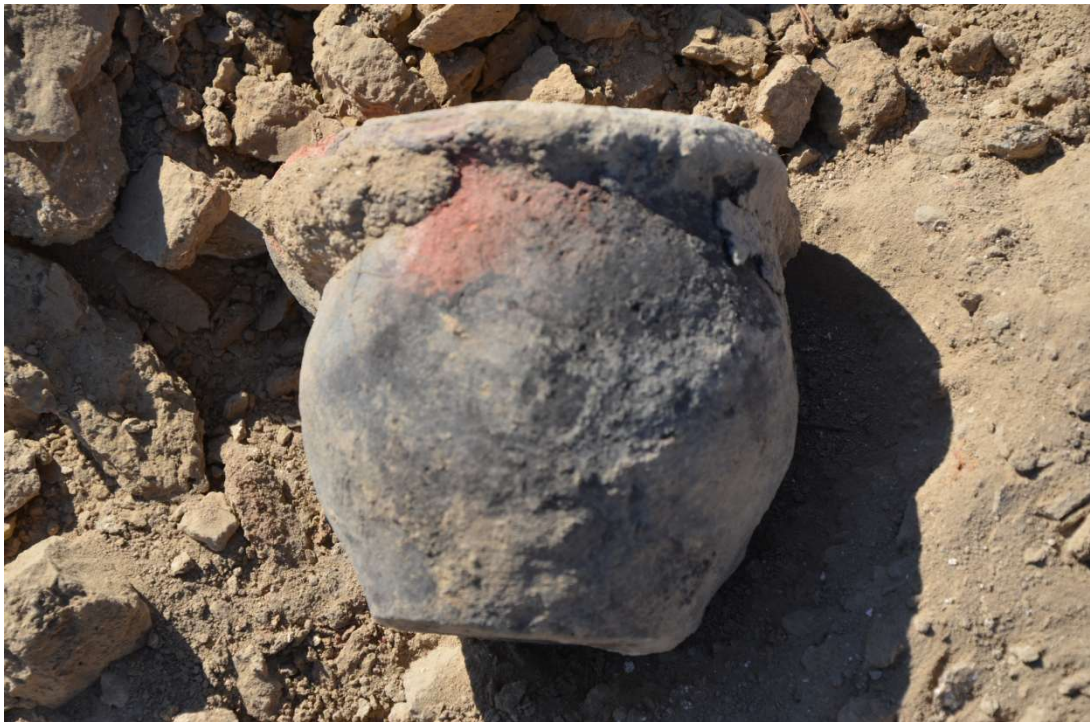
Figure 38. Element 4. Ceramic pot with handle in excavated layer (1) at the center of the excavation. Top view.

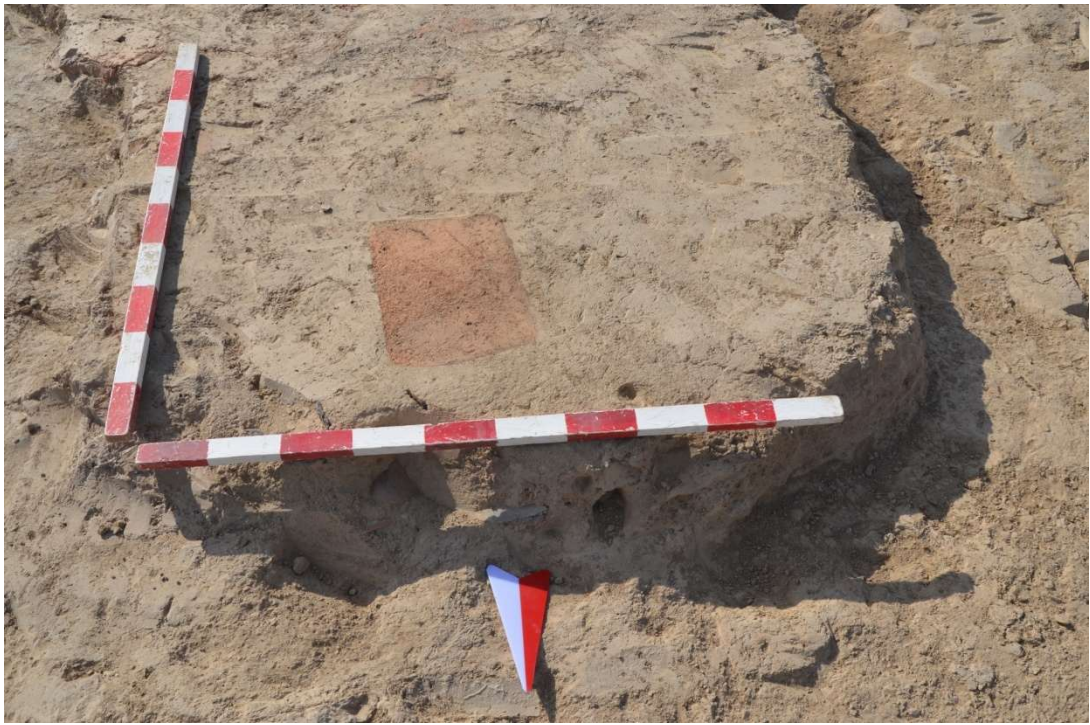
Figure 71. Element7. Square-shaped spot of burnt soil near the layer of ash, soot, and baked loam in the central part of the Excavation.

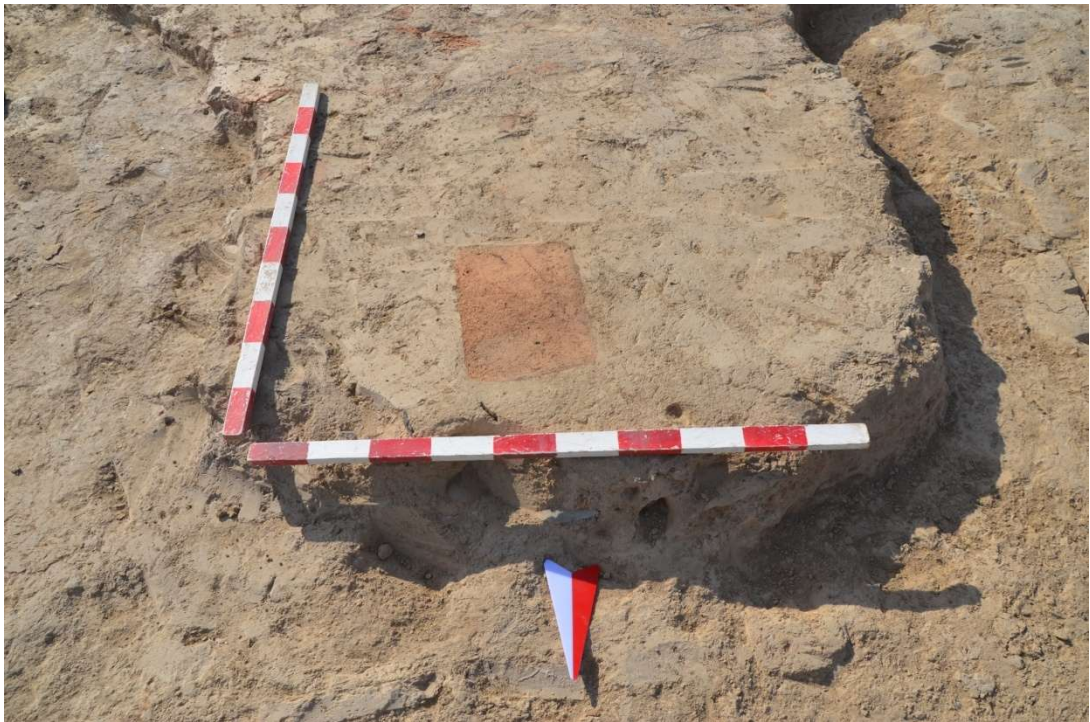
Figure 72. Element7. Square-shaped spot of burnt soil near the layer of ash, soot, and baked loam in the central part of the Excavation.

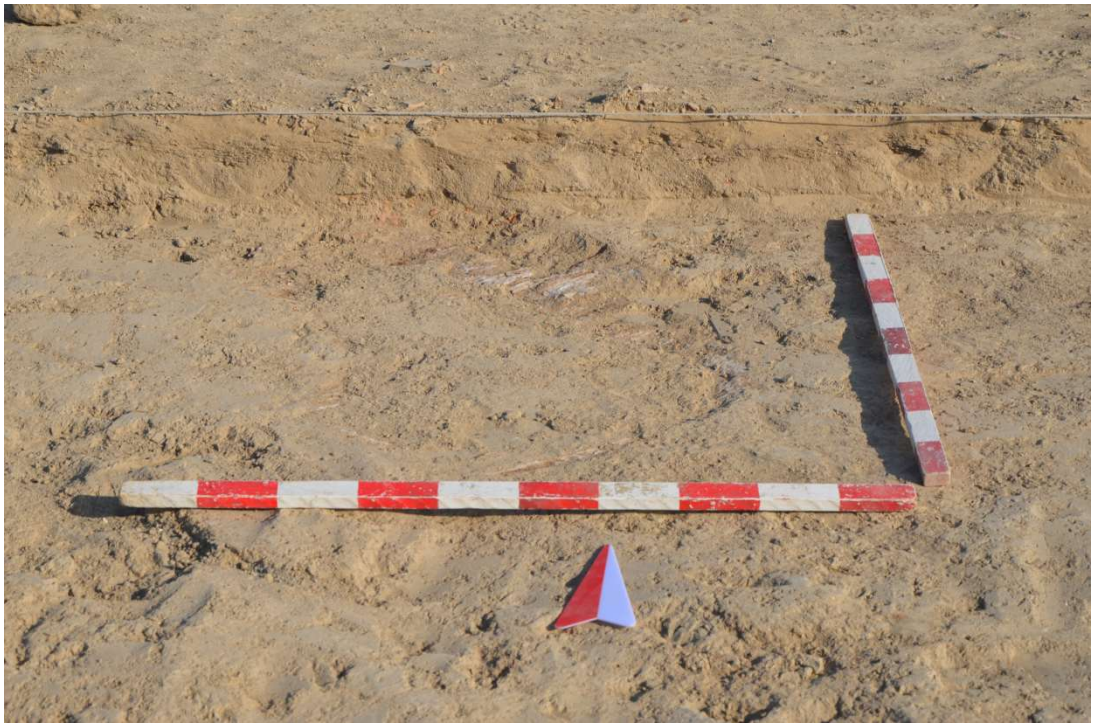
Figure 73. Element 8. Child burial. Rush mat above the child burial at the northern edge of the excavation. View to the north.

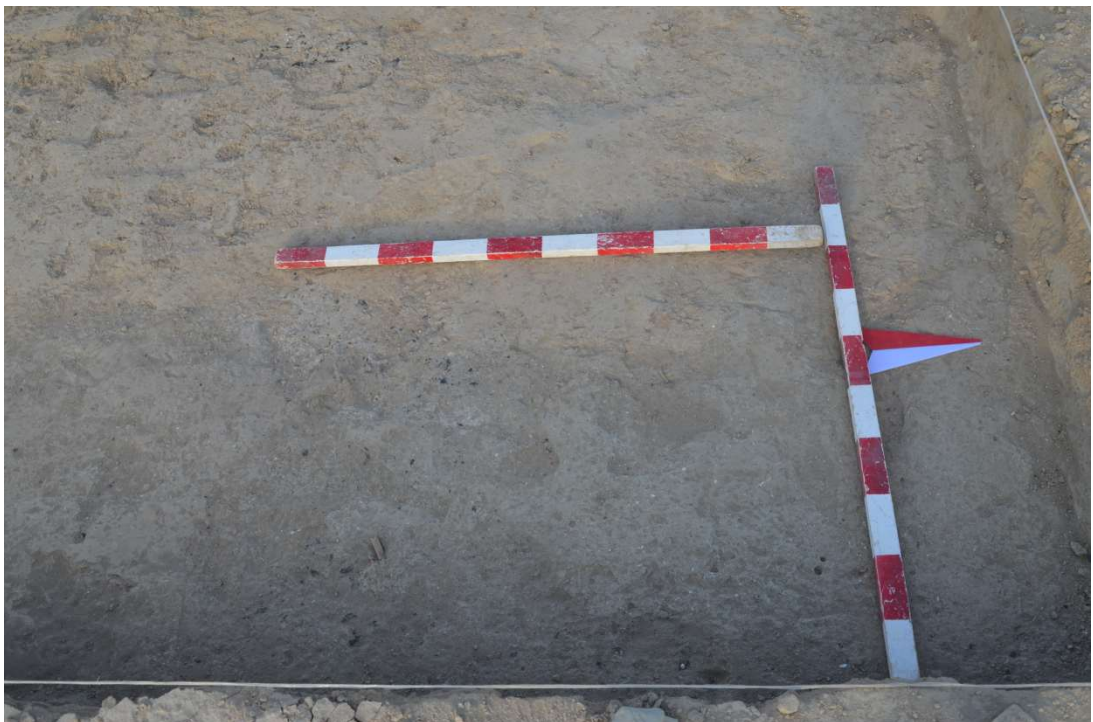
Figure 84. Element 9. Badrah stain in the corner of the northeastern part of the Excavation. View to the west.

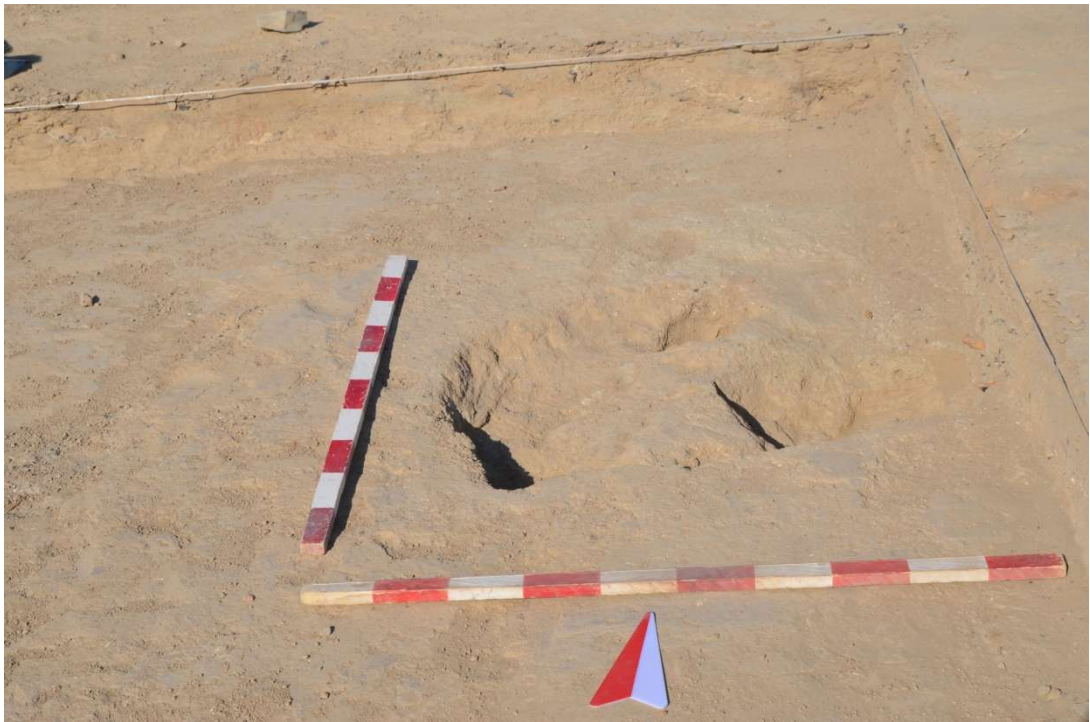
Figure 85. Element 9. Badrah in the corner of the northeastern part of the Excavation after clearing. View to the north.

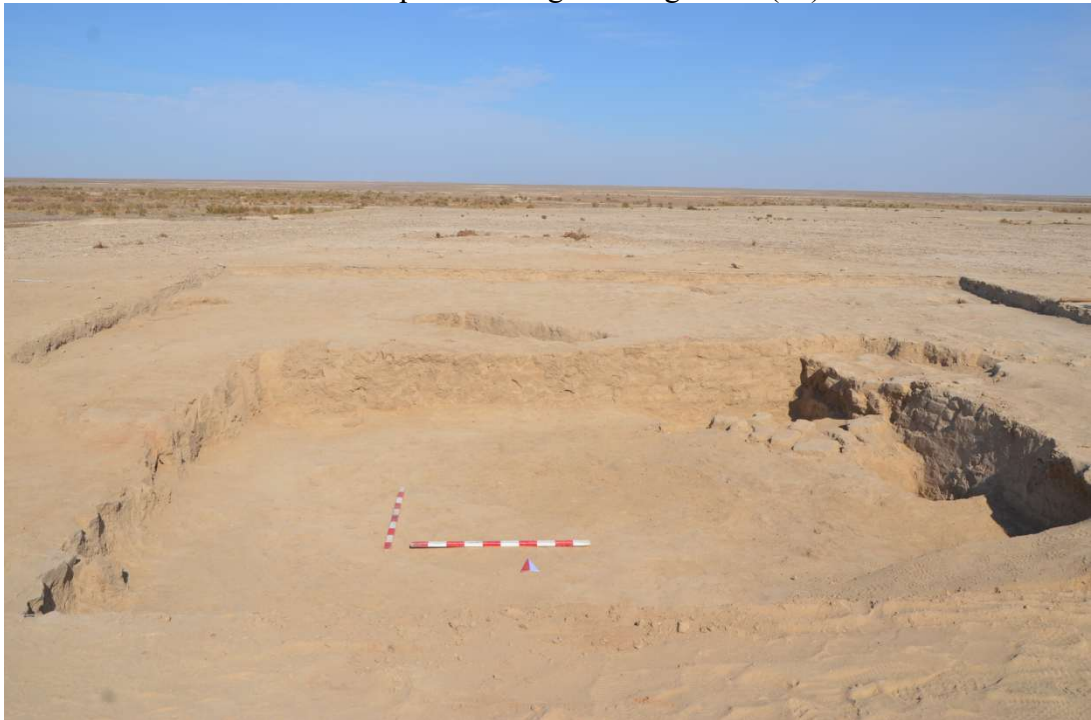
Figure 182. Element 31. General view of the excavation after removal of clayey fill and broken fragments of unfired mudbrick wall blocks of the room. Second construction phase. View to the north.

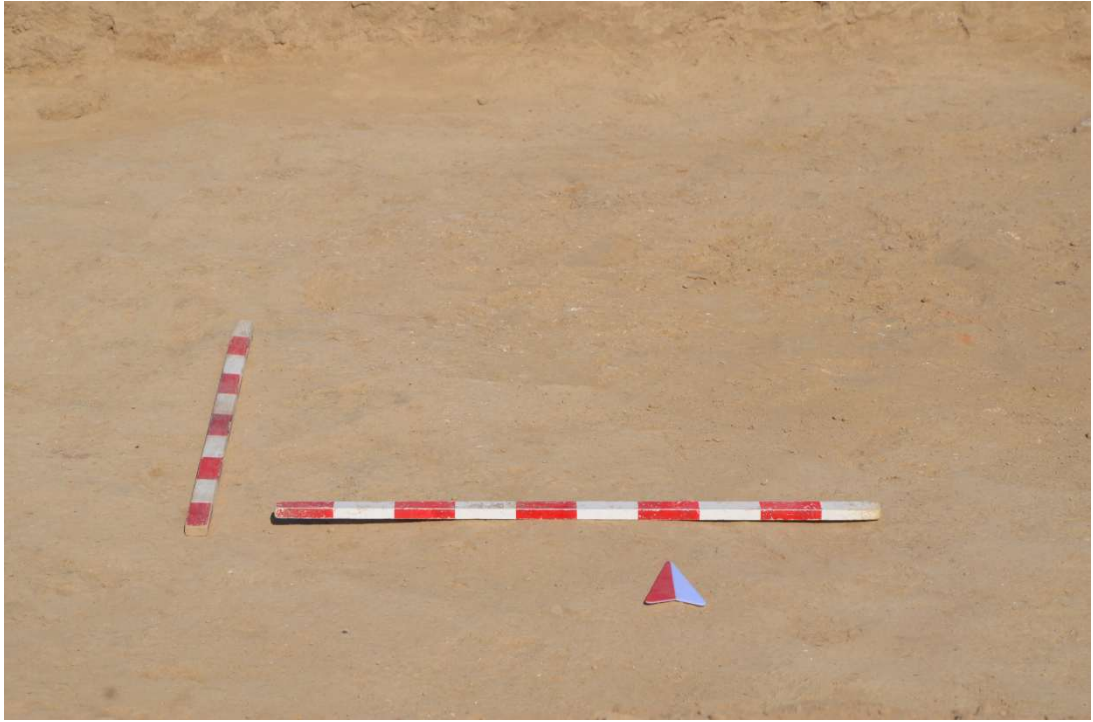
Figure 183. Element 31. General view of the excavation after removal of clayey fill and broken fragments of unfired mudbrick wall blocks of the room. Second construction phase. View to the north.

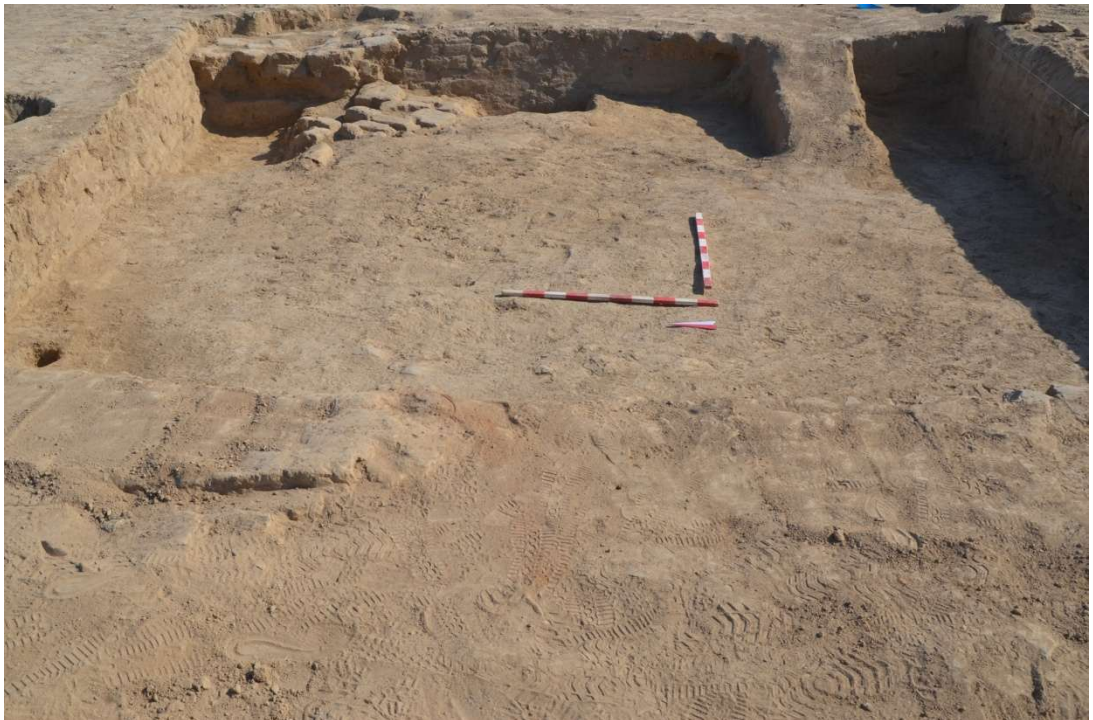
Figure 184. Element 31. General view of the excavation after removal of clayey fill and broken fragments of unfired mudbrick wall blocks of the room. Second construction phase. View to the east.

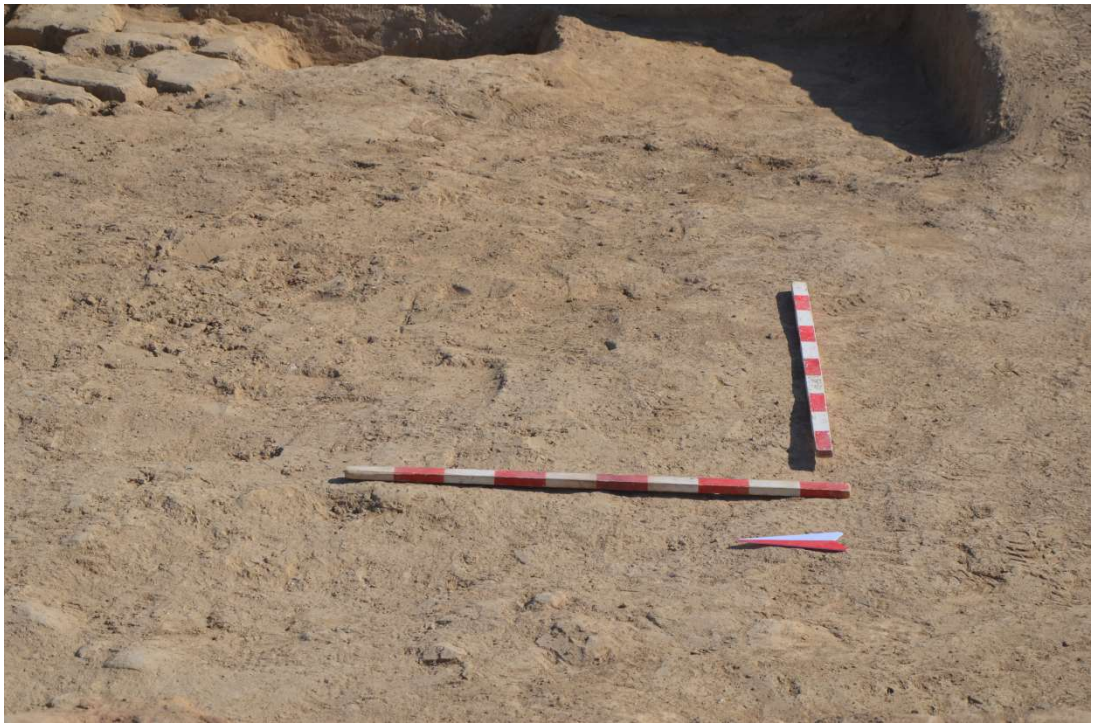
Figure 185. Element 31. General view of the excavation after removal of clayey fill and broken fragments of unfired mudbrick wall blocks of the room. Second construction phase. View to the east.

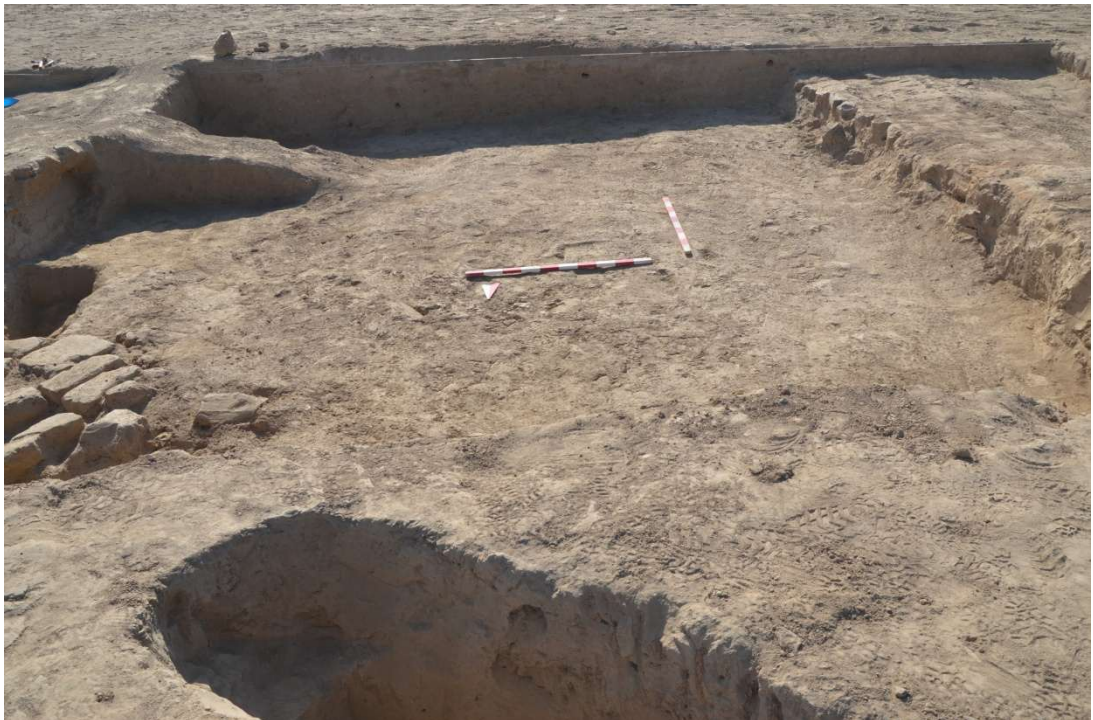
Figure 186. Element 31. General view of the excavation after removal of clayey fill and broken fragments of unfired mudbrick wall blocks of the room. Second construction phase. View to the south.

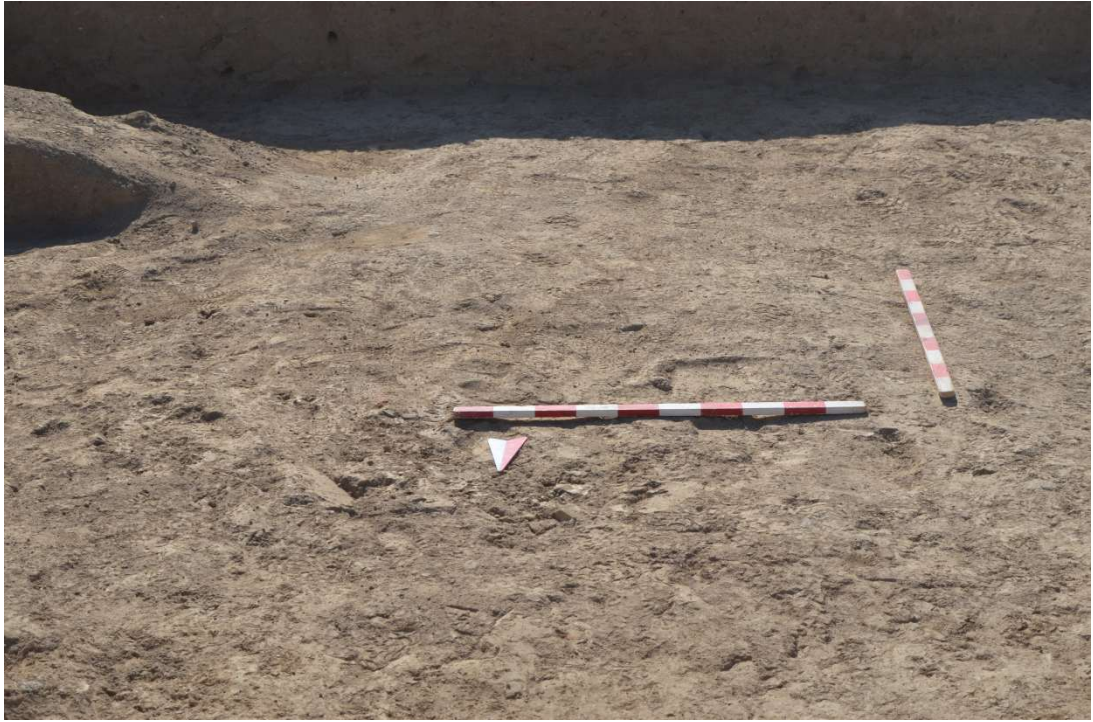
Figure 187. Element 31. General view of the excavation after removal of clayey fill and broken fragments of unfired mudbrick wall blocks of the room. Second construction phase. View to the south.

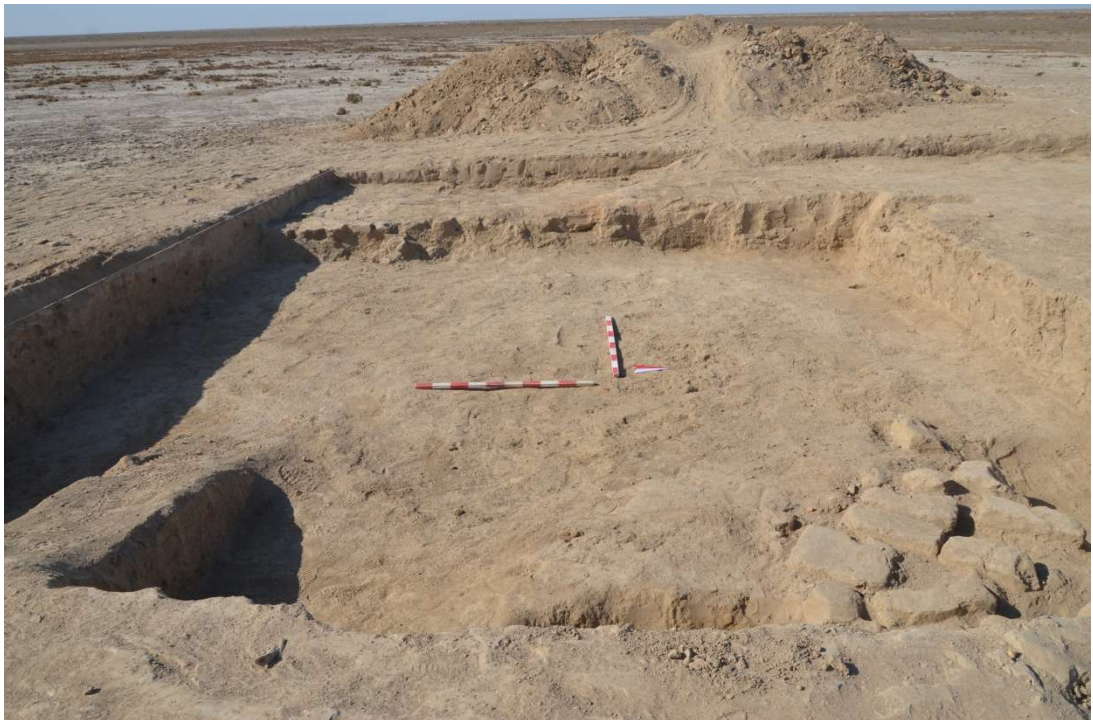
Figure 188. Element 31. General view of the excavation after removal of clayey fill and broken fragments of unfired mudbrick wall blocks of the room. Second construction phase. View to the west.

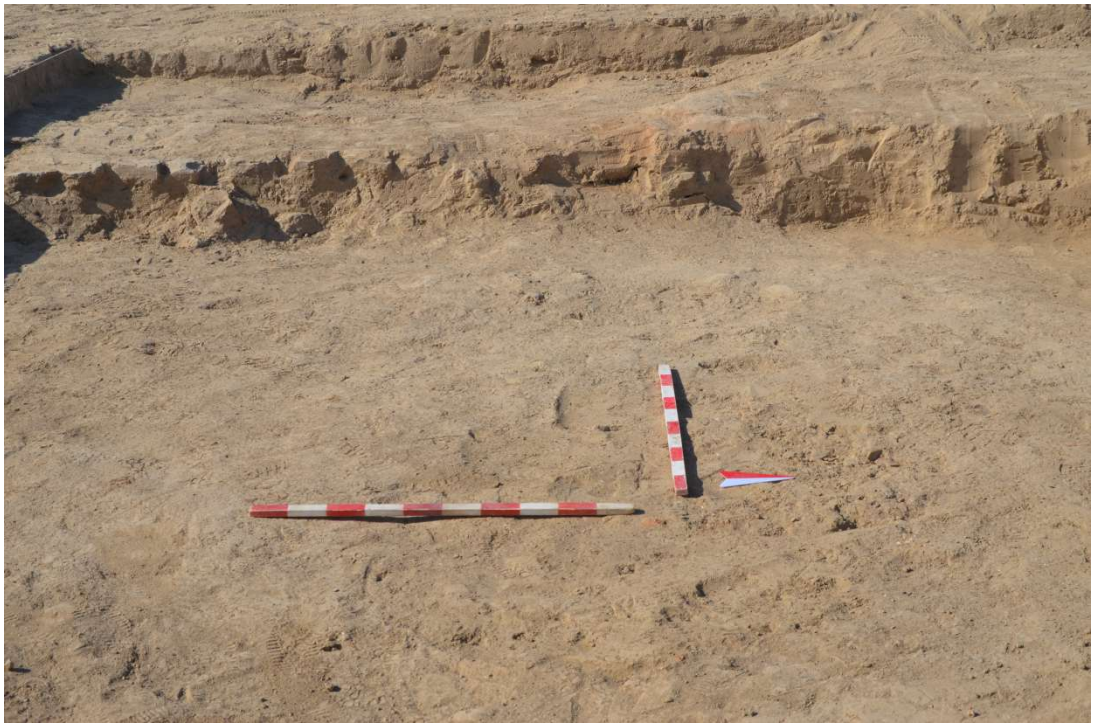
Figure 189. Element 31. General view of the excavation after removal of clayey fill and broken fragments of unfired mudbrick wall blocks of the room. Second construction phase. View to the west.

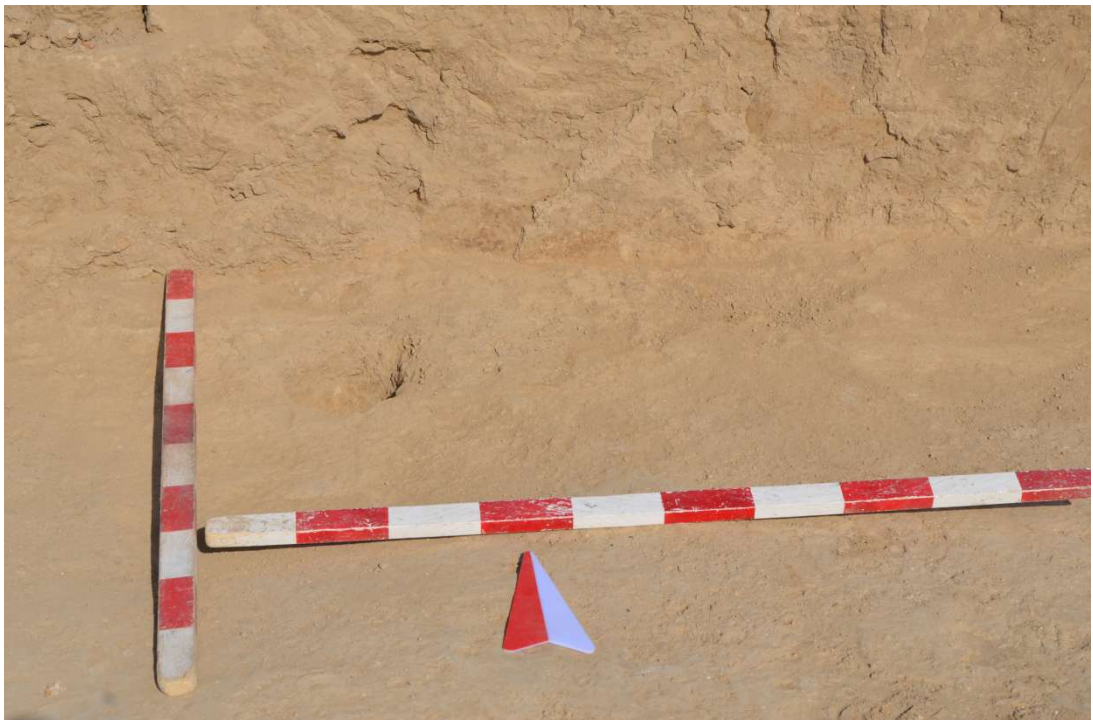
Figure 190. Element 32. Posthole adjacent to the northern wall, second construction phase. View to the north.

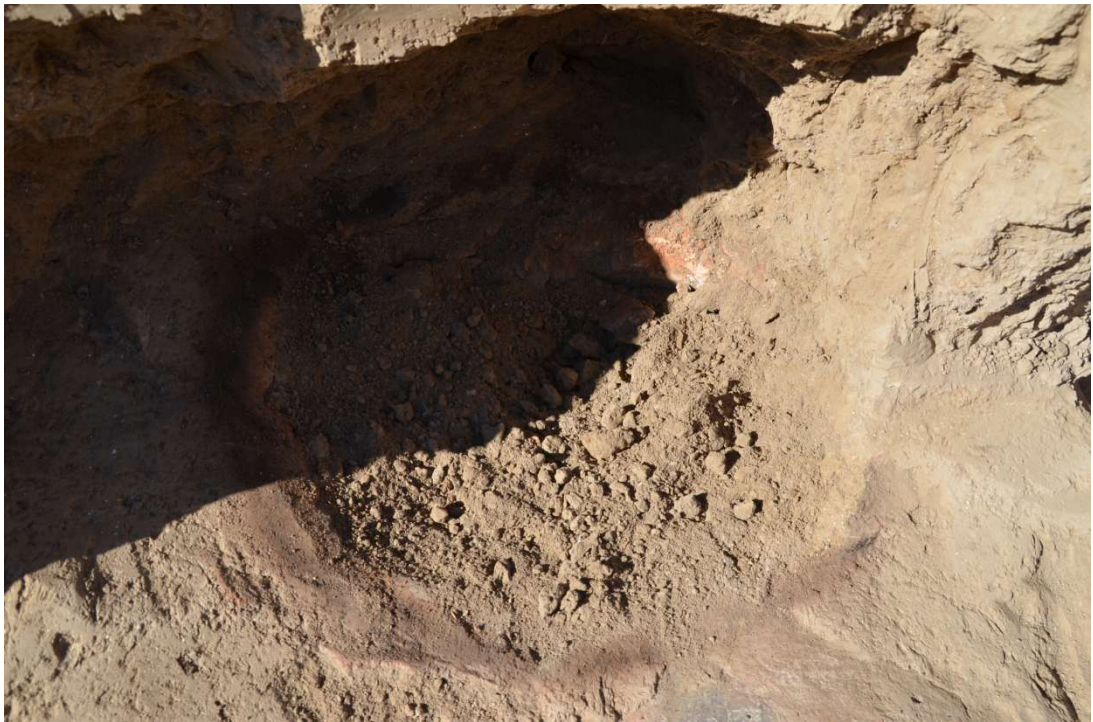
Figure 198. Element 33. Fill of loose and cloddy loam within the wall-adjacent hearth by the western wall (20) of the second and third construction periods. View to the west.

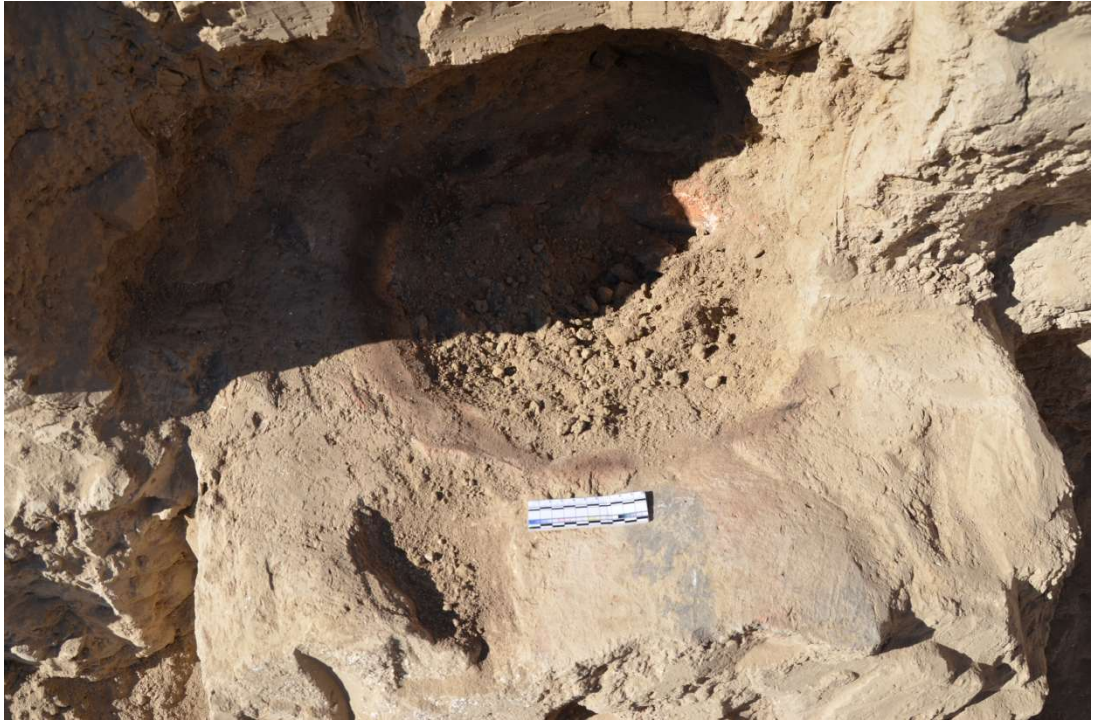
Figure 199. Element 33. Fill within the wall-adjacent stove and the masonry composed of fragments of ceramic vessels on the exterior side near the western wall (20) of the second and third construction phases. View to the west.

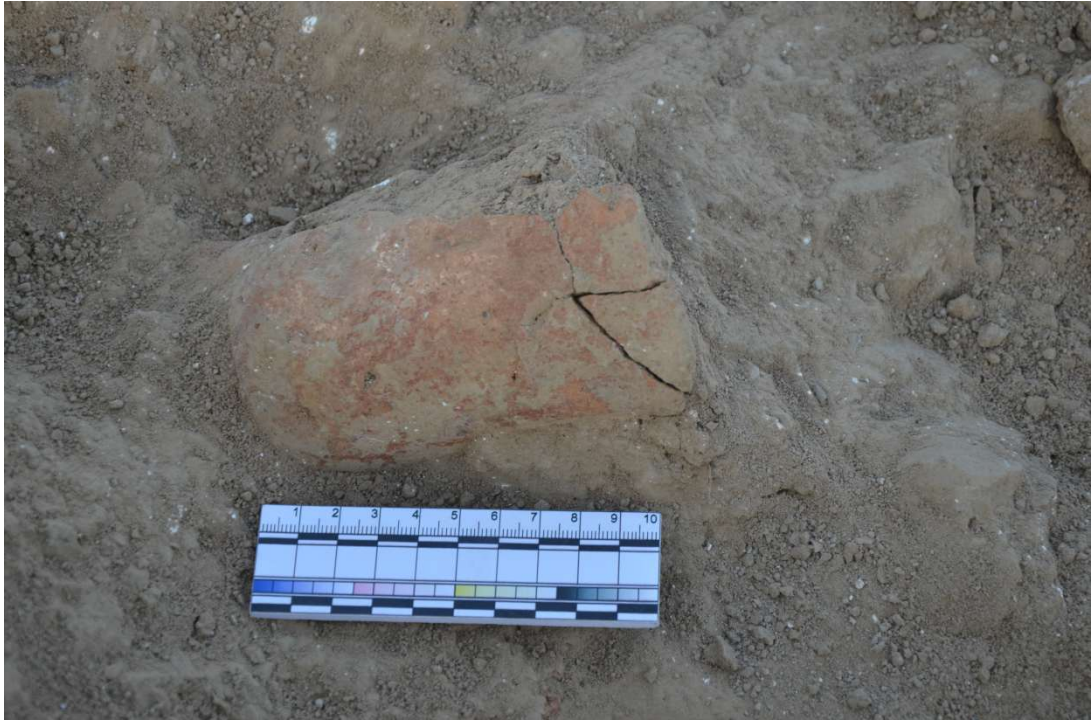
Figure 213. Element 35. Fragment of a ceramic slipware mug in a layer of loamy fill and broken fragments of sun-dried wall blocks from the room. Third construction phase. View to the south.

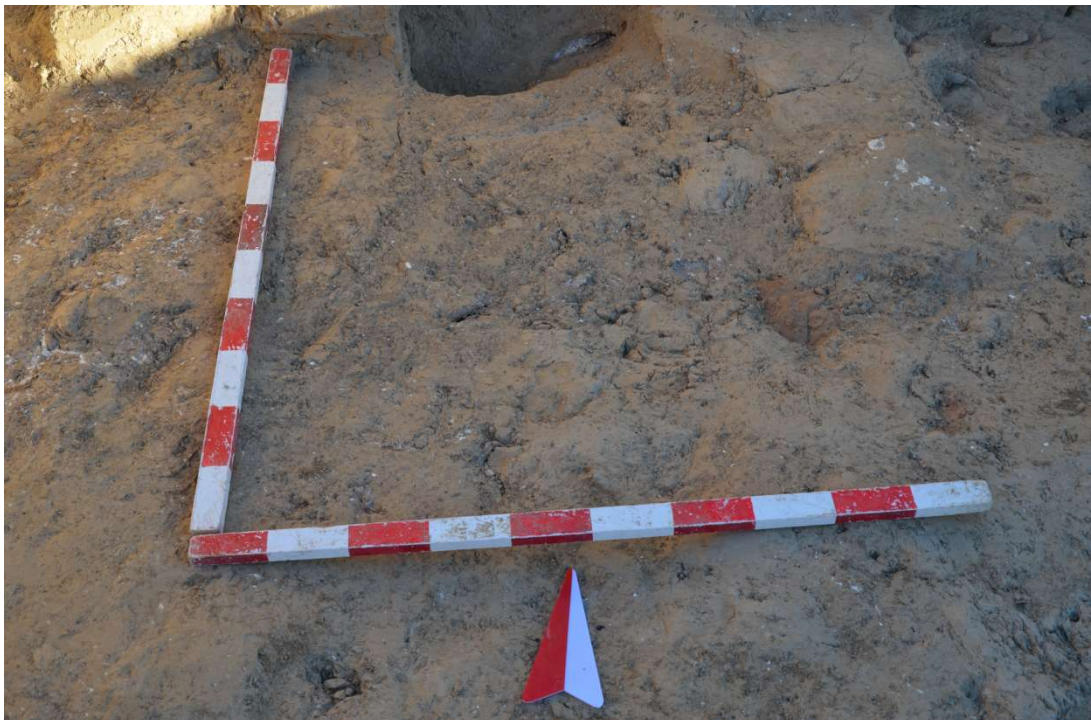
Figure 214. Element 36. Patch of loose loam within a layer of loamy fill and broken fragments of unfired brick blocks near the northern wall (23) of the room. Third construction phase. View to the north.

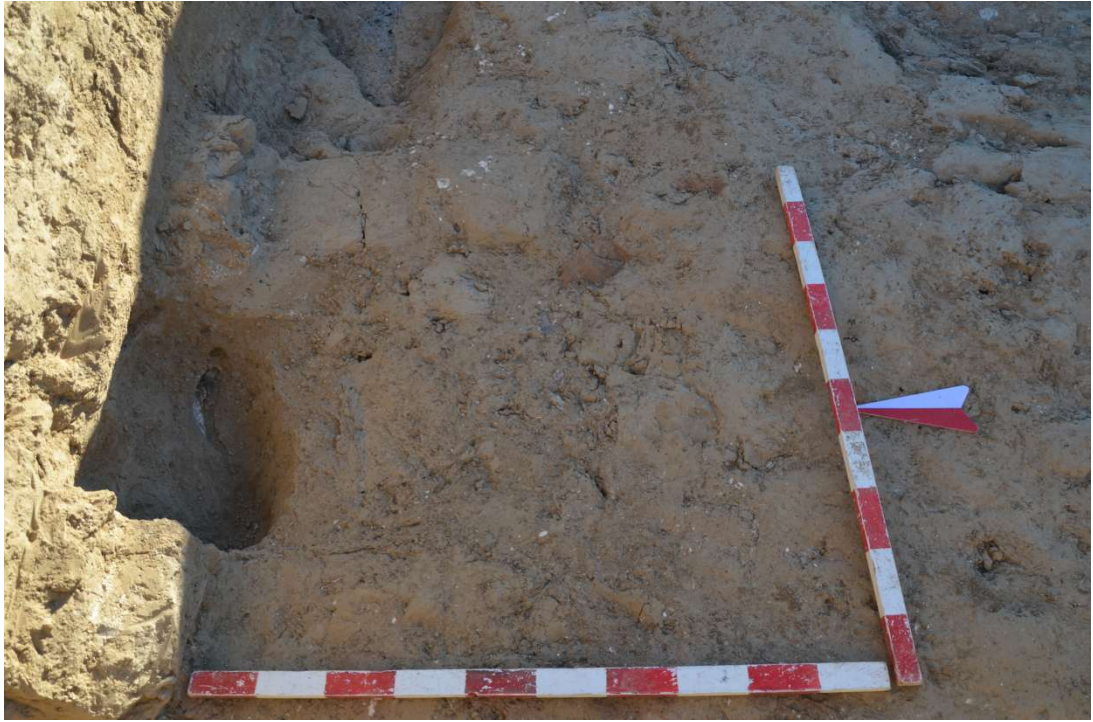
Figure 215. Element 36. Patch of loose loam within a layer of loamy fill and broken fragments of unfired brick blocks near the northern wall (23) of the room. Third construction phase. View to the east.

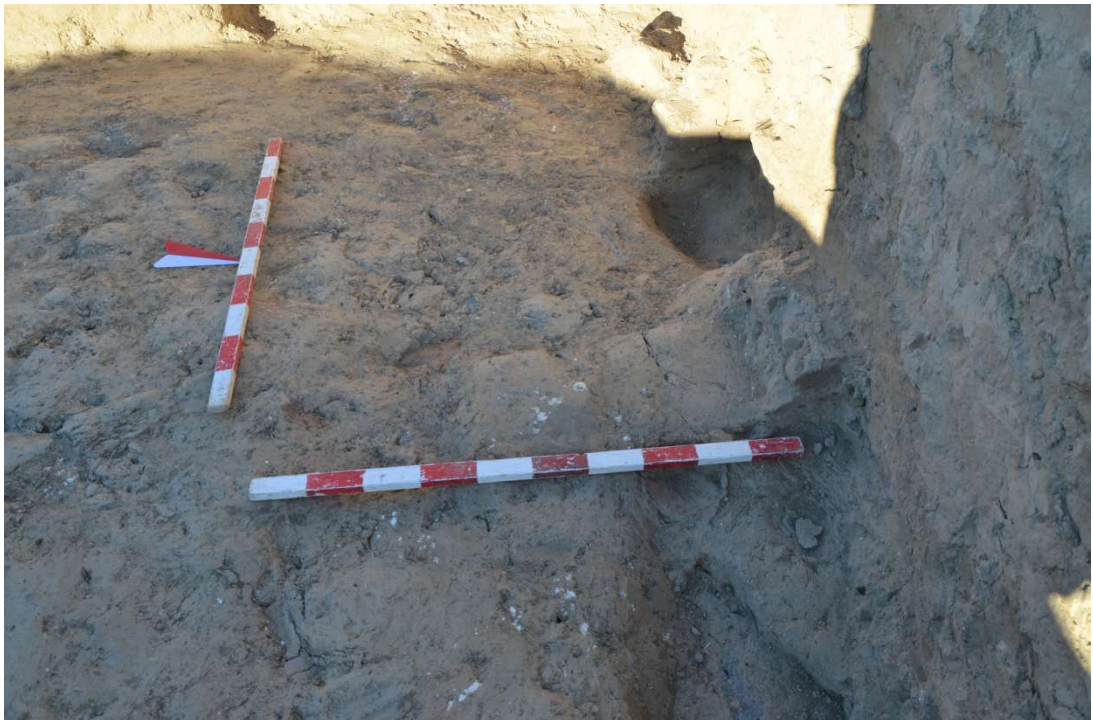
Figure 216. Element 36. Patch of loose loam within a layer of loamy fill and broken fragments of unfired brick blocks near the northern wall (23) of the room. Third construction phase. View to the west.
