Society for the Exploration of Eurasia, Switzerland

LLC RUTRUM

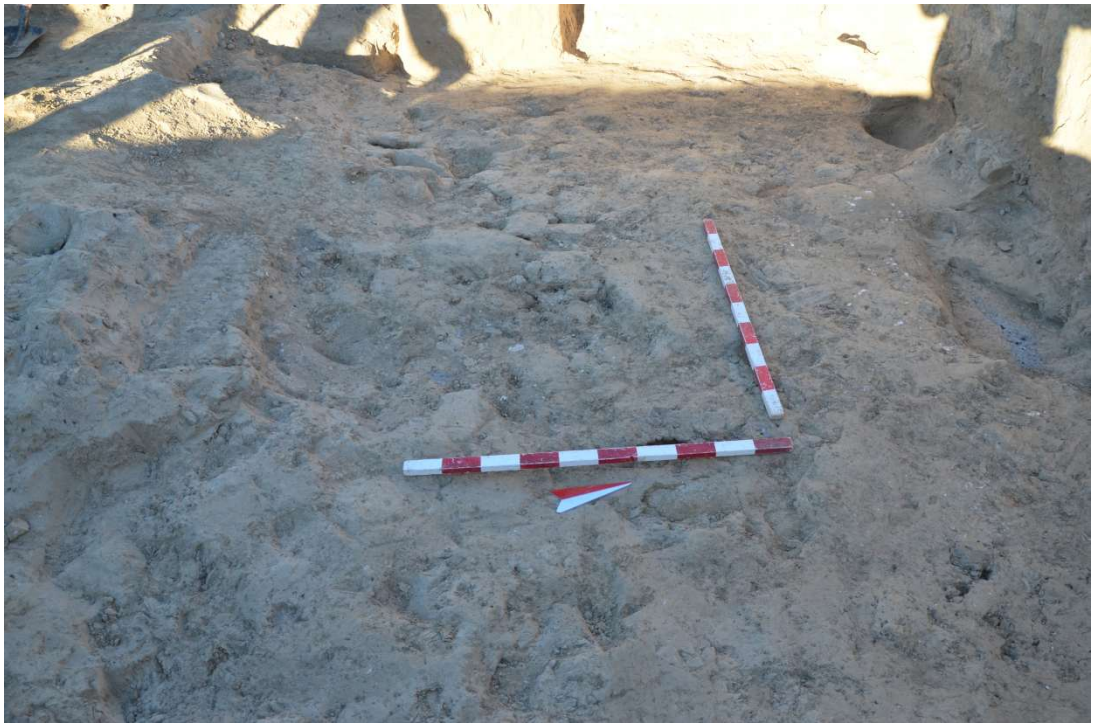
Figure 217. Element 37. Collapse layer consisting of whole and fragmentary unfired brick blocks and loose loam bricks in the center of the room. Third construction phase. View to the west.

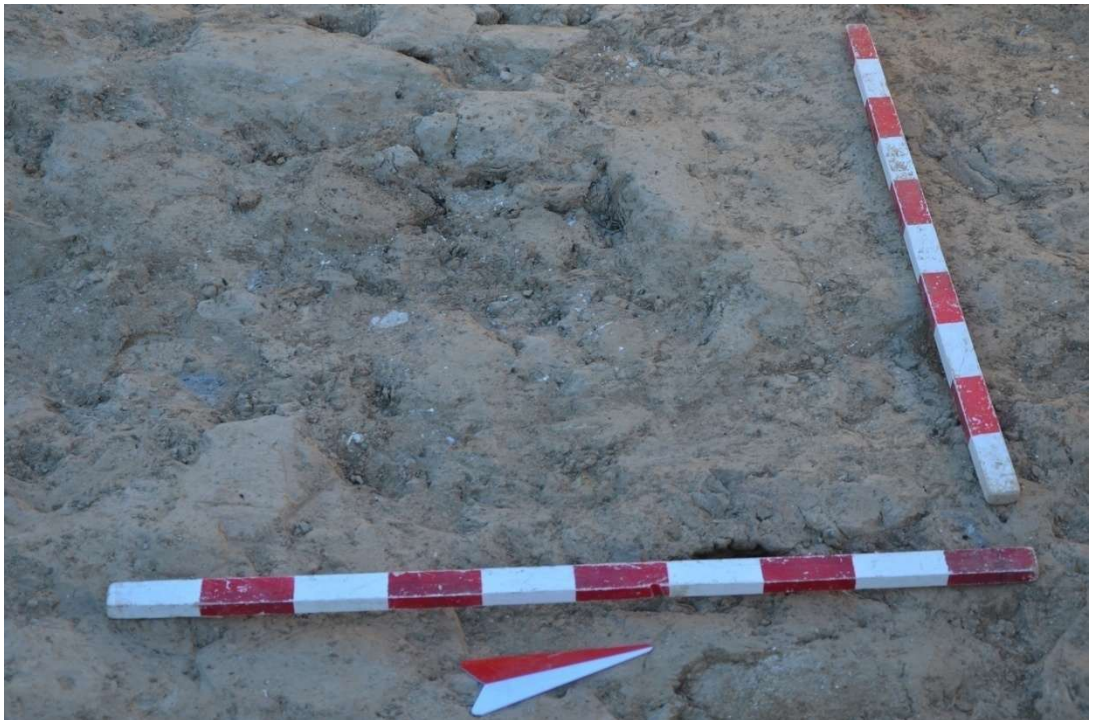
Figure 218. Element 37. Collapse layer consisting of whole and fragmentary unfired brick blocks and loose loam bricks in the center of the room. Third construction phase. View to the west.

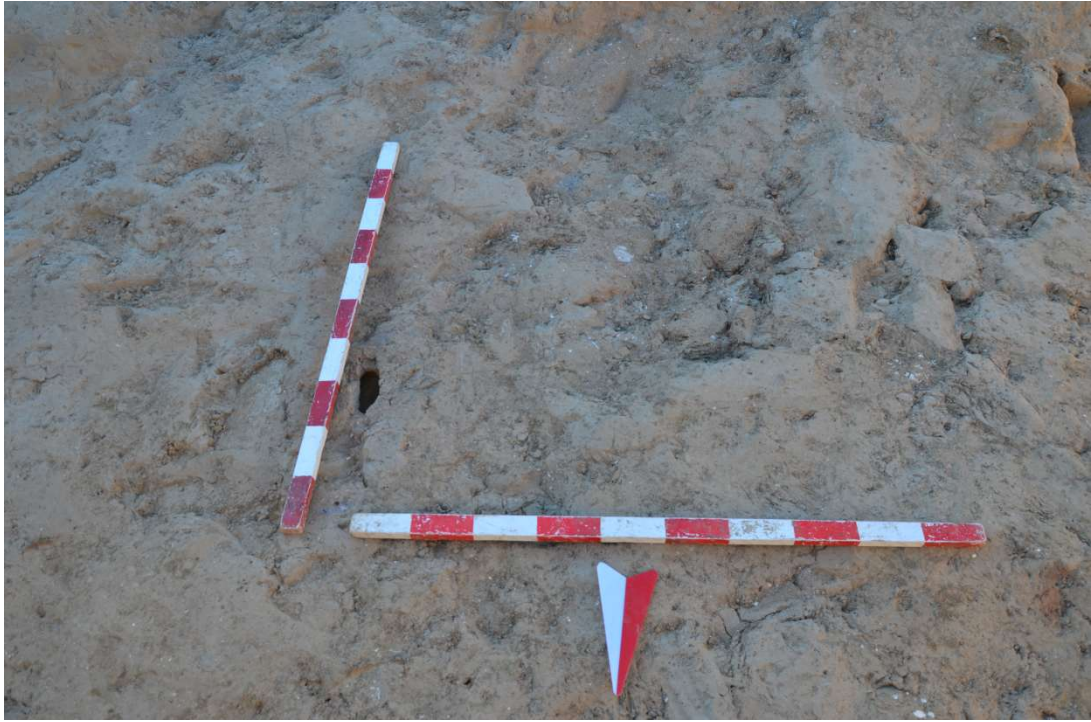
Figure 219. Element 37. Collapse layer consisting of whole and fragmentary unfired brick blocks and loose loam bricks in the center of the room. Third construction phase. View to the south.

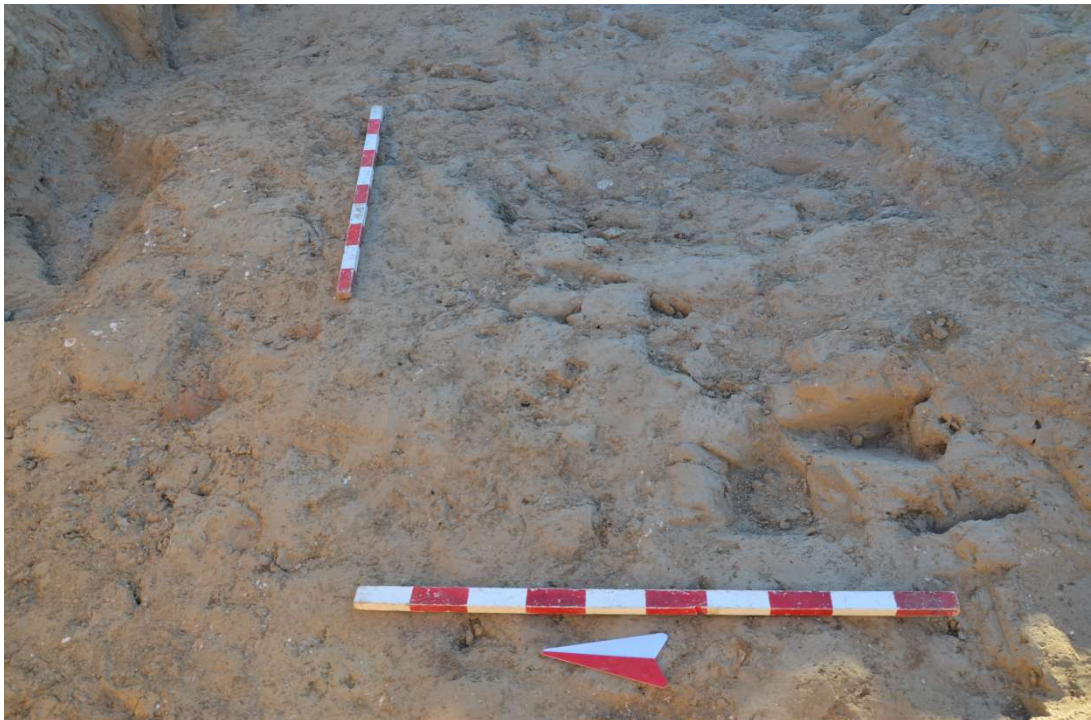
Figure 220. Element 37. Collapse layer consisting of whole and fragmentary unfired brick blocks and loose loam bricks in the center of the room. Third construction phase. View to the east.

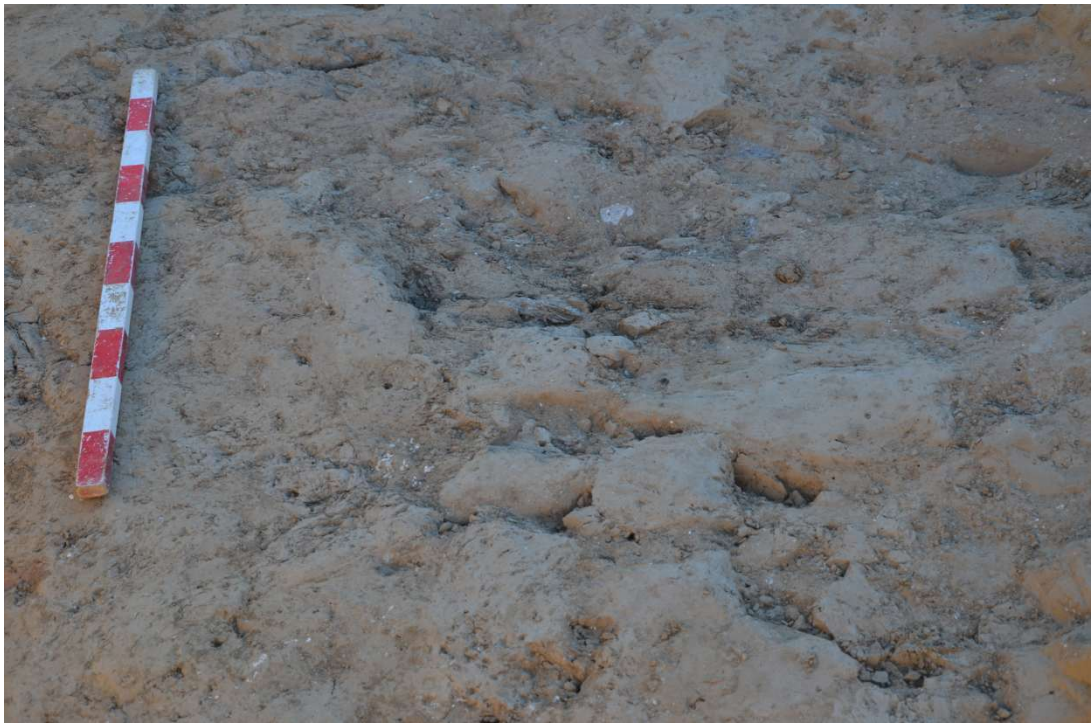
Figure 221. Element 37. Collapse layer consisting of whole and fragmentary unfired brick blocks and loose loam bricks in the center of the room. Third construction phase. Plan view.

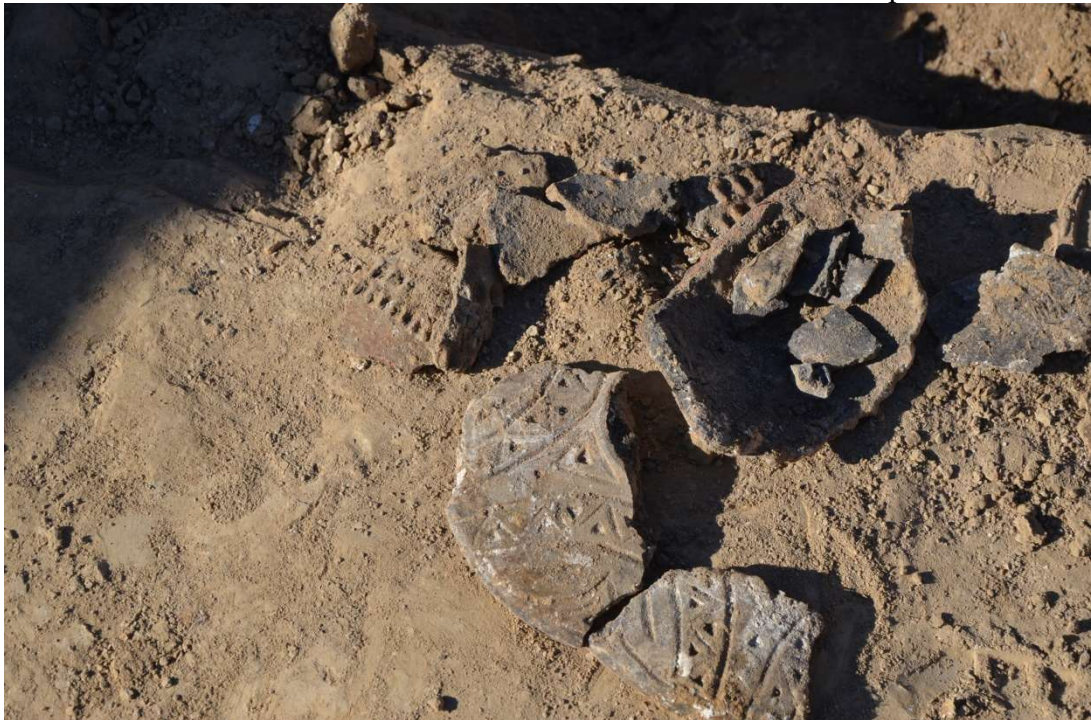
Figure 222. Element 37. Fragments of ceramic vessels recovered during the clearance of collapsed intact and fragmented unfired clay blocks and bricks, as well as loose loam, in the center of the room. Third construction phase. Plan view.

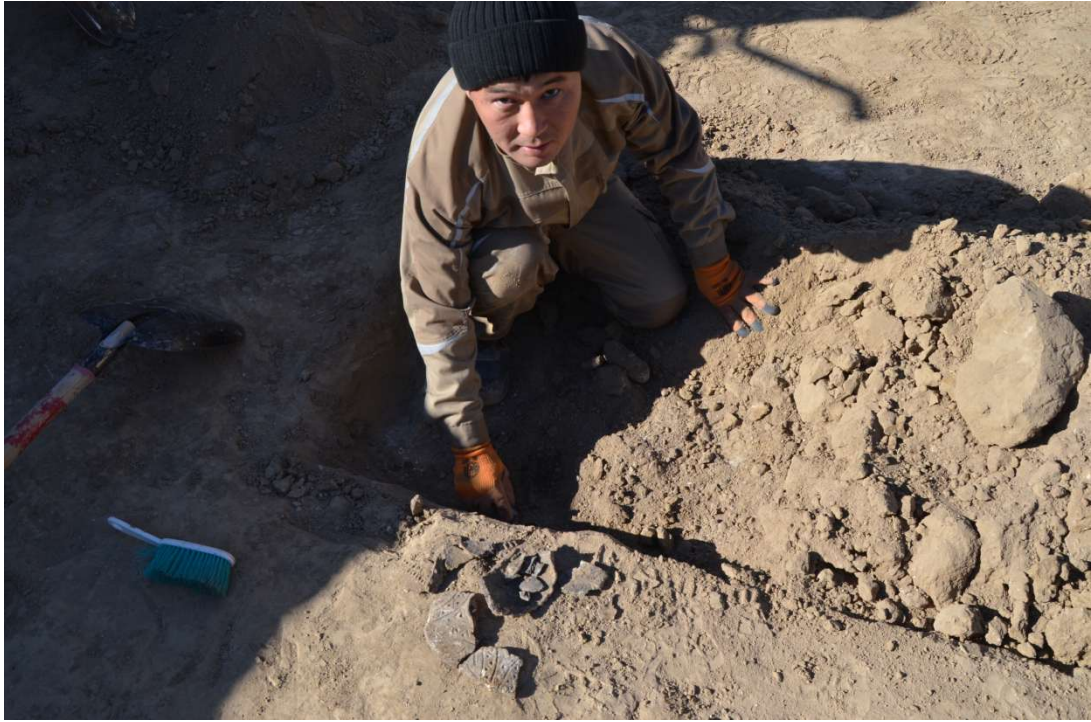
Figure 223. Element 37. Fragments of ceramic vessels recovered during the clearance of collapsed intact and fragmented unfired clay blocks and bricks, as well as loose loam, in the center of the room. View to the west.

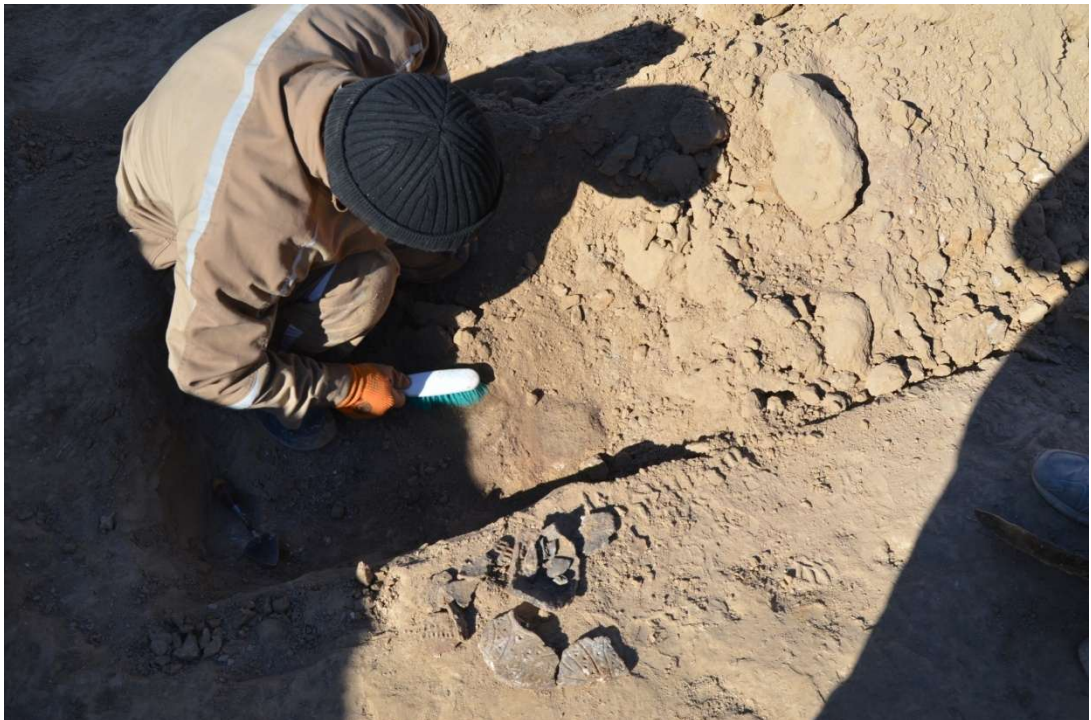
Figure 224. Element 37. Fragments of ceramic vessels recovered during the clearance of collapsed intact and fragmented unfired clay blocks and bricks, as well as loose loam, in the center of the room. Third construction phase. View to the west.

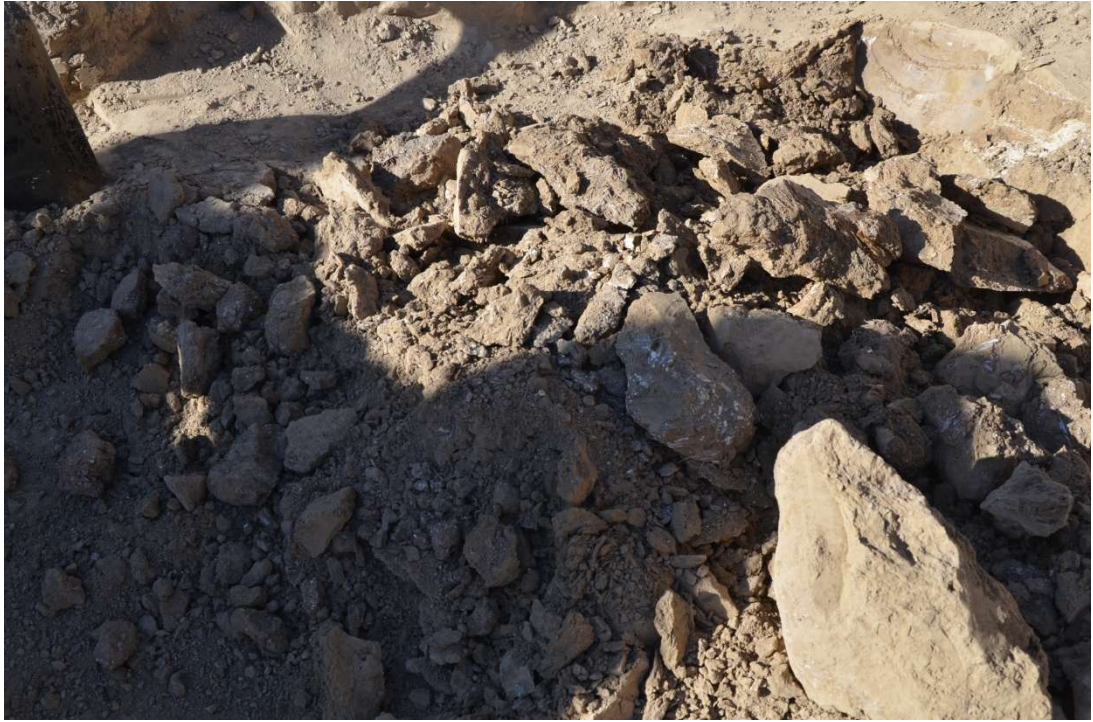
Figure 225. Element 37. Fragments of unfired clay blocks and bricks of loose loam, as well as decomposed reed and bulrush, in the center of the room. Third construction phase. View to the west.

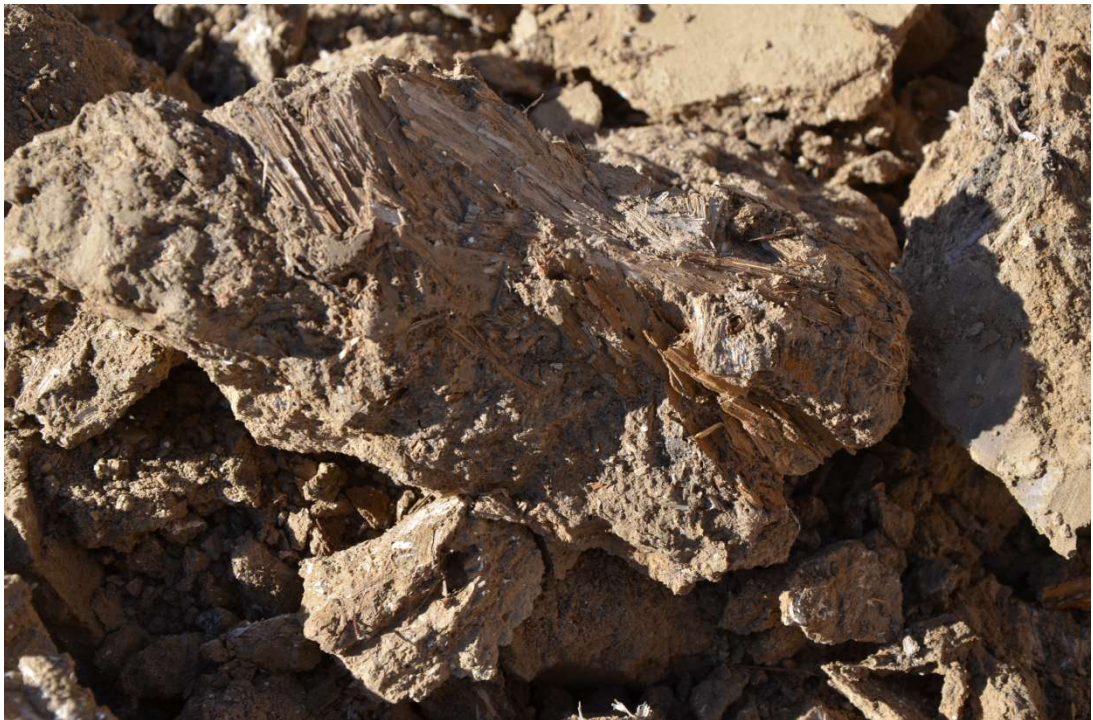
Figure 226. Element 37. Fragments of unfired clay blocks and bricks, loose loam, and decomposed bulrush in the room. Third construction phase. View to the south.

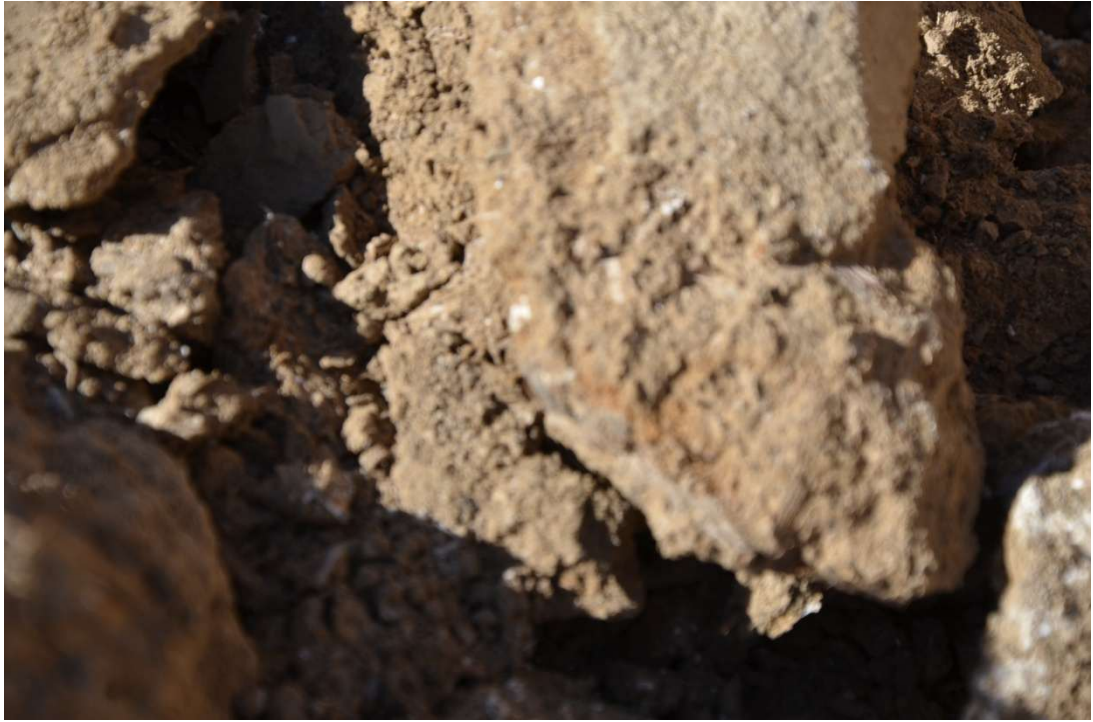
Figure 227. Element 37. Fragments of un-fired clay blocks and bricks, and loose loam in the room. Third construction phase. View to the west.

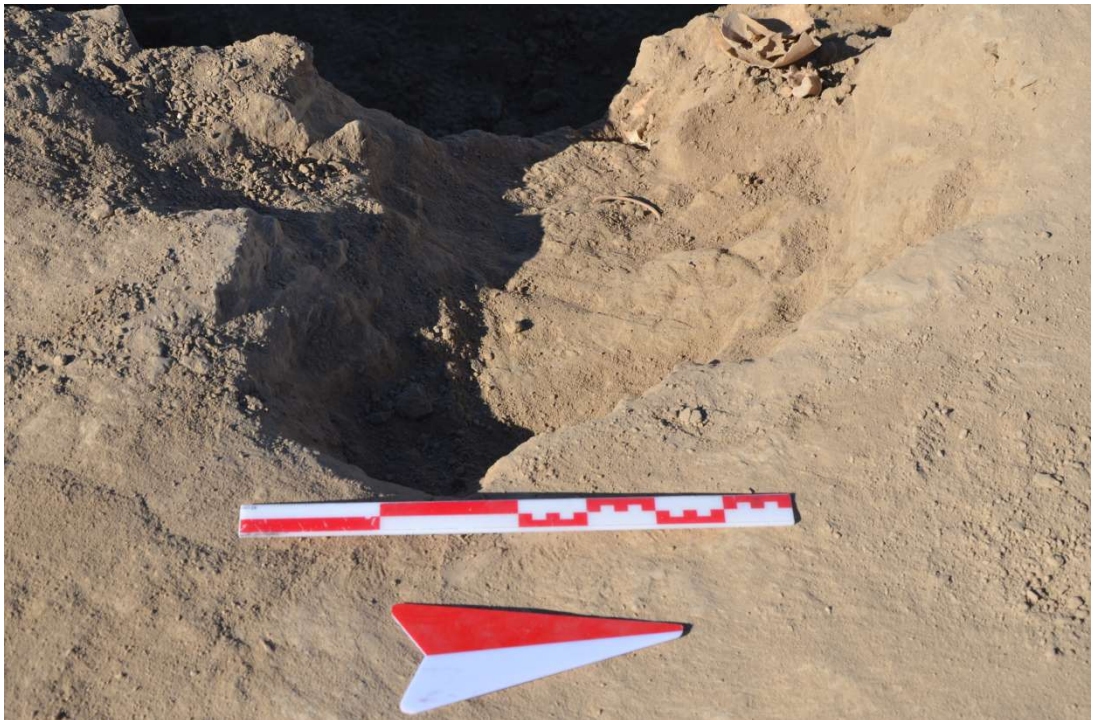
Figure 228. Element 38. Late-period child burial on the surface of the eastern wall (12). First construction phase. View to the east.
