## **Sanjar-Shah Excavations Report 2016**

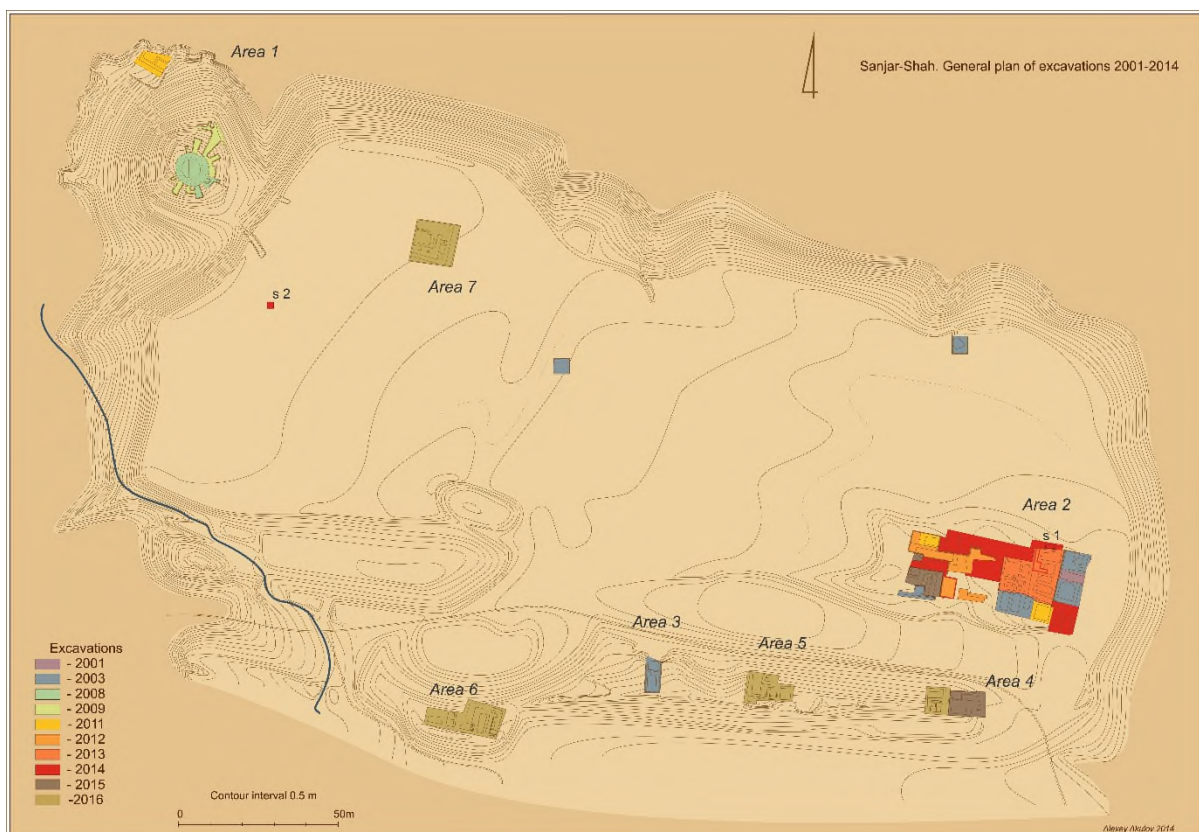
Fig. 1. Sanjar-shah. General plan of the excavated areas (2016).

This season we have continued investigations in Area IV and in Area VII initiated during last year. We have also started excavations in two new areas (V and VI) located along the southern wall of the town (Fig. 1). Area V is situated approximately in the middle of the southern wall, some 65 m to the west of Area IV, and Area VI is adjacent to the southwestern part of the southern wall. The area along the southern wall is the only one apart from Area II, which was not levelled during the Soviet period.

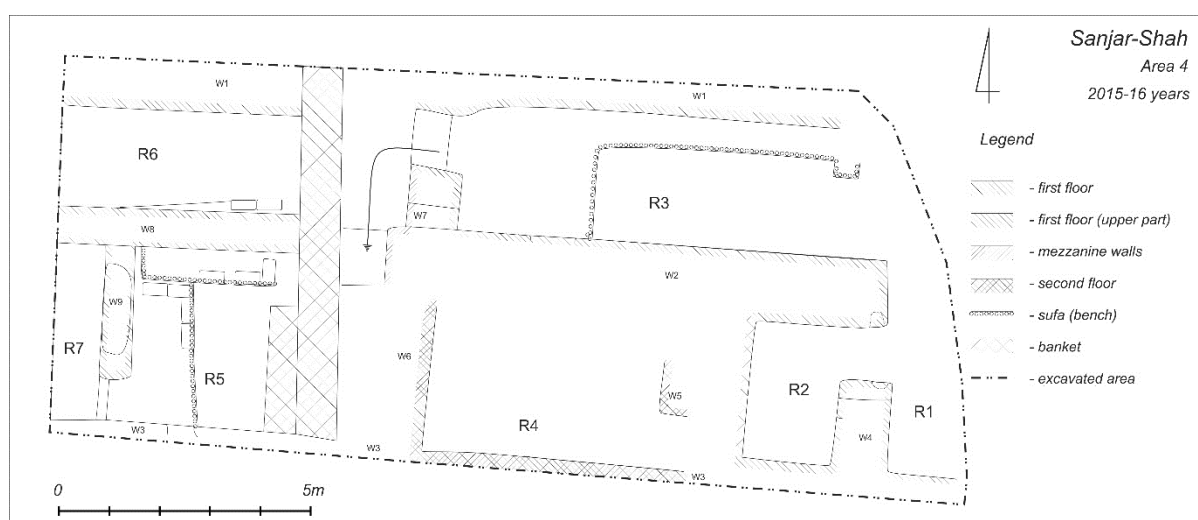
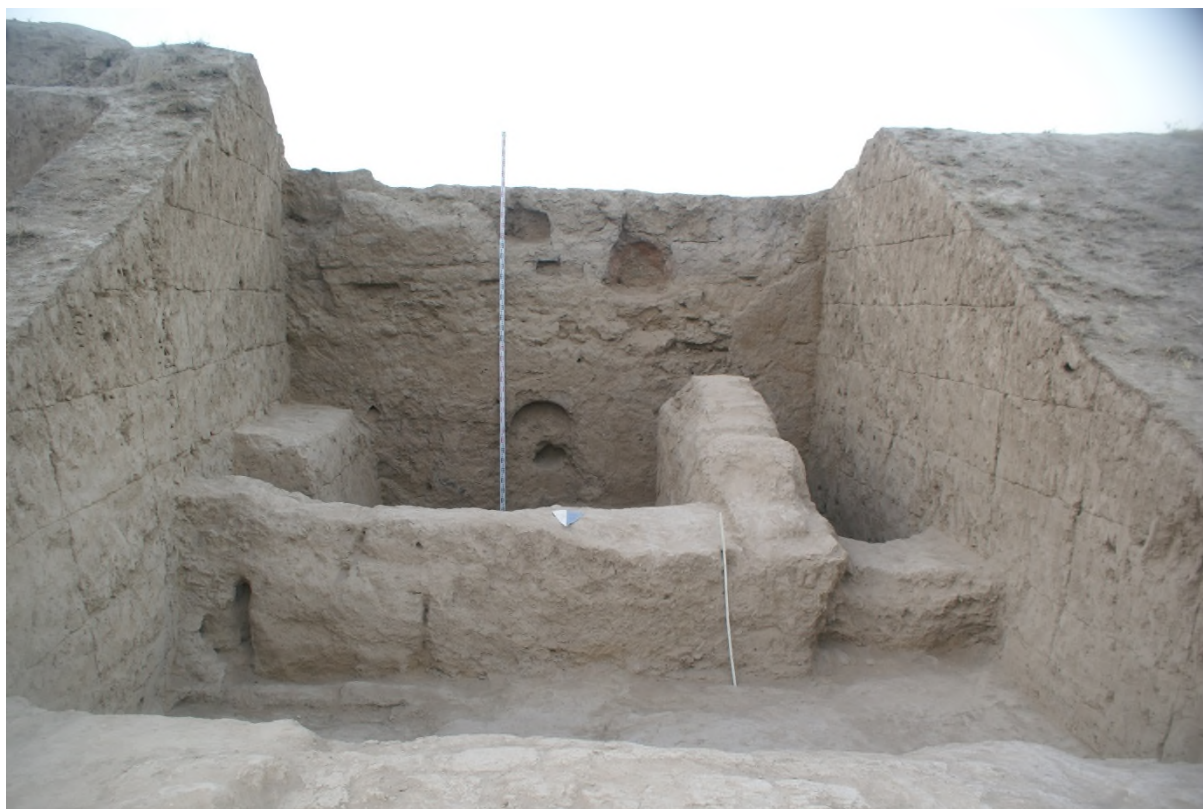
Fig. 2. Area IV. Drawing by Aleksey Akulov.

This Area is situated at the easternmost corner of the southern wall of town (Figs. 2-3). The investigations here were started last year and were continued this season when three additional rooms were partly excavated. A banket (section) was left running through entire area from north to the south that separates Rooms (5-7) excavated this season from Rooms (1-4) which were investigated last year.

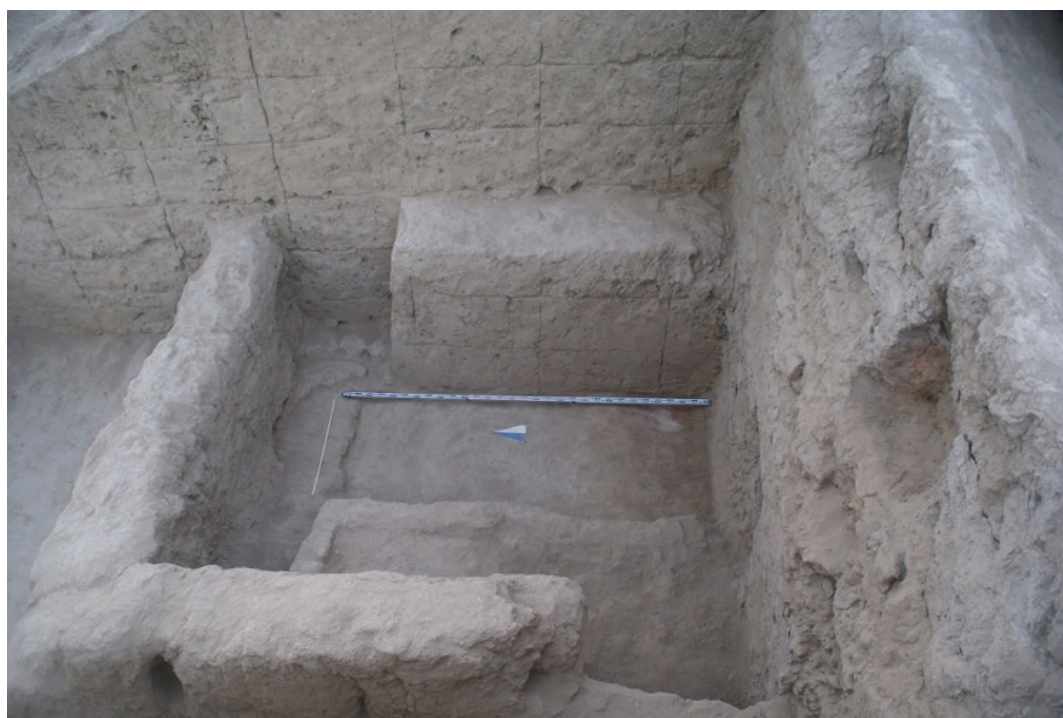
Fig. 4. Area IV. Room 5.

Room 5 (3.5 x 3.2 m) is located to the south of Room 6 (Fig. 4). In this season, three walls of this room were cleared. Wall 3 (h. 3.1 m from the floor level) is made of layers of *pakhsa* blocks and mud brick. The upper part of the wall is badly preserved. On the height of 2.05 m

there are mud bricks that were probably originally part of a mezzanine. At the distance of 45 cm from the upper floor there is a semi-circular niche (62 x 50 x 45 cm). Inside the niche there are traces of intense burning and it seems that it functioned as a hearth of the second storey. The second niche (45 x 56 x 35 cm) was found at the distance of 60 cm to the east from the first niche. The lower part of the wall is relatively well preserved and is built entirely of *pakhsa* blocks. At the distance of 2.25 m from the banket there is a niche (145 x 16 x 33 cm) which has a semi-circular shape in its upper part. Wall 9 (h. 1.36 m from the sufa level; l. 2.52 m; w. 80 cm) is made of *pakhsa* blocks. In the southern part of the Wall there is a niche (blocked passage; 1 x 0.53 m). In some places on the Wall there are fragments of plaster. Wall 8 (h. 1.3 m from the sufa level; l. 3.24 m) is built of *pakhsa* blocks and plastered. L-shaped sufa was installed along the Walls 8 and 9. Along the Wall 8 the sufa is very badly preserved (h. 15 cm; w. 80 cm). The sufa along the Wall 9 (h. 55 cm; l. 195 cm; w. 84 cm) is better preserved. It is constructed of standard mud brick. Along the edge of the sufa there is a mud brick enclosure (l. 293 cm; w. 15-20 cm). There is one floor level in this room. Its surface is greenish and solid. In the southern part of the floor there are traces of intense burning.

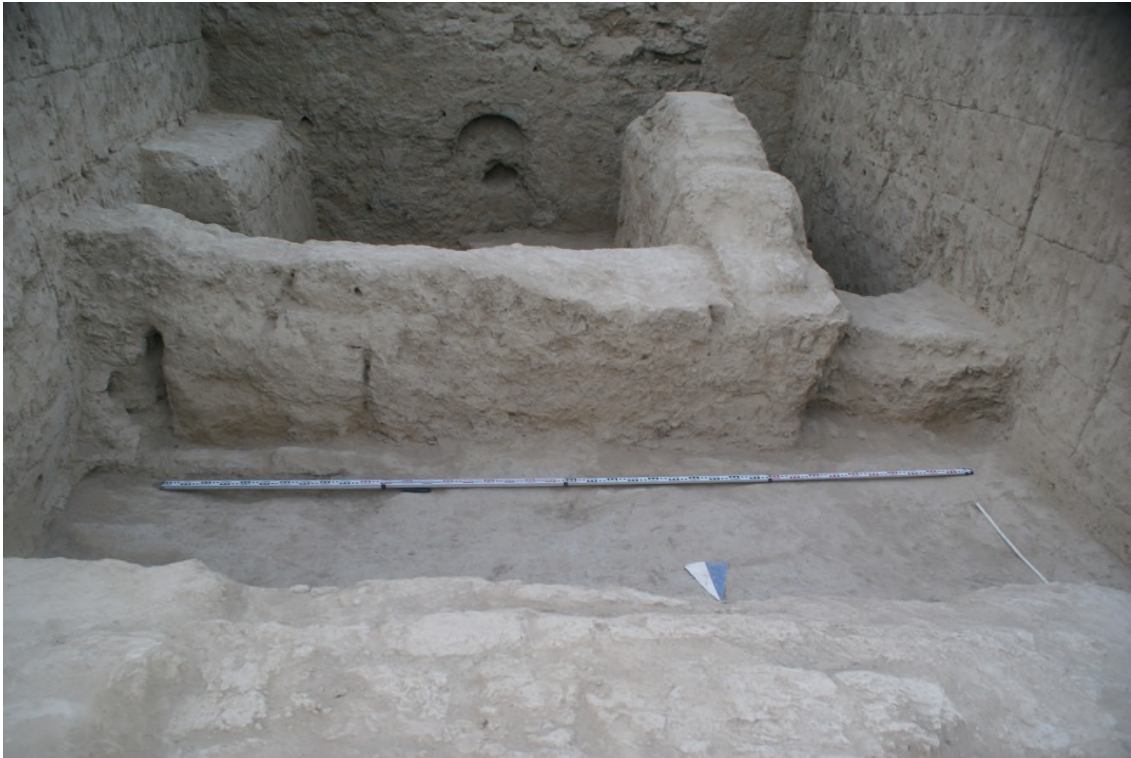
Fig. 5. Area IV. Room 6.

Room 6 is located to the north of Room 5 and 7 (Fig. 5). Only two Walls 1 and 8, and parts of the floor were exposed during this season (4.6 x 1.85 m). Wall 8 (h. 1.1 m; l. 3.71 m) is shared with Rooms 5-7 and is made of *pakhsa* blocks. There was probably a passage or a ramp leading to Room 7 in the western part of the wall. Wall 1 (h. 95 cm; l. 4.65 m) is made of both *pakhsa* blocks and rows of mud brick. The floor surface uncovered so far is smooth, solid and green.

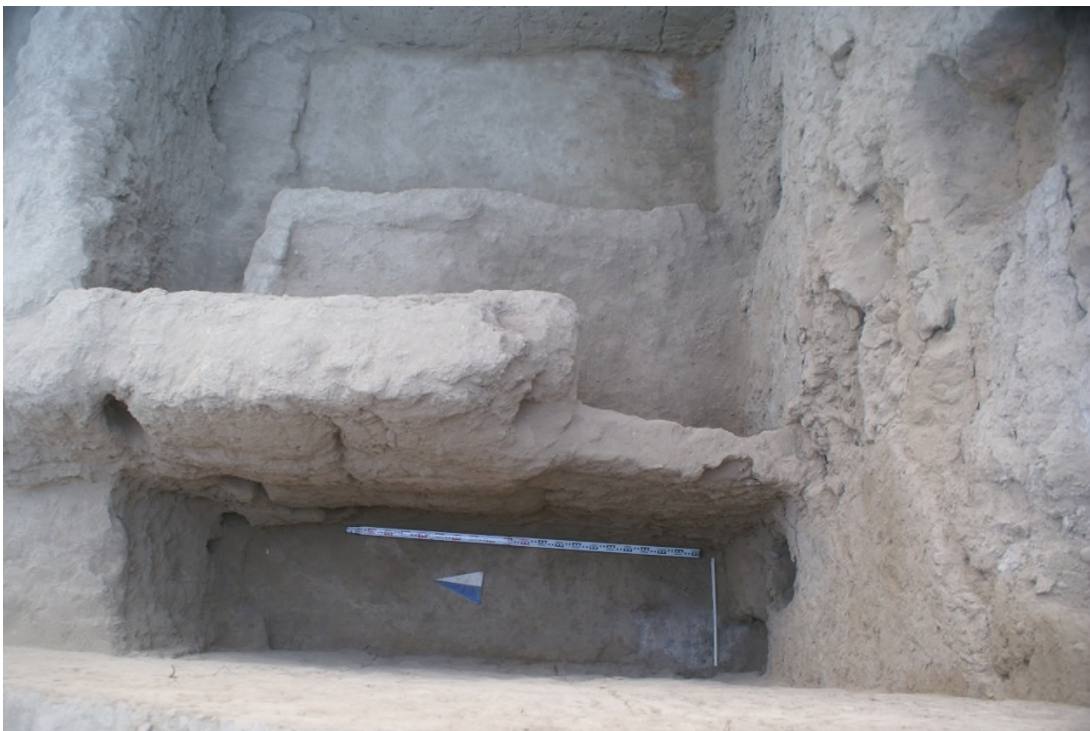
Fig. 6. Area IV. Room 7.

Room 7 (excavated area: 260 x 90 cm) is located to the west of Room 5 and to the south of Room 6 (Fig. 6). Wall 3 (h. 3.5 m) is the southern wall of the city built of *pakhsa* blocks. At the height of 2.9 m from the floor level, a layer of plaster is preserved. At the height of 60 cm and at the distance of 10 cm from Wall 9 there is a niche (40 x 36 x 30 cm). Its upper part has a semi-circular shape and is plastered. Around the niche, the surface of the wall is burned. At the distance of 43 cm from Wall 9, there is a hearth attached to the Wall 1. Wall 9 (h. 1.75 m; l. 2.1 m) is shared with Room 5 and is constructed of *pakhsa* blocks and of mud brick. One floor level was identified in the room. Its surface is relatively smooth, solid and yellowish.

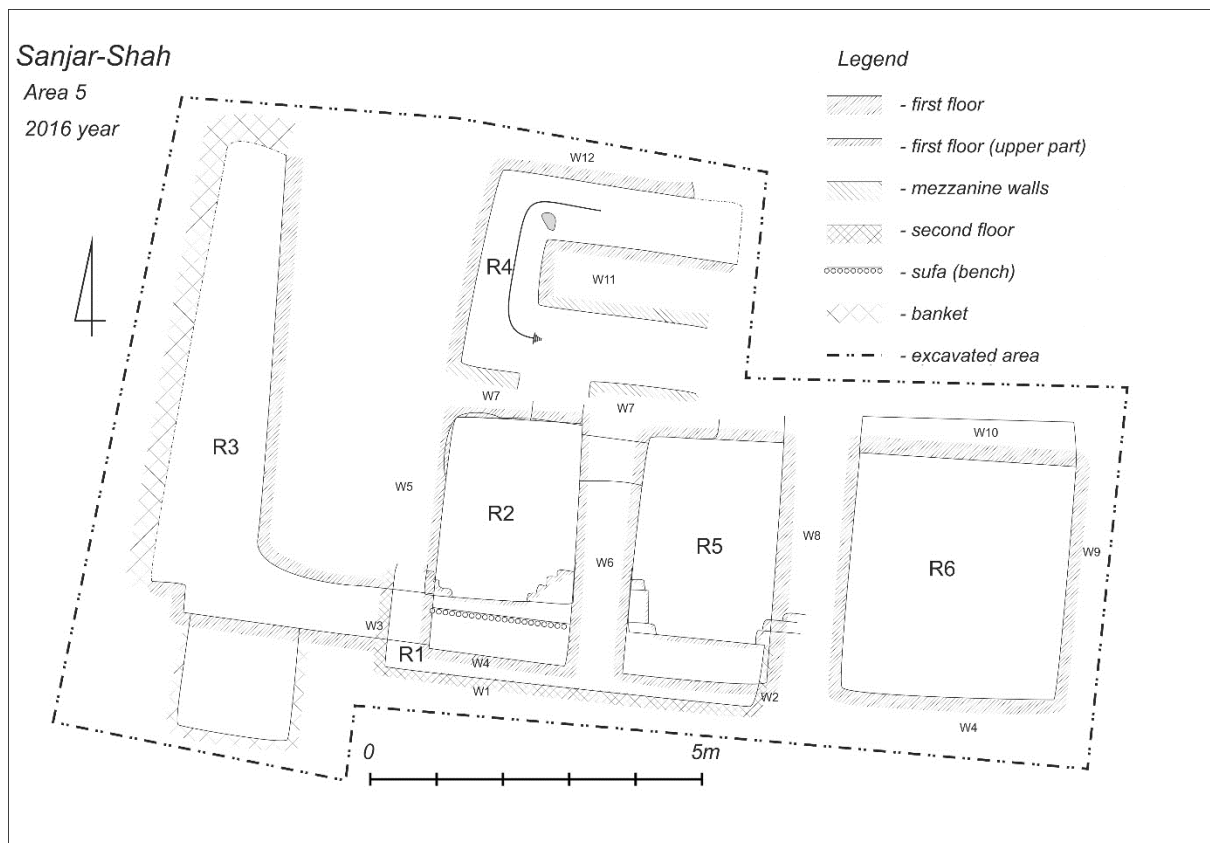
Fig. 7. Area V. Drawing Alexey Akulov

The excavations of this Area were initiated in this season (Fig. 7). So far, we have uncovered 5 rooms (Rooms 1-3 and Rooms 5-6) adjacent to the southern wall and a ramp (Room 4). In addition, partially preserved room of the upper floor was excavated (Room 1). Room 6 stands out with its particularly large size.

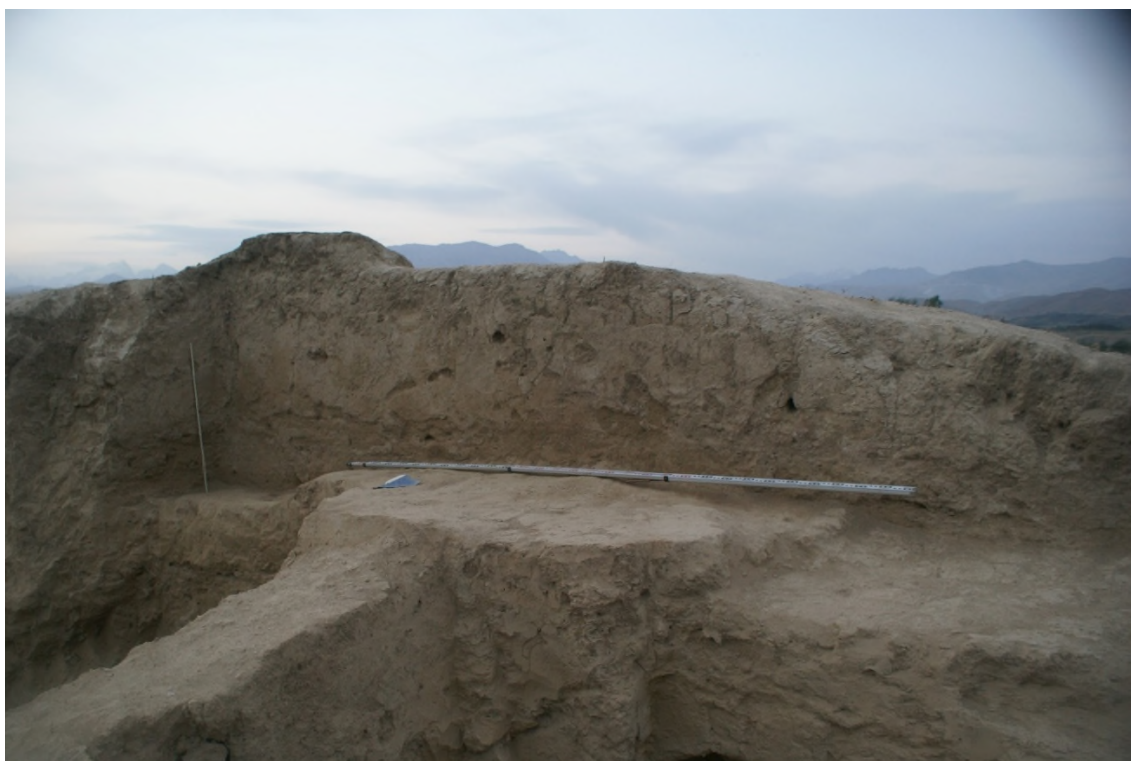
Fig. 8. Area V. Room 1.

Room 1 is located on the third floor above the Rooms 2 and 5. It has a rectangular shape (Fig. 8). Only southern (1) and eastern (2) walls are partially preserved. An outline of the western wall was also visible. Wall 1 (h. 5.4 m from the floor level) was constructed together with the southern wall of the town. In the upper part of the Wall three layers of plaster were identified. The middle layer has traces of red color, which most probably represent the evidence for the existence of wall paintings. Also on Wall 2 (l. 1.2, h. 1.45 m) three layers of plaster were found, but no traces of paintings. One level of floor was cleared in the southern part of the

room above Rooms 2 and 5. Only parts of it are preserved. It is made of standard mud brick, its surface is solid and has a yellowish color.

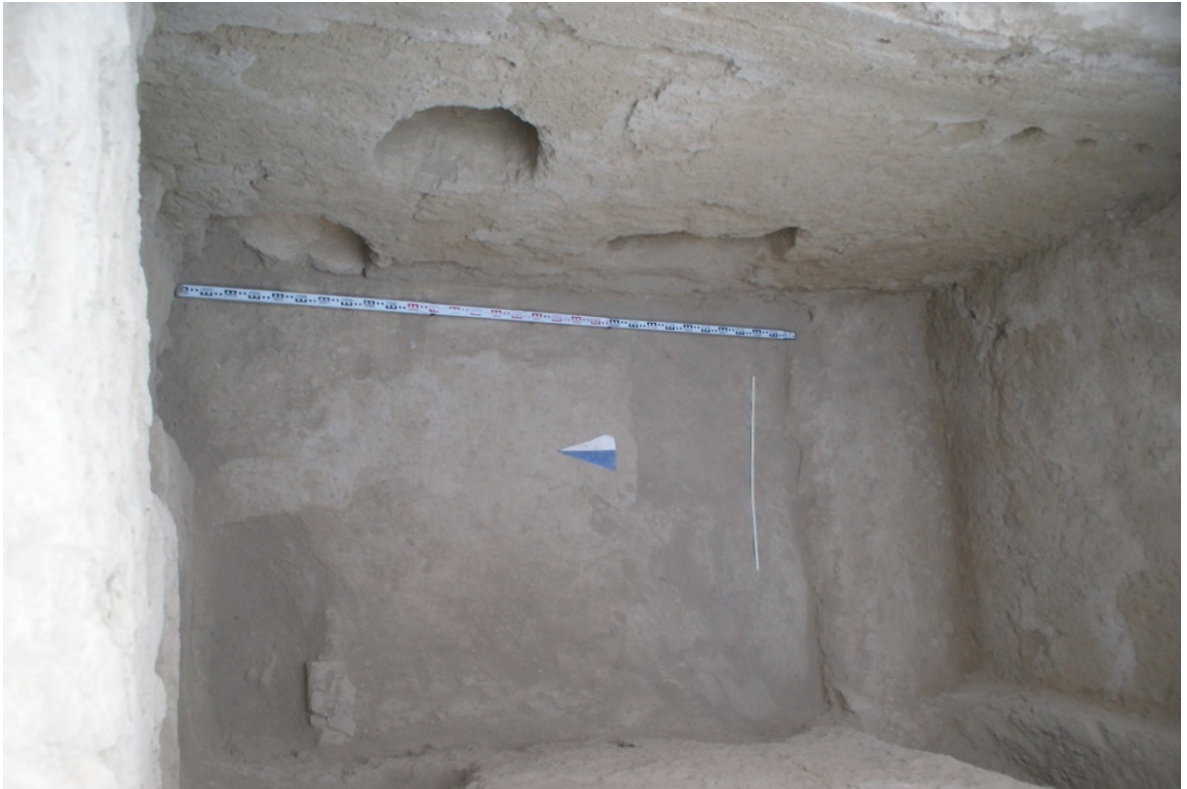
Fig. 10. Area V. Room 2.

Room 2 (3.9 x 2.1 m) is located south from Room 4, to the west from Room 5 and to the east of Room 3 (Fig. 10). It has a rectangular shape and has a partially preserved vault. The lower part (up to 2.1 m) of Wall 7 (h. 7 m) is built from *pakhsa* and the upper part from standard mud bricks. It is attached to the Wall 6. In the western part of Wall 7 (20 cm from Wall 5, high 20 cm from the floor level) a niche was found (h. 50 cm; w. 40 cm; d. 20 cm). In the eastern part of the Wall 7 there is a passage (h. 1.5 m) to Room 4 which has not been cleared yet. In the upper part of the passage there is a skylight (h. from ramp level 50 cm; w. 1.2. m) leading to Room 4 (Fig. 11). Traces of plaster are visible on some parts of the wall. Wall 6 (h. 3.8) is built from *pakhsa* blocks and has a well-preserved layer of plaster (Fig. 12). The vault begins at the high of 1.9 m from the floor level. It is built from mud brick and is preserved up to a height of 1 m. The vault is also plastered. In the lower part of the northern section of the wall there is a manhole (h. 70 cm; w. 70 cm) leading into Room 5 (Fig. 13). At the distance of 2.6 m from Wall 4 there is a niche (50 x 50 x 30 cm). The upper part of the niche has a semi-circular shape and is plastered. Wall 4 (h. 2.9 from the sufa level) is completely preserved (Fig. 14). It is made of *pakhsa* and plastered. This wall is in fact a northern face of town wall. Wall 5 (h. 2.9 m) is built of *pakhsa* and has traces of plaster. The vault begins at the height of 2.1 m from the floor level. In the southern part of the room there is a passage (h. 1.7 m from the sufa level; 20 cm from Wall 4; w. 90 cm) to Room 3. In the corner of Walls 5

and 7 there is a semi-circular depression (h. 90 cm; w. 1 m; d. 25 cm). The lower part of this depression is plastered and it seems that it served for storage.

In the southern part of the room there are remains of a vault (l. 1.2 m; h. 3 m). Along the Wall 4 there is a plastered sufa (w. 80 cm; h. 25 cm) made of mud brick. The floor of the room is flat and have a plaster layer of some 4-5 cm which was made over a fill of pebbles.

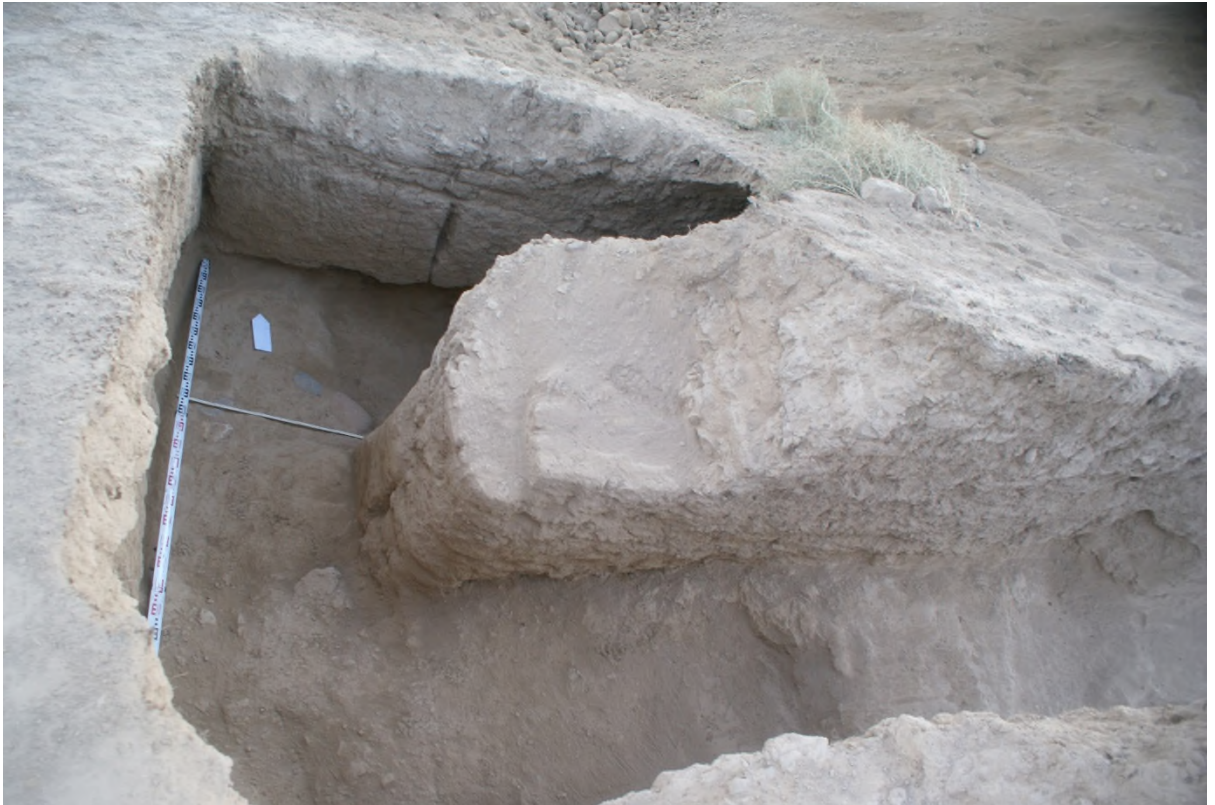
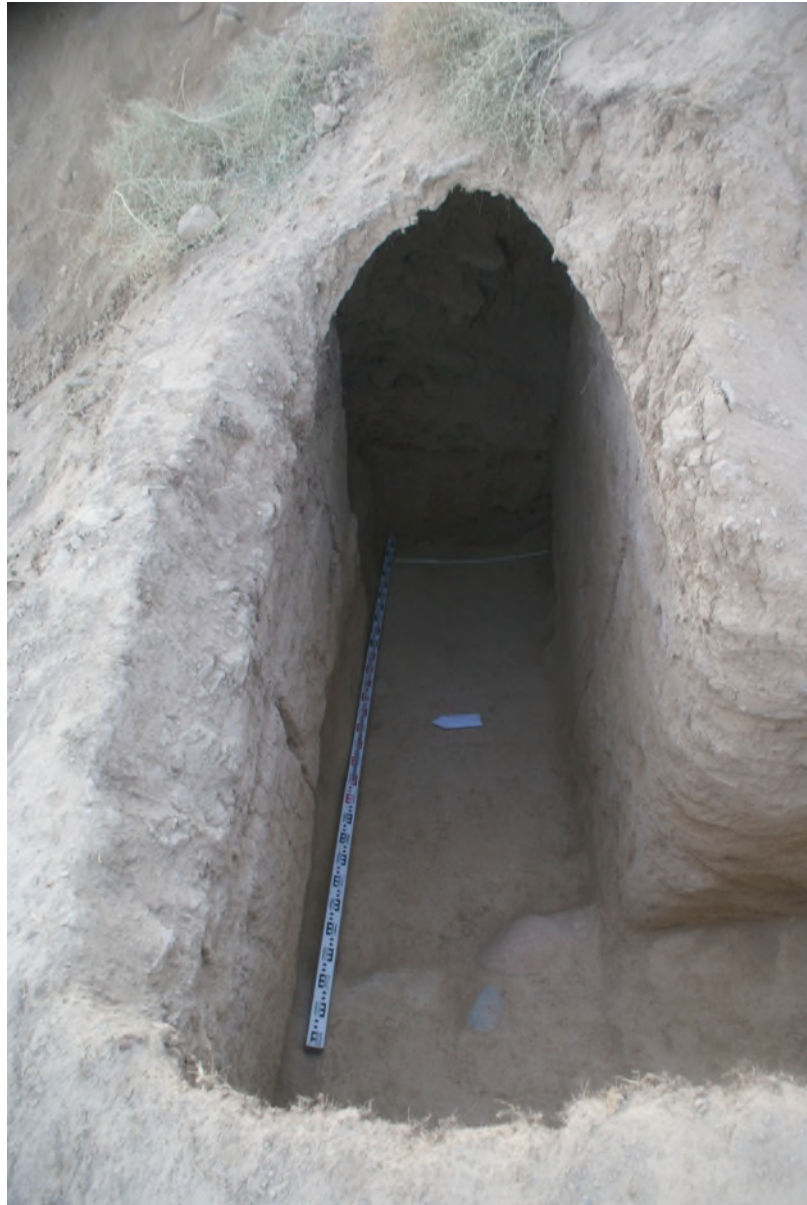
Fig. 15. Area V. Room 4.

This room is a ramp located to the north of Rooms 2 and 5 (Figs. 15-16). The ramp led to the second (mezzanine) and third floors. The direction of the ramp is counter clockwise. It was vaulted and is well-preserved. In the western section of the ramp there is a small window for the second floor.

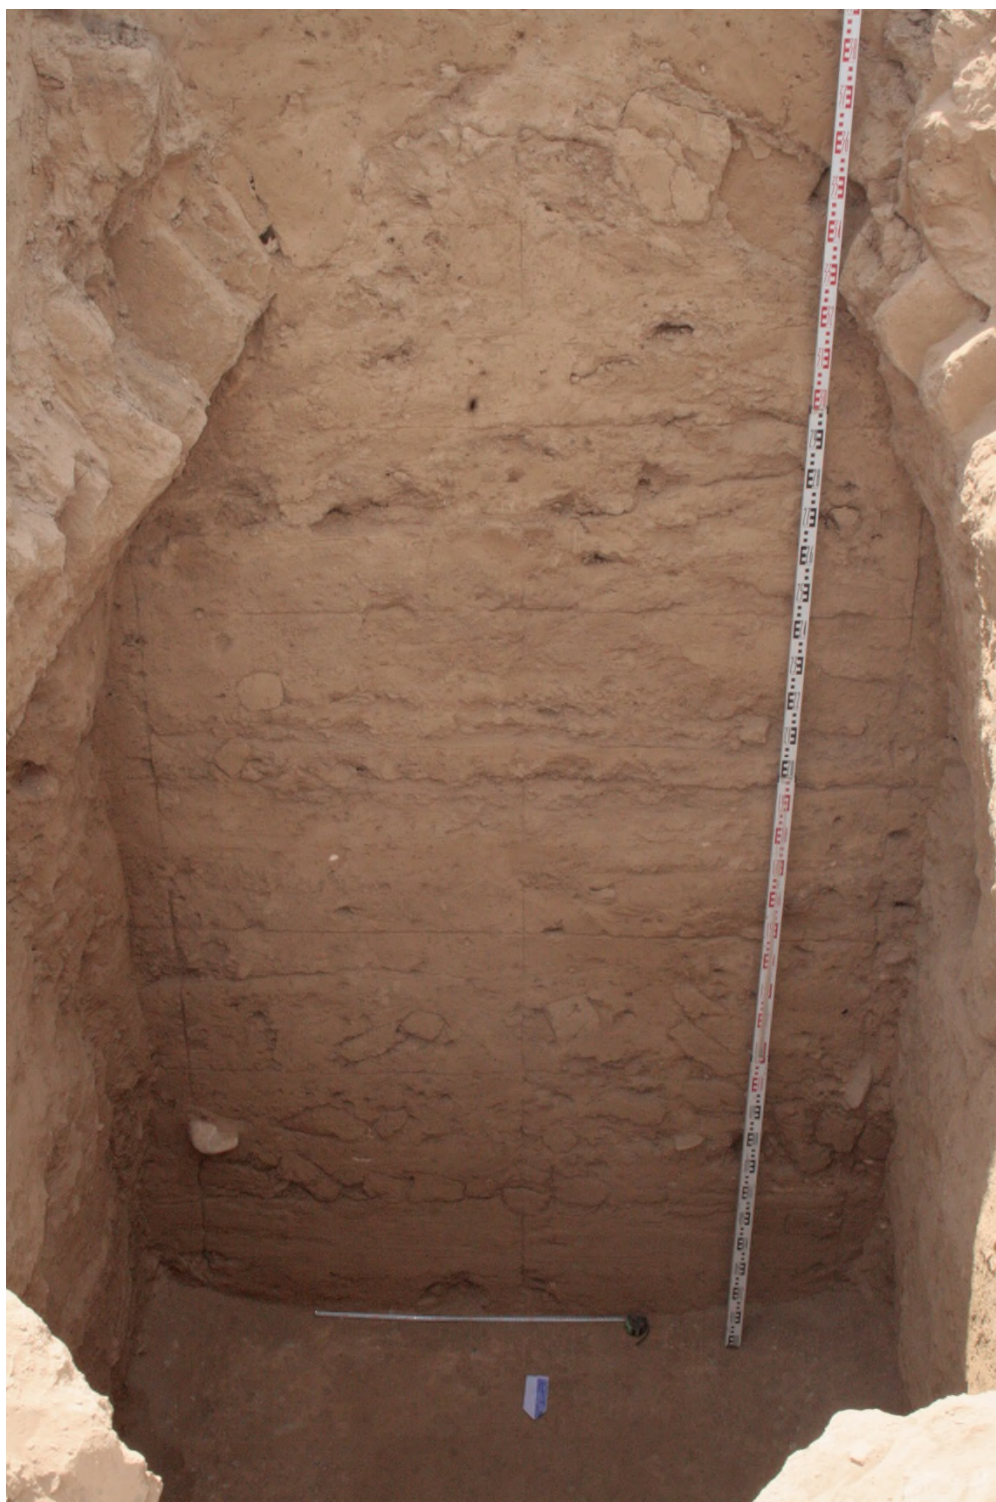
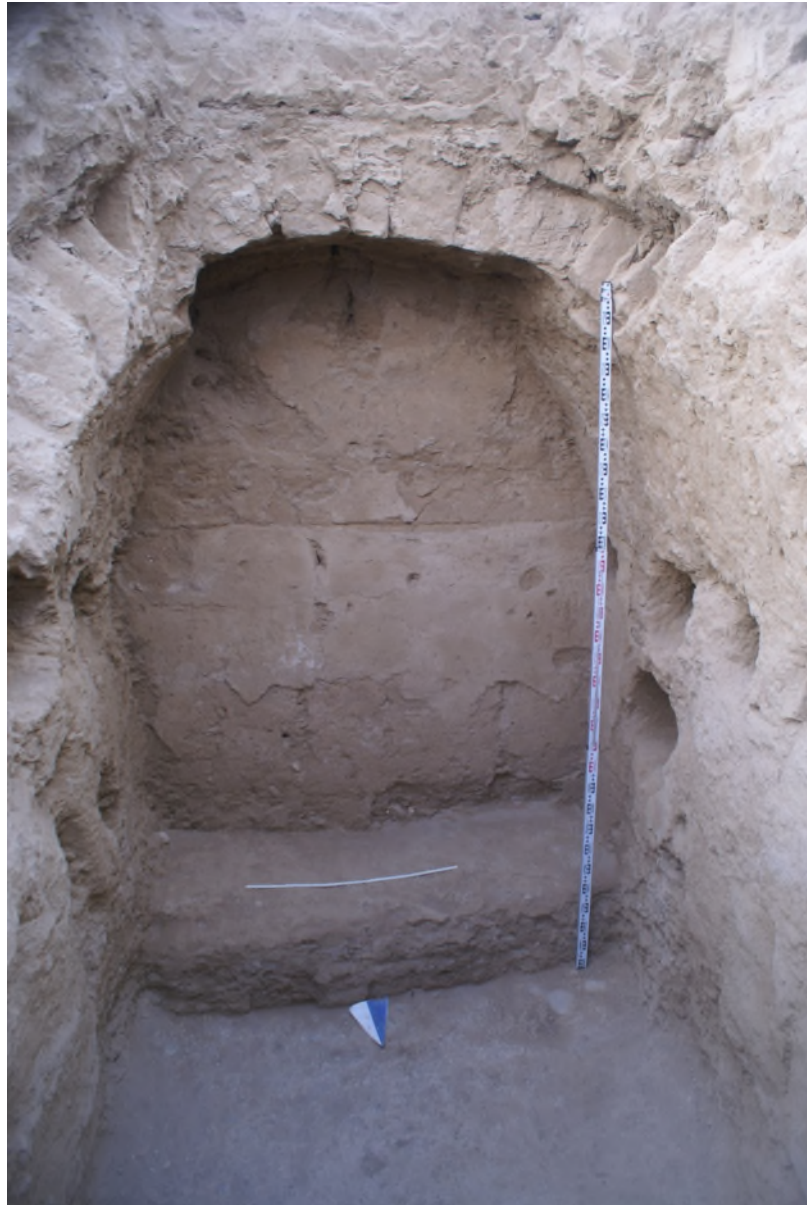
Fig. 17. Area V. Room 5.

Room 5 (3.6 x 2.2 m) is situated to the south from Room 4 and to the east from Room 2 (Figs. 17-18). The preservation of the Wall 4 (h. 2.8 m from the sufa level) in this room is very good. It also has a well-preserved level of plaster. Wall 8 (h. 2.7 m) is built from *pakhsa* blocks (1.1 m) and is attached to Wall 4. The plaster on this wall was not preserved. The cornice is situated at the height of 2 m from the floor level. In addition, 6 holes for wooden beams that supported the mezzanine were made in Wall 8. All of them are situated at the height of 1.8 from the floor level and have similar dimensions (h. 25 cm; w. 30 cm; d. 40 cm). An arch-like niche (h. 60 cm; w. 60 cm; d. 22 cm) was found beyond the 5<sup>th</sup> hole. The

upper part of the niche was destroyed when the inhabitants removed the beam of the mezzanine. Traces of burning left by a lamp were found in the niche. Wall 6 (w. 90 cm) is attached to Wall 4 and is also made of two rows of *pakhsa* blocks (h. 1 m), but is better preserved than Wall 8. Cornice is found at the height of 2 m from the floor level. Also here 6 holes for mezzanine beams were made which correspond to the holes in the opposite Wall 8. In the corner between Walls 4 and 6 in one of the holes, a 10 cm fragment of the mezzanine floor made of reed and straw is preserved. At the distance of 50 cm from Wall 4 there is a plastered arch-like niche (h. 40 cm; w. 40 cm; d. 40 cm). In the corner of Walls 8 and 7 there is a plastered manhole (h. 90 cm; w. 60 cm; d. 90 cm). Later the manhole was filled with standard mud bricks. Wall 7 (w. 80 cm) is built of large *pakhsa* blocks (h. 2 m). There is a passage (h. 1.7 m; w. 1.1 m) in the corner with Wall 6. Above the passage there was a ramp that leads to the second and the third floors; the direction is from west to east. The height of the second floor from the mezzanine to the vault is 1.3 m. The vault in this room is preserved in the southern part only. It is made of mud brick (50 x 25 x 10) and is plastered with fine plaster.

In the southern part of the room, along Wall 4 a plastered sufa (h. 45 cm; w. 70 cm) was found. The floor is flat with a slight degradation towards south. The surface of the floor is plastered. It seems that this room functioned as a granary.

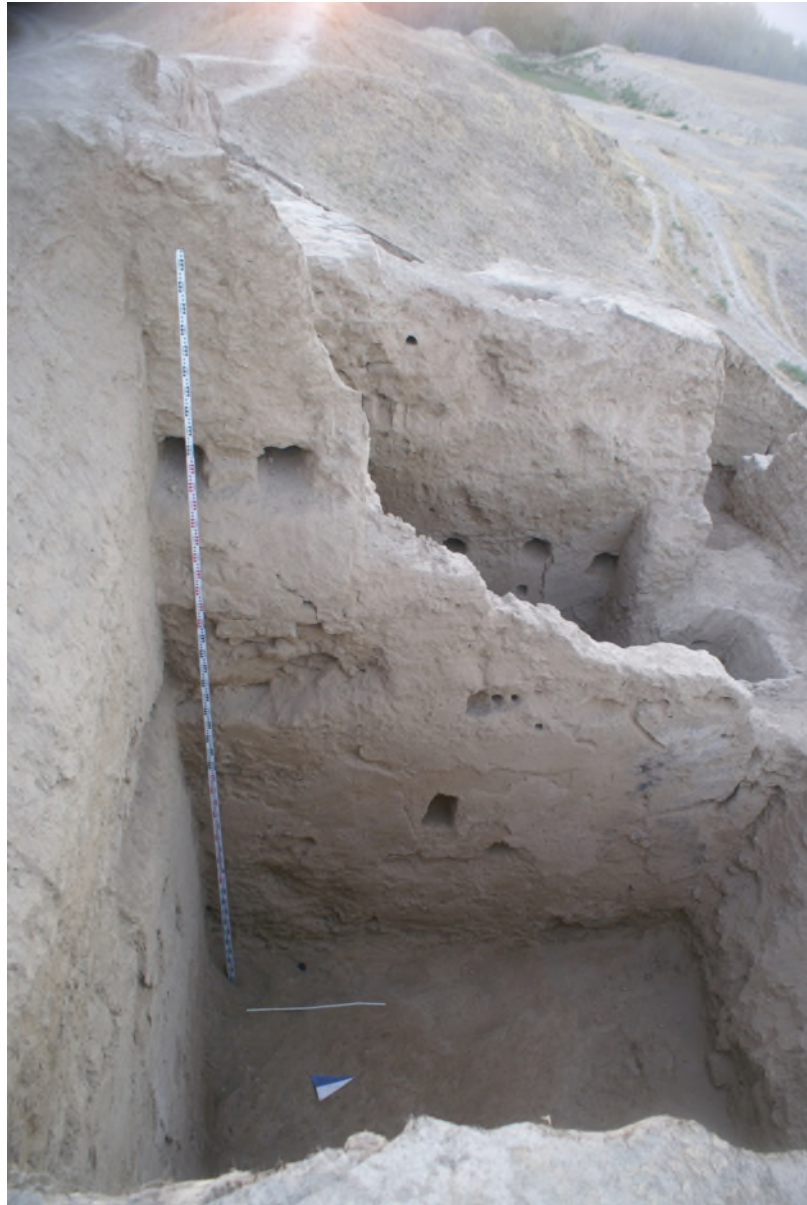
Fig. 19. Area V. Room 6.

Room 6 (3.4 x 3.9) is situated to the east of Room 5 (Fig. 19). Wall 4 which forms also the southern city wall is preserved up to the height of 5.2 m from the level of the first floor. It is built of *pakhsa* blocks (1 x 1.4 m) and mud brick. In the corner of Walls 9 and 10 parts of the wall are washed away with rain. The wall is plastered with fine plaster layer. In the south-eastern part there is a soot from a domestic hearth. Wall 9 (h. 1.4 m) was constructed from

*pakhsa* blocks and in the upper part there was a row of mud brick. It is attached to Wall 4. The plaster layer on the wall is well-preserved and covered with soot. At the height of 3.5 m above the level of the first floor 8 holes from mezzanine beams (h. 30 cm; w. 20 cm; w. 45 cm) were found. Wall 8 (h. 5.2 m) is shared with Room 5 and is covered with fine layer of plaster. In the northern part of the wall there are traces of burning. At the distance of 1.5 m from Wall 4 at the height of 1.3 m from the first floor there is a plastered niche (h. 35 cm; w. 15-20; d. 20 cm) for a lamp. Traces of soot are visible in the upper part. At the height of 3.5 m from the level of the first floor there are 8 holes from wooden beams identical to those in Wall 9. The beams that were originally installed in these holes formed the roof of this room. Wall 10 is almost completely destroyed. In the corner between Walls 9 and 10 there was a passage, which has not been cleared in this season. Two floor levels were identified in Room 6. The first floor has a smooth surface and slightly rises from north to south. Second floor was found in the southern part of the room. On this floor a “case” (1.7 x 3.4 x 1.7 m) was constructed made of baked brick put vertically on the smaller side. Ceramic assemblage from this room is characterized by a large percentage of cooking pots (large fragments and archaeologically complete cooking pots were found here).

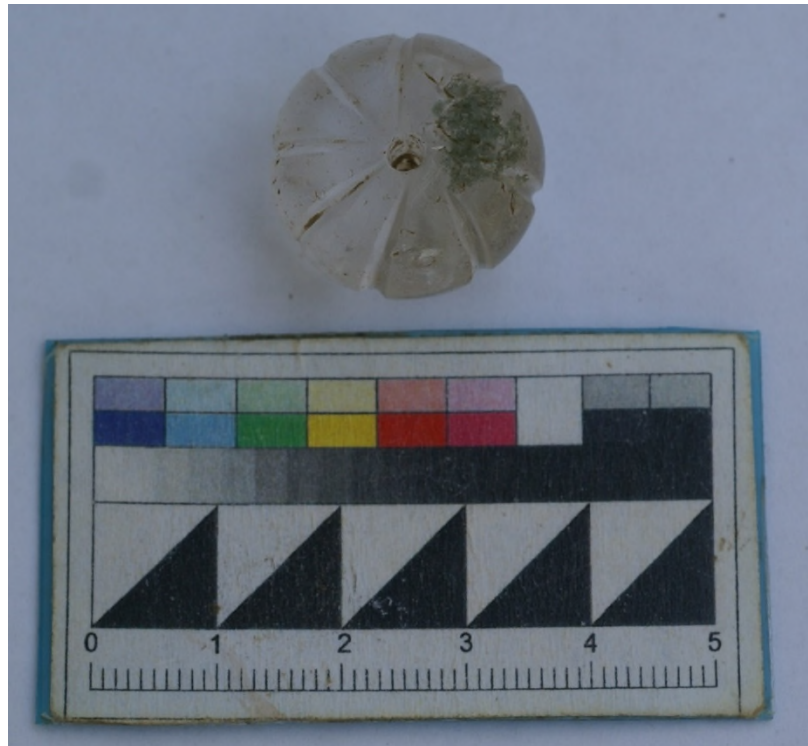
Fig. 20. Area V. Room 6. A crystal bead.

Two remarkable finds were made in the fill in this room. One is a crystal bead (Fig. 20) and another is a unique cast bronze pin, topped by a “Janus” like double image of a human head wearing a helmet (Fig. 21). The pin will be a subject of a special study.

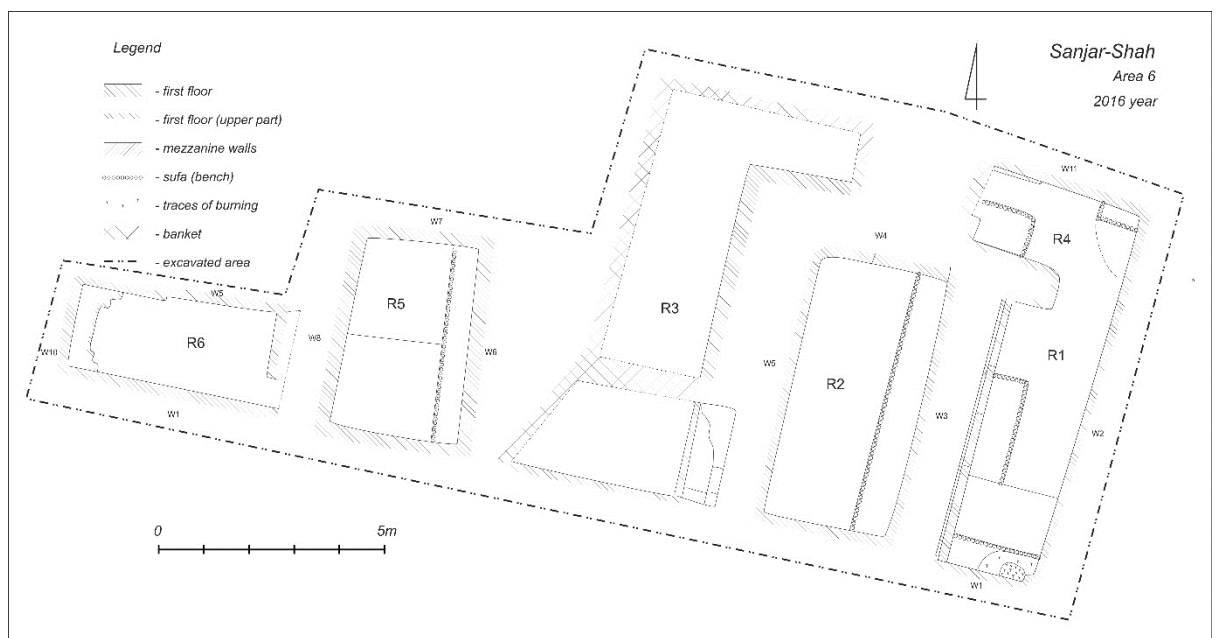
Fig. 22. Area VI. Drawing by Alexey Akulov.

This area was opened this season in the western part of the southern city wall (Fig. 22). We have excavated four vaulted rooms (1, 2, 5, 6), a courtyard (3), a tambour (4) with parts of a corridor.

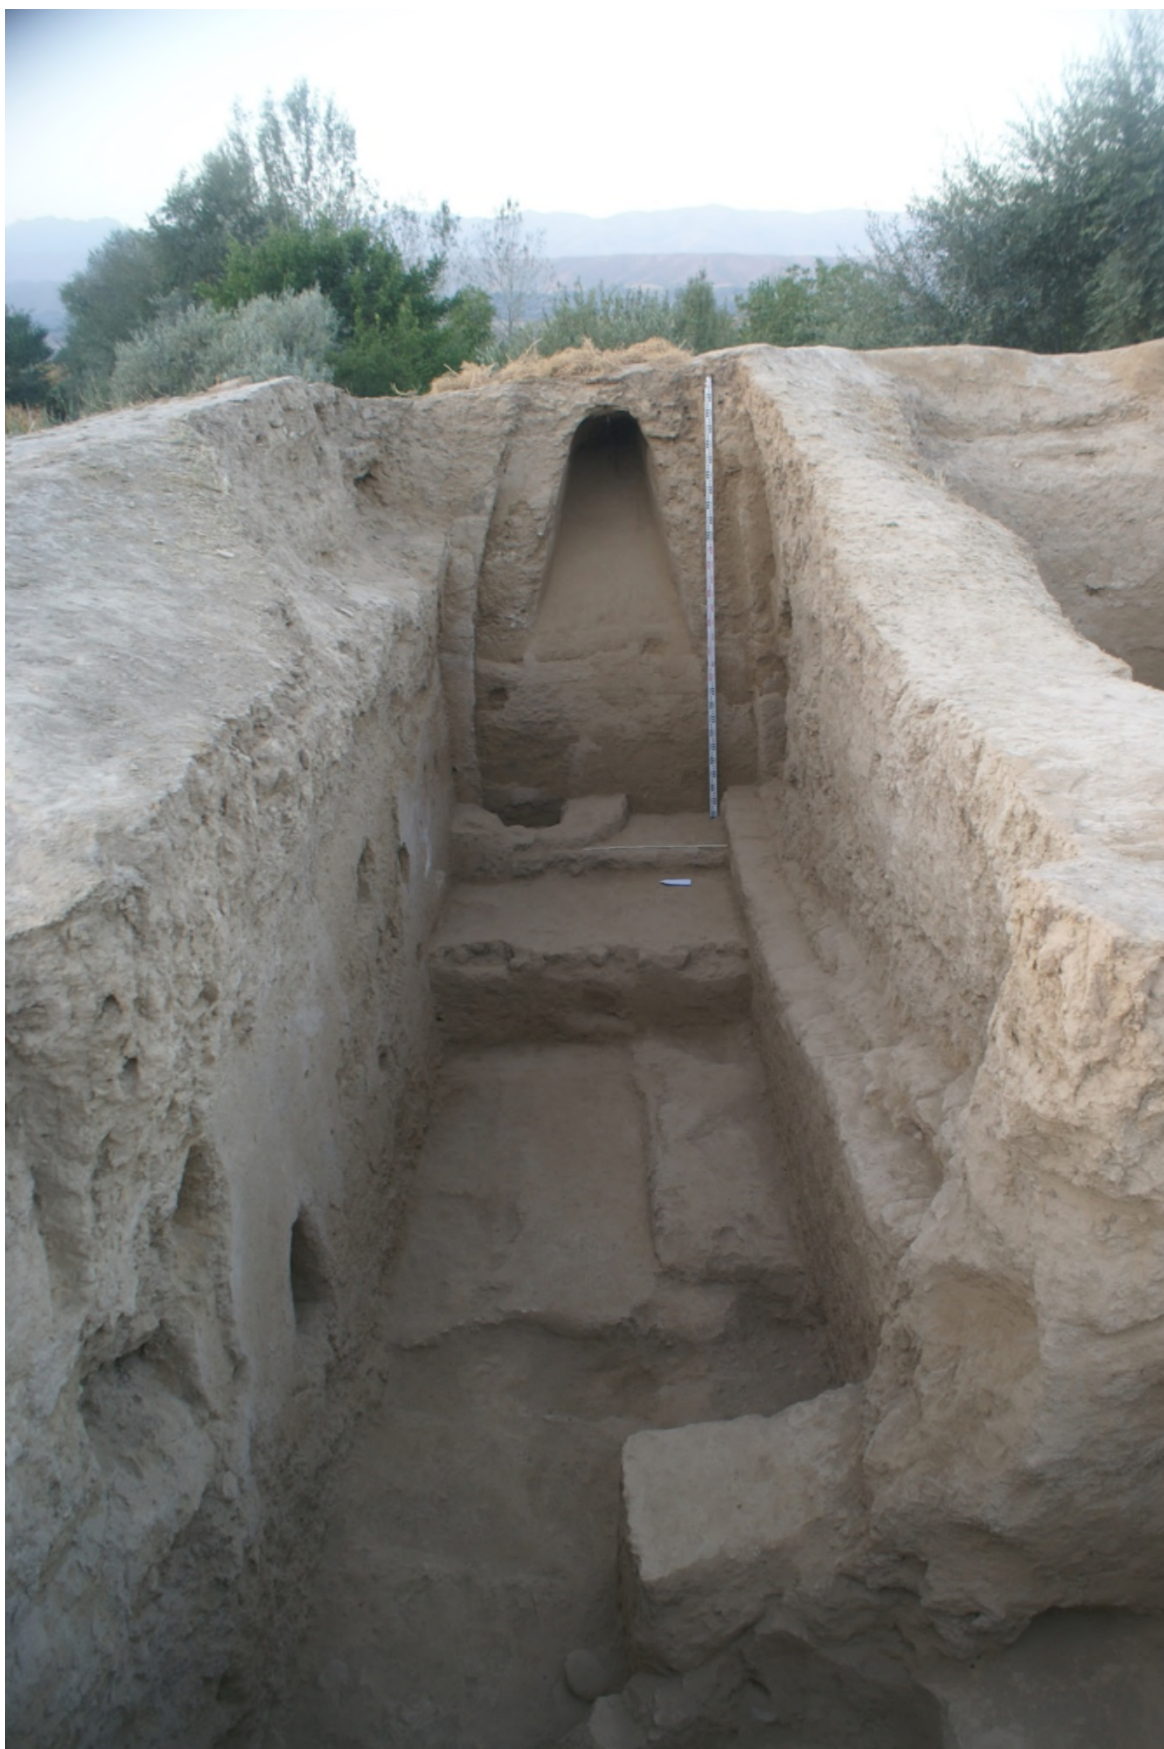
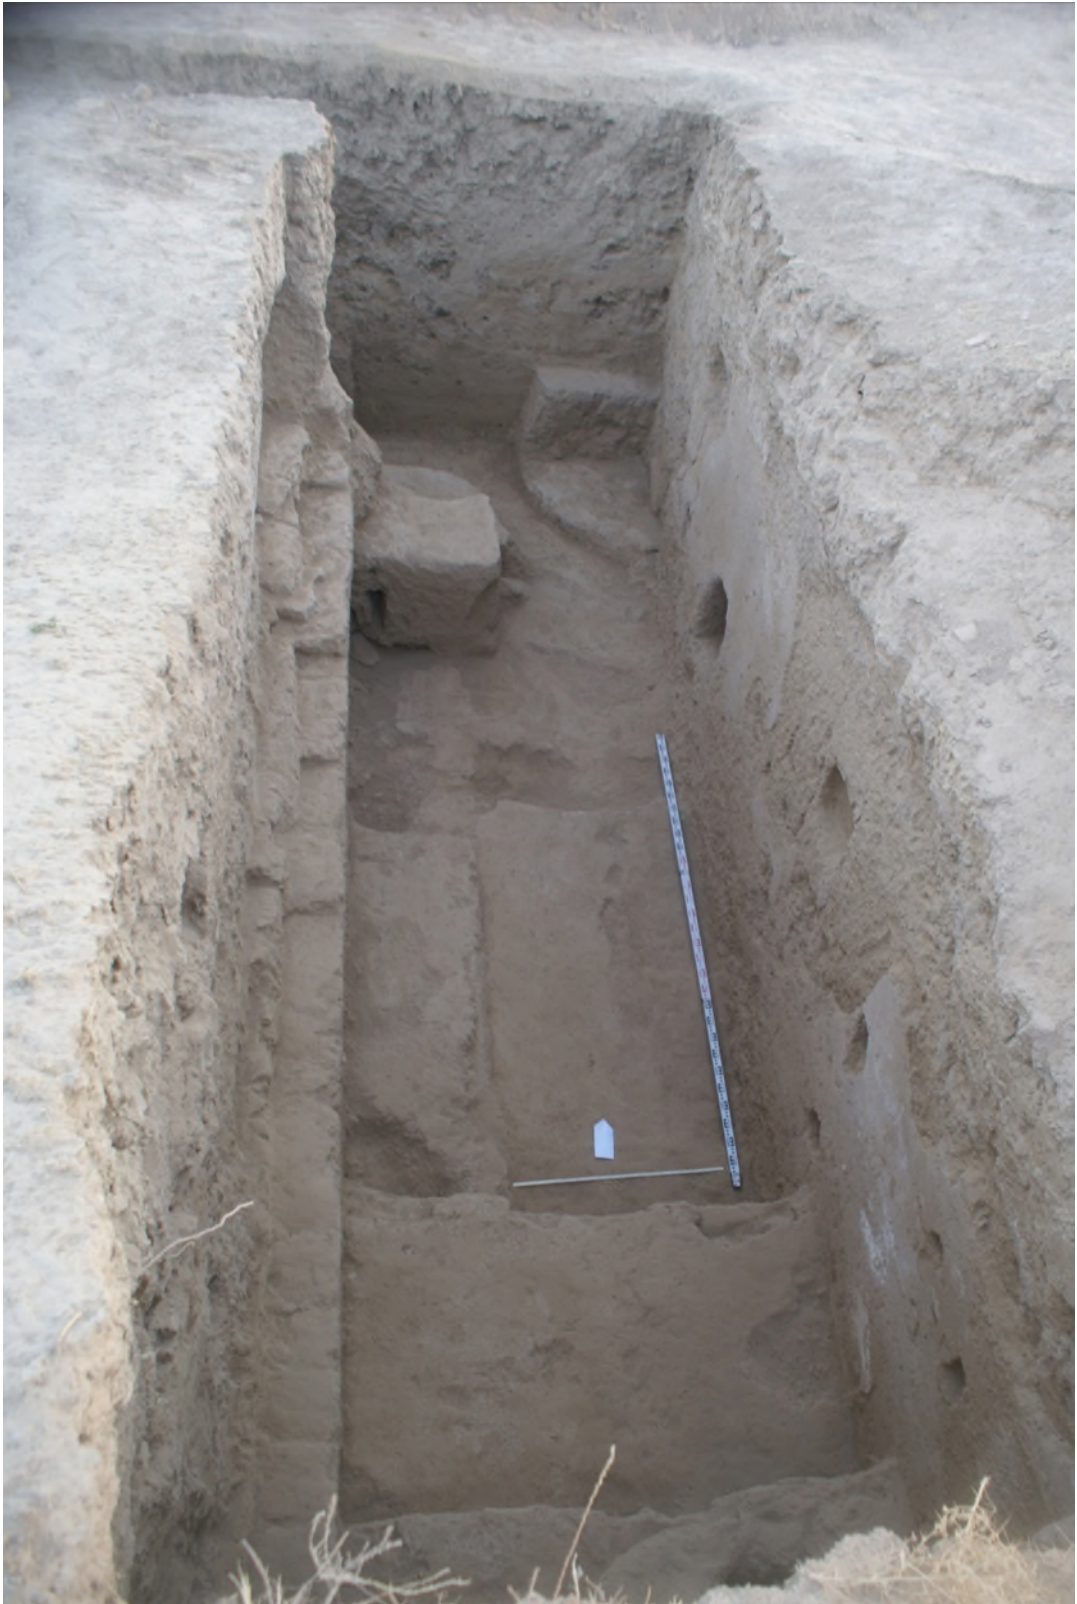
Fig. 23. Area VI. Room 1.

This room (5.8 x 2.2 m) is located on the eastern edge of the excavated area (Figs. 23-24).

Wall 1 (2.8 m) of the Room forms the inner side of the city wall. Originally, the wall was constructed entirely from *pakhsa* blocks. Later, its upper part (from 1.2 m) was repaired using mud brick. At the height of 1.2 m from the sufa and at the distance of 60 cm from Wall 3 there is a window (h. 1.5 m; w. 1.1 m; d. 1.5 m). The surface of the window is covered with soot. Wall 2 (h. 3.9 m from the earliest floor). Up to the height of 1.6 m it is built of *pakhsa* blocks and its upper part is made of standard mud brick. Vault beings at the height of 1.9 m from the floor level, and it is preserved up to the height of 1.6 m. At the distance of 2.7 m from Wall 1, at the height of 1.4 m above the level of the earliest floor there is a niche (40 x 40 x 10 m). At the distance of 2.2 m to the north there is a second niche (60 x 50 x 35 cm). Wall 4 (h. 75 cm from the level of the earliest floor; w. 70 cm) is built from *pakhsa*. Wall 3 (h. 2.8 m) is built from standard mud brick up to the height of 1.3 m. Plaster is not preserved. The upper part of the wall was built later. On this part of the wall there are trace of plaster. The lower part of the wall projects forward for 25 cm. Wall 3 is attached to Wall 1.

Two floor levels were found in this room. The first floor is found at the depth of 3.5 m from the surface level. The floor is smooth, solid and yellowish. A sufa (h. 15 cm; w. 70 cm) was constructed on this floor along Walls 3 and 1. In the sufa attached to Wall 1, in the corner with Wall 2, a semi-circular hearth was found (h. 45 cm; l. 1.15 m; 30 cm). The inner part of the hearth is circular and is built from the halves of bricks placed vertically (Fig. 25). The hearth shows traces of intense burning. The second floor was found at the depth of 60 cm from the first floor. The surface is irregular, solid and has yellowish color. A small sufa (h. 20 cm; w. 70 cm) is attached to Wall 4. The sufa has a yellowish plastering.

It seems that this room was used for dwelling. Soot on the walls testifies to the intense use of hearth. The window which is located directly above the hearth probably also served as chimney.
