## **Sanjar-Shah Excavations Report 2016**

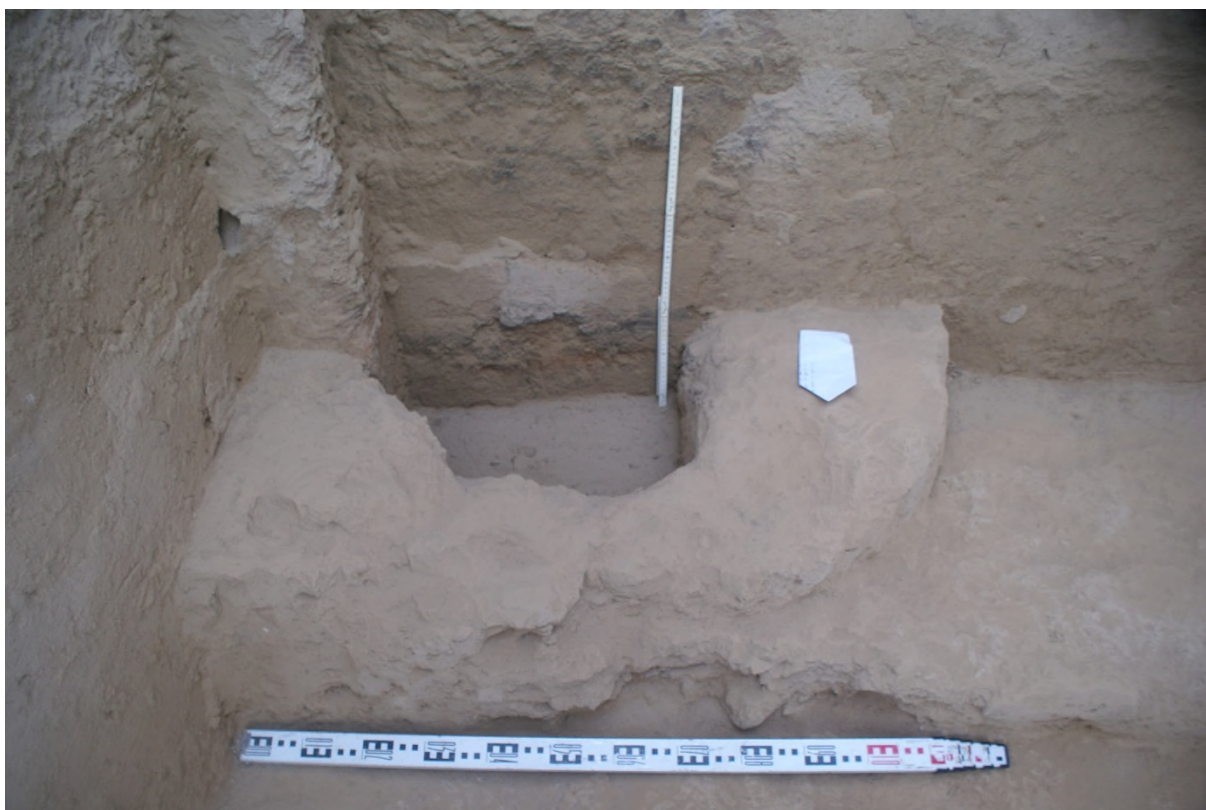
Fig. 25. Area VI. Room 1, hearth.

Two floor levels were found in this room. The first floor is found at the depth of 3.5 m from the surface level. The floor is smooth, solid and yellowish. A sufa (h. 15 cm; w. 70 cm) was constructed on this floor along Walls 3 and 1. In the sufa attached to Wall 1, in the corner with Wall 2, a semi-circular hearth was found (h. 45 cm; l. 1.15 m; 30 cm). The inner part of the hearth is circular and is built from the halves of bricks placed vertically (Fig. 25). The hearth shows traces of intense burning. The second floor was found at the depth of 60 cm from the first floor. The surface is irregular, solid and has yellowish color. A small sufa (h. 20 cm; w. 70 cm) is attached to Wall 4. The sufa has a yellowish plastering.

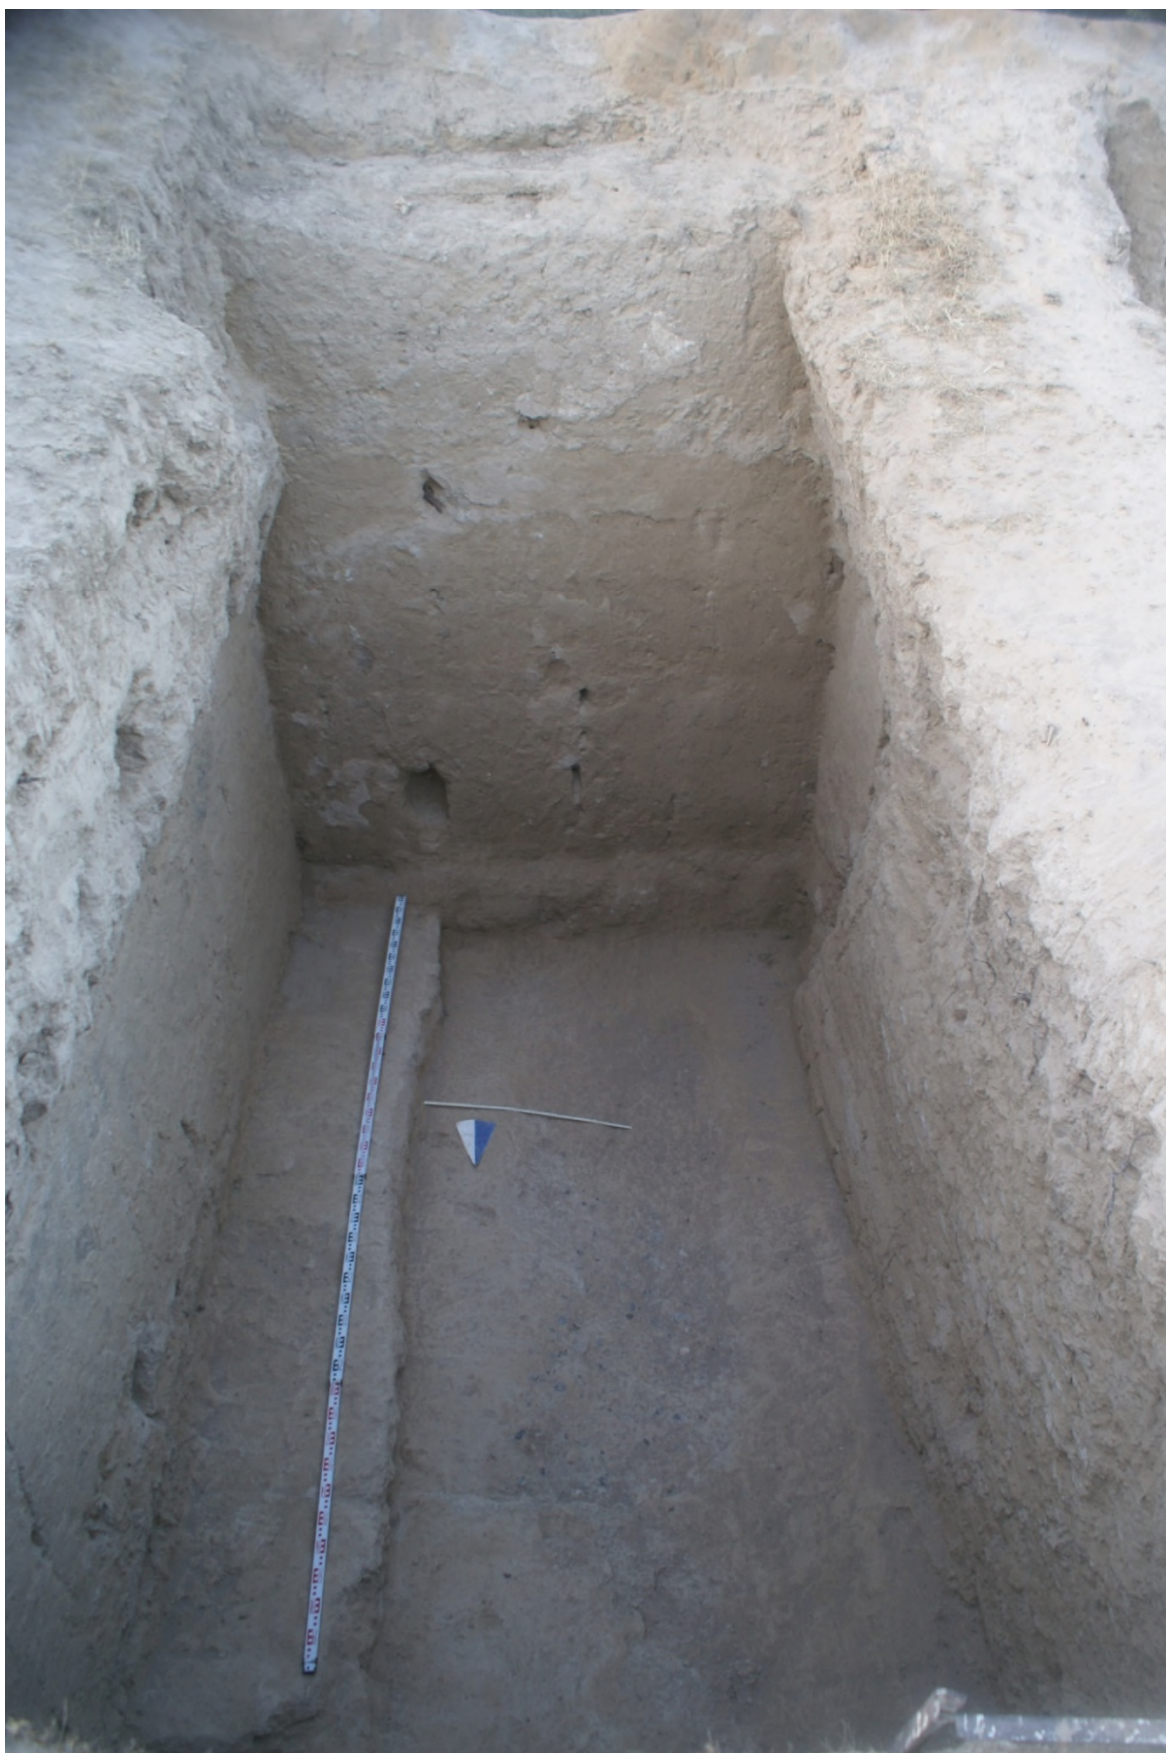
Fig. 26. Area VI. Room 2.

This room (5.5 x 2.7 m) is situated to the west of Room 1 and has a rectangular shape (Fig. 26). Wall 1 (h. 4.4 m) which corresponds to the inner side of the city wall is built of *pakhsa* blocks and is plastered. The lower part of the wall shows traces of burning. Along the whole length of the wall, at the height of 2.6 m there is a rectangular “chest-like” installation. The bottom of the installation is hard and yellowish with traces of alabaster plaster. Originally, it was placed on two wooden beams whose holes are visible in the walls. The northern wall of the installation is not preserved. Wall 3 (h. 2.3 m from the sufa level) is built of *pakhsa* blocks. It has two layers of plaster. The early layer is completely burned. At the height of 1.8 m from the sufa there is a cornice of the vault which is preserved up to 1 m and built of standard mud brick. The vault hangs over the room and projects forward for 30 cm. His total height from the sufa level is 2.8 m. Two holes for wooden beams (25 x 20 x 30 cm) were made in the room at the height of 1.9 m from the sufa level. The first hole is situated at the distance of 30 cm from Wall 1 and the second is made 50 cm further to the north. Wall 4 (h. 2.8 m) is built of *pakhsa* blocks and is attached to Wall 3. At the distance of 1.2 m from Wall 5 there is a passage. Since this part of the wall is not preserved well, the dimensions of the passage are still to be established in the next season. Wall 5 (h. 2.8 m from the floor level) is made of standard mud brick. The plaster is not preserved. In the southern part of the wall there is a passage (h. 2 m; w. 1 m) which was later filled with *pakhsa* blocks. Above this blocked passage at the height of 2.2 m from the floor level, there are two beam holes. The first one (25 x 20 x 45 cm) is made 25 cm to the north of Wall 1, the second one has a slightly bigger dimensions (30 x 20 x 55 cm). A sufa (h. 30 cm; w. 70 cm) was constructed along the

entire Wall 3. It is built of mud brick and plastered with solid, yellowish plaster. The southern part of the sufa is better preserved than the northern part.

Only one floor level was identified in this room. It has an irregular surface of yellowish color. In the middle of the room there is a deepening (d. 15 cm; w. 60 cm) characterized by slightly green surface and the presence of pebbles. In the ceramic assemblage found in this room particularly notable is an almost complete small vessel probably used for incense.

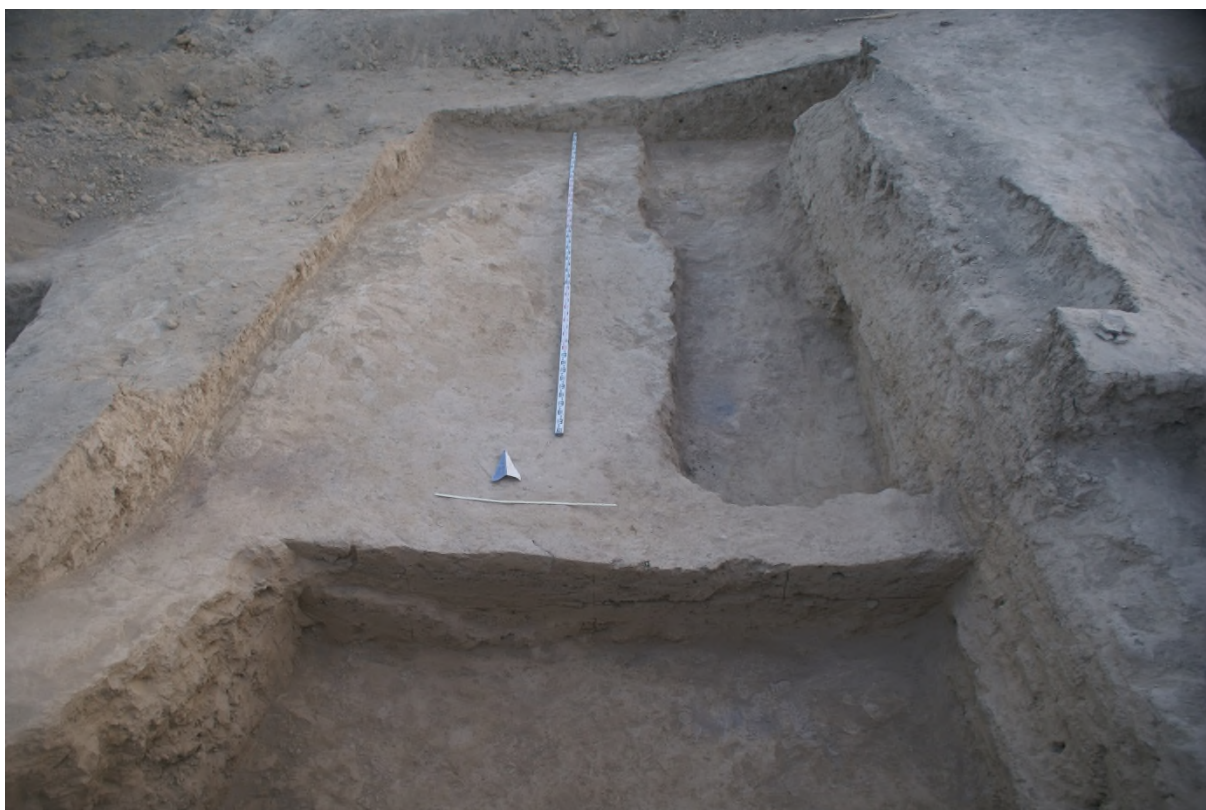
Fig. 27. Area VI. Room 3.

Room 3 is situated to the west from Room 3 and was only partially excavated this season (Fig. 27). Large dimensions (l. 8.3. m; w. 4.4 m) of already investigated area indicate that this room was probably in fact a courtyard. Wall 1 (h. 3 m from the third floor) is the inner side of the city wall and is made of *pakhsa* blocks. The plaster is not preserved. Wall 5 (h. 1.3 m from the second floor; l. 7.3 m) is built of standard mud brick. This wall stands on the second floor. Three floor levels were identified in this room. The first floor was found at the depth of 90 cm from the top of Wall 5. The surface is irregular and is of light green color. In the western part of the room the floor level is significantly higher. It seems that from this floor there was an ascent to the upper floors. The second floor was found at the depth of 20 cm from the first. It is also of green color, but is characterized by small pieces of charcoal. Similar to the first floor, it also rises to the west. The third floor was only partly preserved at the depth of 30 cm from the second floor. The surface is relatively smooth, of yellowish color in the southern part and of green color in the northern part of the room. In the northern part of the room we have started excavating a corridor going eastwards. The width of the already excavated passage is 1.5 m. Wall 4 in this room is preserved up to the height of 1.5 m. The excavations of this corridor will be continued in the next season.

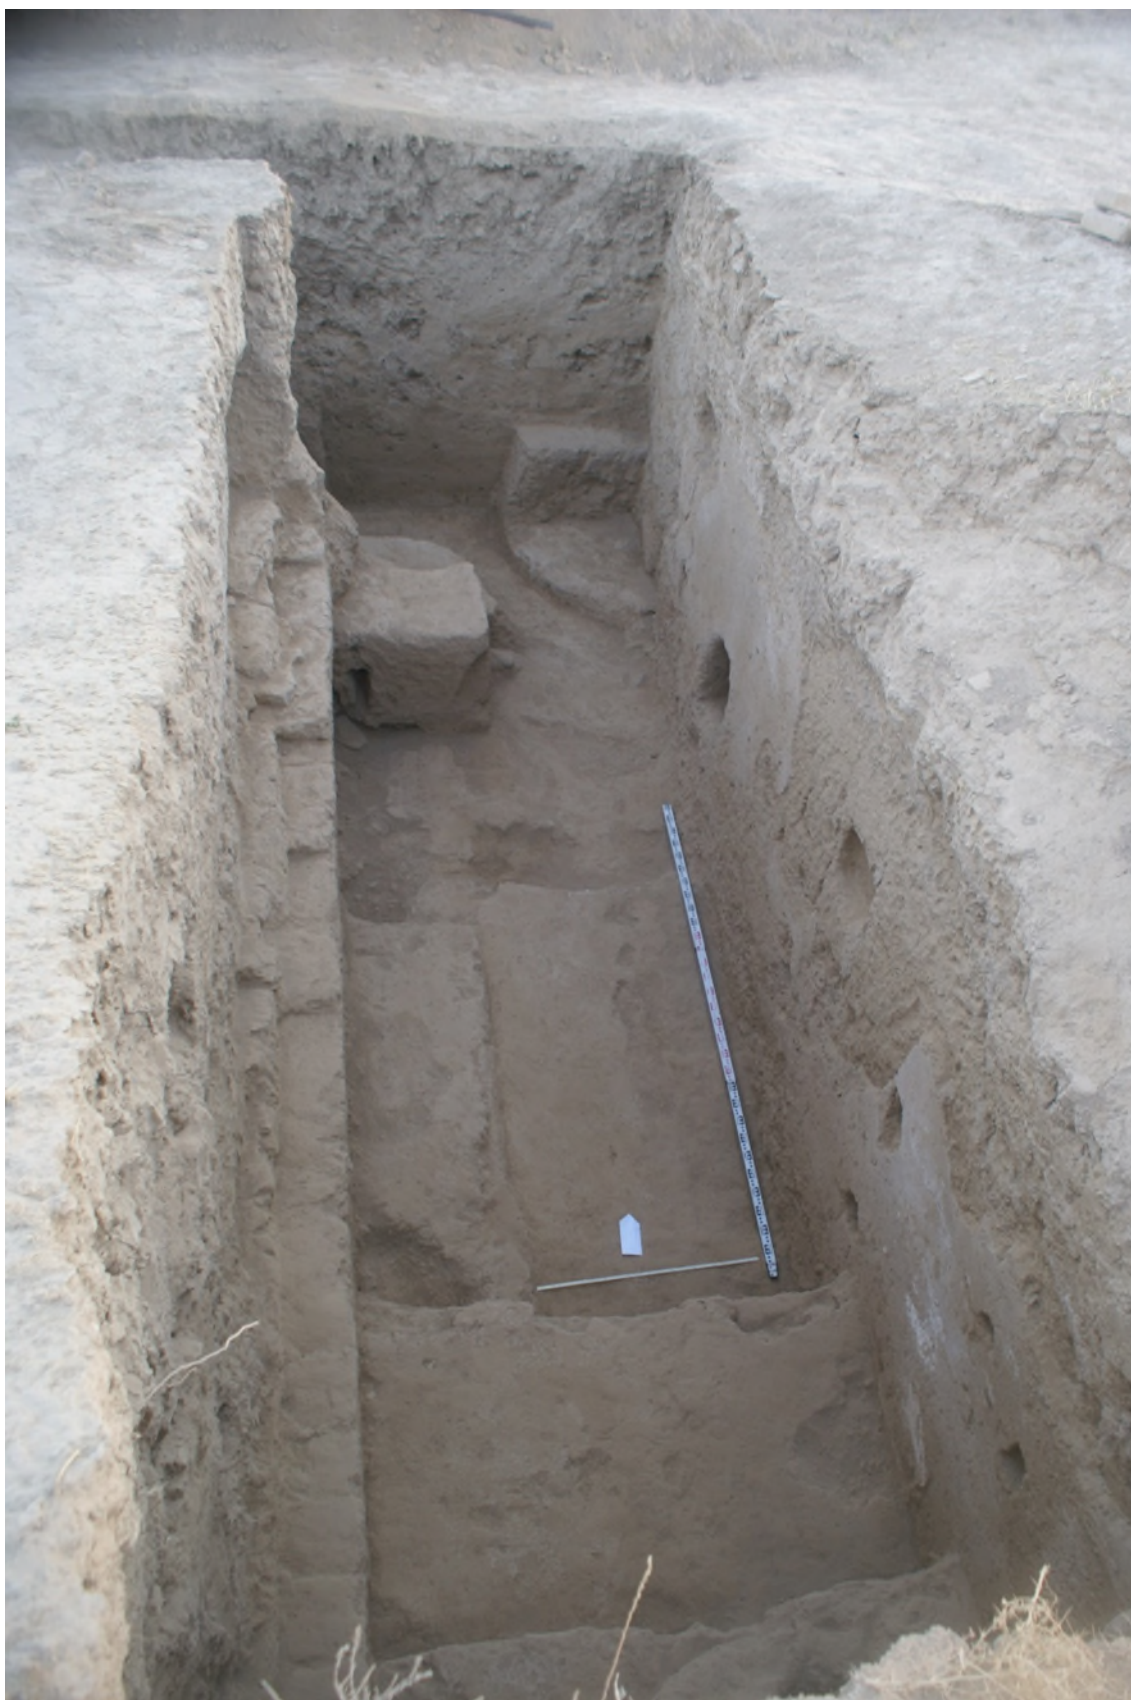
Fig. 28. Fig. VI. Room 4.

Room 4 is located to the north of Room 1 (Fig. 28). It probably functioned as a corridor and it has three passages, to Room 1, to the north and to the west. Wall 4 (h. 2 m) is shared with Room 1 and is made of *pakhsa* blocks. In some places of the surface a layer of plaster is preserved. Attached to the Wall there is a repair wall (h. 90 cm; l. 1.2 m) which projects forward for 95 cm. Wall 2 continues from Room 1. In the northern part there is a semi-circular sufa (h. 70 cm; w. 1.5 m) attached to it. In the Wall 3 there is an arched passage (h. 1.8 m; w. 1.2 m). In this room there are two levels of floor that correspond to those in Room 1.

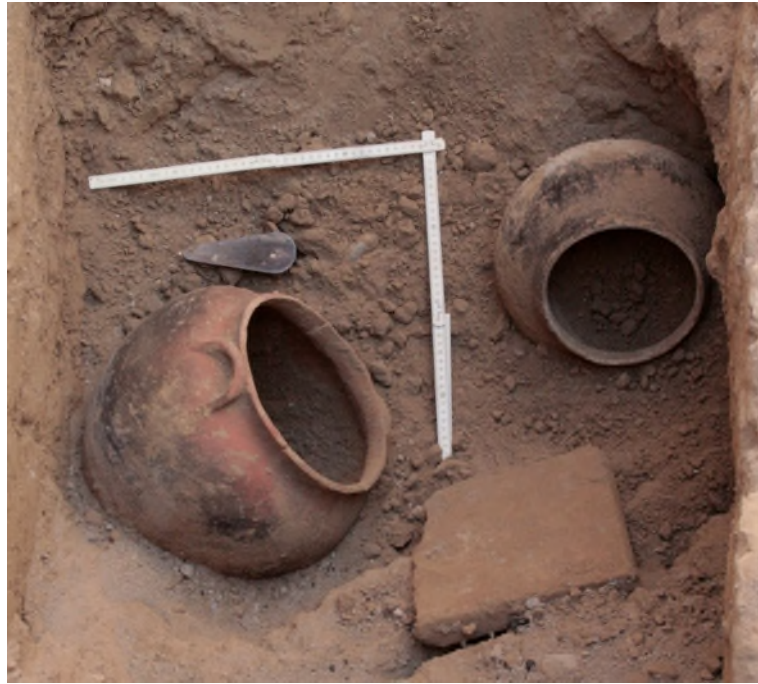
Fig. 29. Area VI. Room 4. Cooking pots.

Two complete cooking pots were found in this room (Fig. 29)

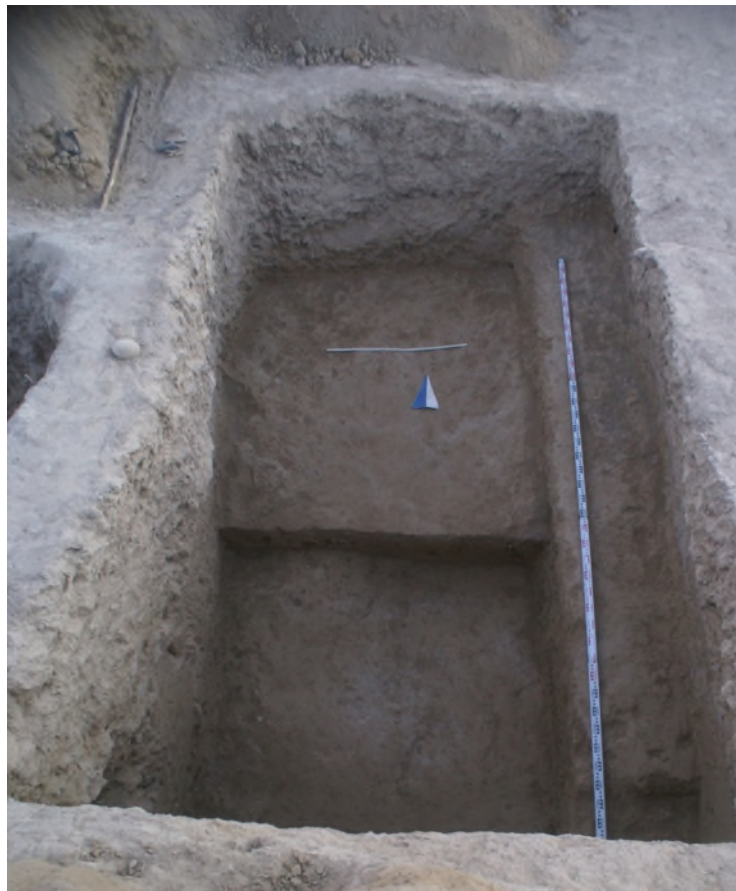
Fig. 30. Area VI. Room 5.

This room (4.2 x 2.9 m) is located to the west from Room 3 (Fig. 30). It has two passages and a sufa installed along the Wall 6. Wall 1 here is preserved up to the height of 4.1 m. The plaster is sooty. Wall 6 (h. 1.6 m from the sufa level) is made of *pakhsa* blocks. Fragments of plaster layer are preserved on the wall. At the height of 55 cm from the sufa level there is a vault (h. 1 m). The vault is plastered and also here, the plaster is sooty. Wall 7 (h. 1.2 m) is built of mud brick and is quite badly preserved. In the western part of the Wall there is a passage (w. 1 m) to the still unexcavated room. Wall 8 (h. 2.5 from the second floor) is built of *pakhsa* and its preservation is bad. Like the other rooms it was also vaulted. The vault begins at the height of 1.2 m from the level of the second floor. In the southern part of the wall there is a passage (h. 1.4 m; w. 1 m) to Room 6. A sufa (h. 35 cm from the first floor; w. 60 cm) is found adjacent to Wall 6. Its surface is solid and is of yellowish color. The first floor has a slightly green color. The second floor was found at the depth of 30 cm from the first one and is of the same color and substance.

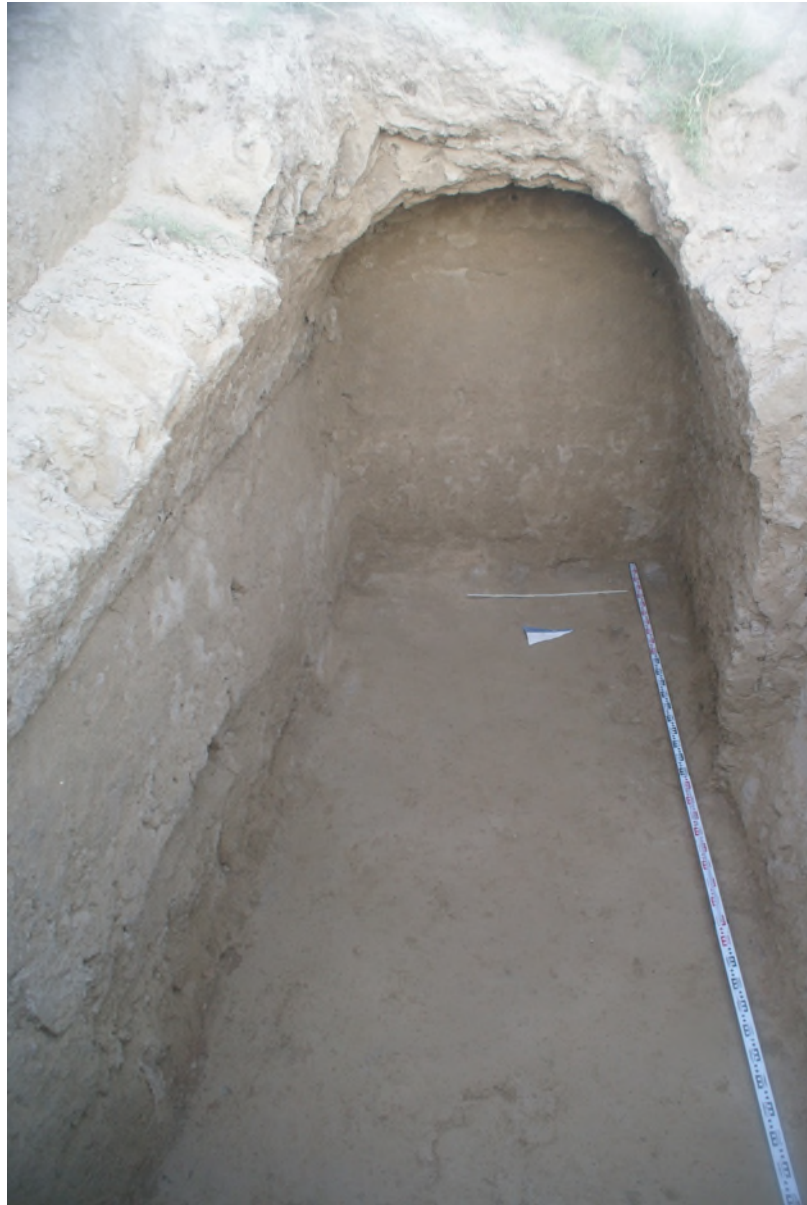
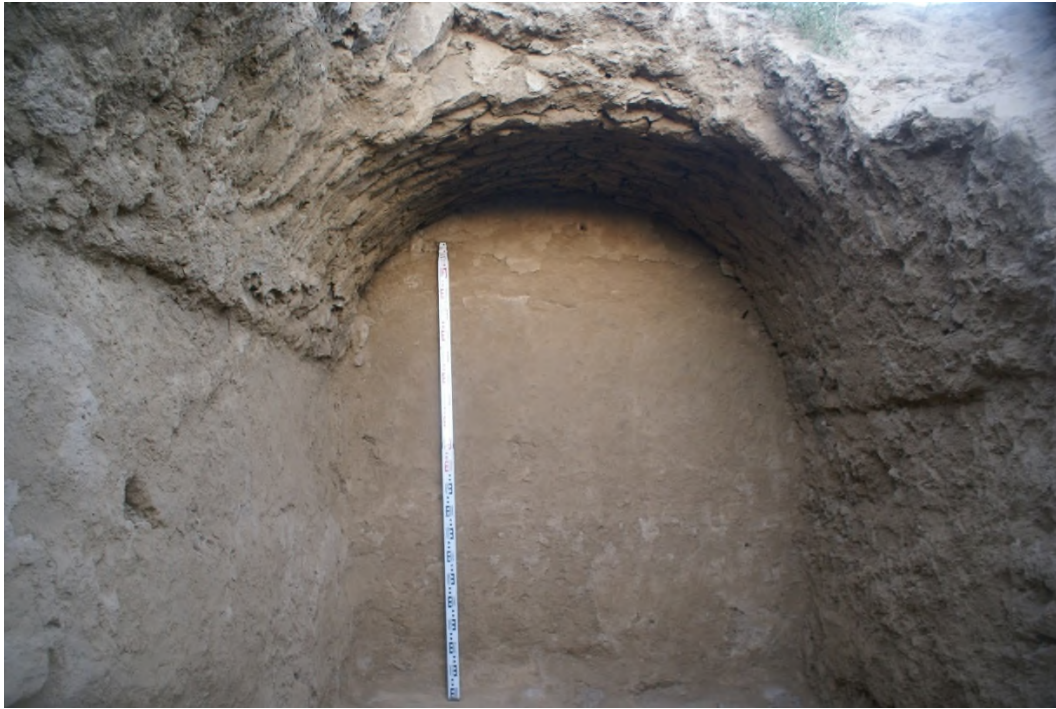
Fig. 31. Area VI. Room 6.

This room (4.4 x 2.2 m) is located to the west of Room 5 (Figs. 31-32). Wall 1, which corresponds to the city wall is preserved in this room up to the height of 3.2 m. It is built from *pakhsa* blocks and was plastered with two layers of plaster. This room was also vaulted and the vault begins at the height of 1.5 m above the floor level. The cornice of the vault is found at the height of 1.3 m. The vault is built of mud brick and its height was 2.35 m from the floor level. Wall 8 (h. 2.5 m; w. 1.7 m) is shared with Room 5 and is badly preserved. It is made of *pakhsa* blocks. In the southern part of the wall there is a passage (h. 1.3 m; w. 70 cm) at the distance of 1.5 m from Wall 9. Wall 9 (h. 2.5 m) is constructed of mud brick. Wall 10 (h. 2.35 m) is built of mud brick and has a thin layer of plaster. The floor is constructed of standard mud brick and is plastered. One floor level was identified in this room. It has a smooth, solid and yellow surface.

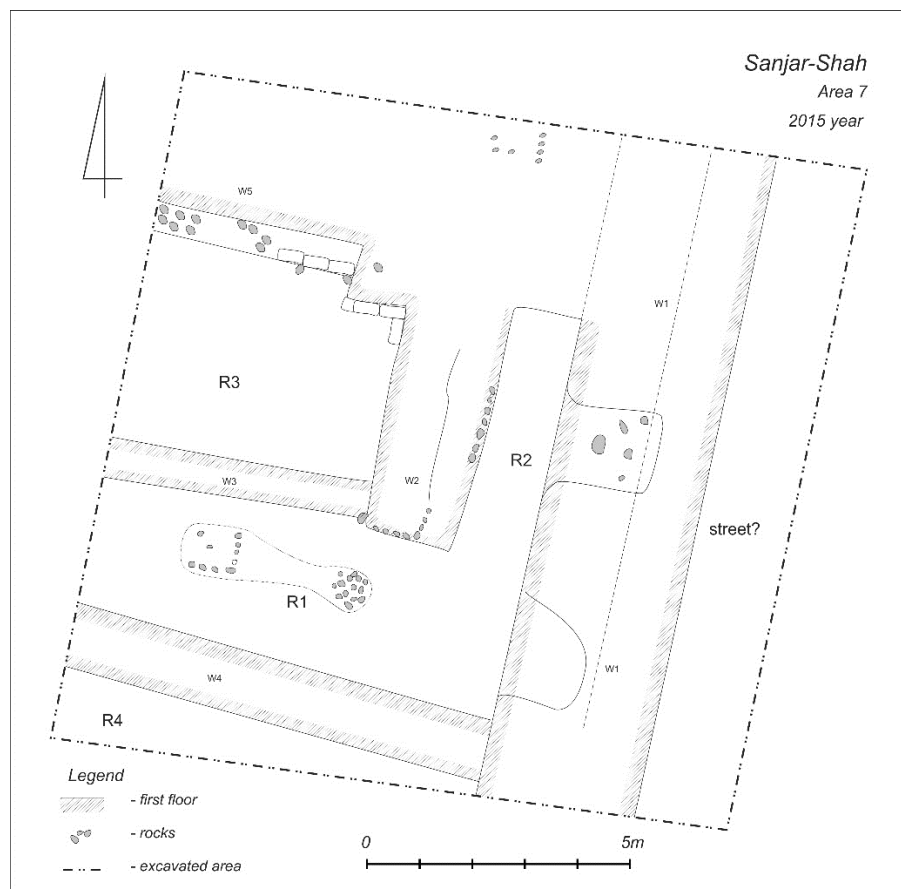
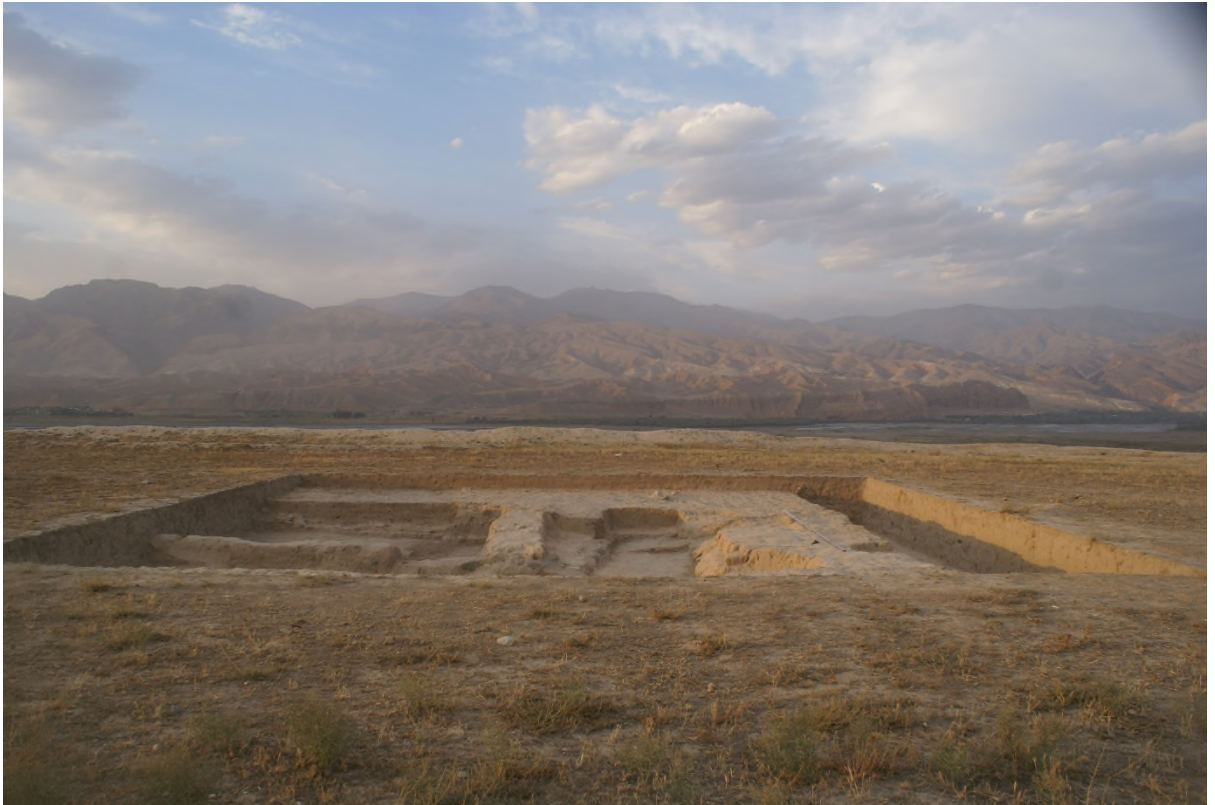
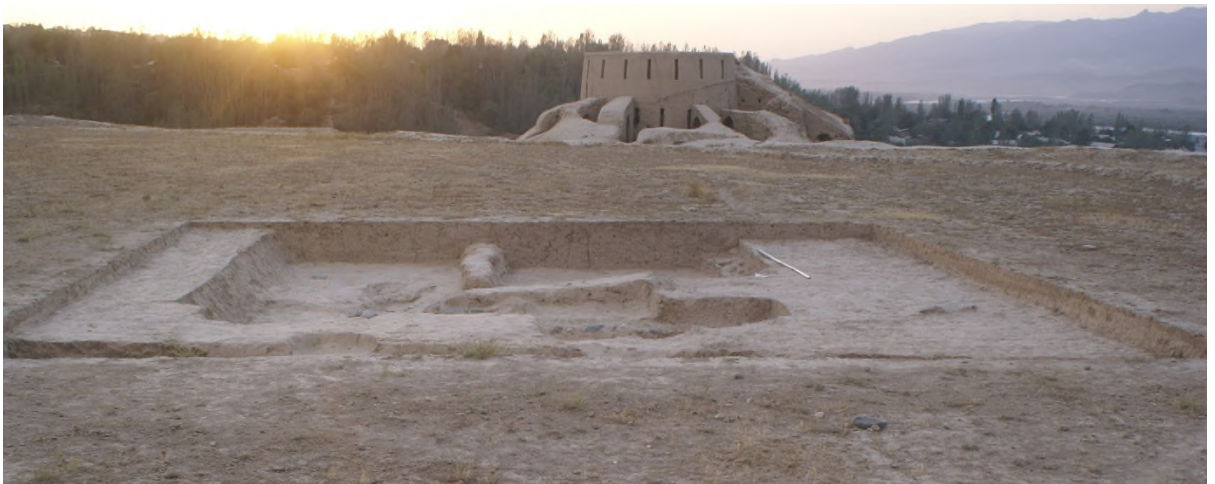
Fig. 33. Area VII. Drawing by Alexey Akulov.

This season we have continued excavations started last year in the northwestern part of the site, close to the Round Tower (Area I) (Fig. 33-35). This is the first time that the western part of Sanjar-Shah becomes subject of archaeological investigations, because in the Soviet period this part was completely levelled by bulldozers for agriculture. Therefore, also the soil here is extremely hard and difficult for the excavations. We have opened an area of 13x13 m in the place where a large, rectangular building was identified by us on the air photos of the site. Indeed, we have excavated a huge Wall 1, 3 m thick, whose exact function is not clear at this stage (Fig. 36). To the east of the Wall 1 we have excavated so far a small, elongated area (1.9 x 13 m) for a depth of 1.2 m. Two layers of grey color were identified. The first one at the depth of 55 cm from the surface level, and the second one at the depth of 25 cm from the

first. In the southern part of the excavated area at the depth of 25 cm there is a layer of soil (6-10 cm thick) with a large admixture of ashes. Wall 1 is preserved to the height of 80-90 cm.
